CT&F - Ciencia, Tecnología y Futuro Vol 11, Num 1 June 2021. pages 11 - 20

# EVALUATION OF PERFORMANCE AND EARLY DEGRADATION OF A 180.8 KWP ROOFTOP ON A GRID-CONNECTED PHOTOVOLTAIC SYSTEM IN A COLOMBIAN TROPICAL REGION ENVIRONMENT

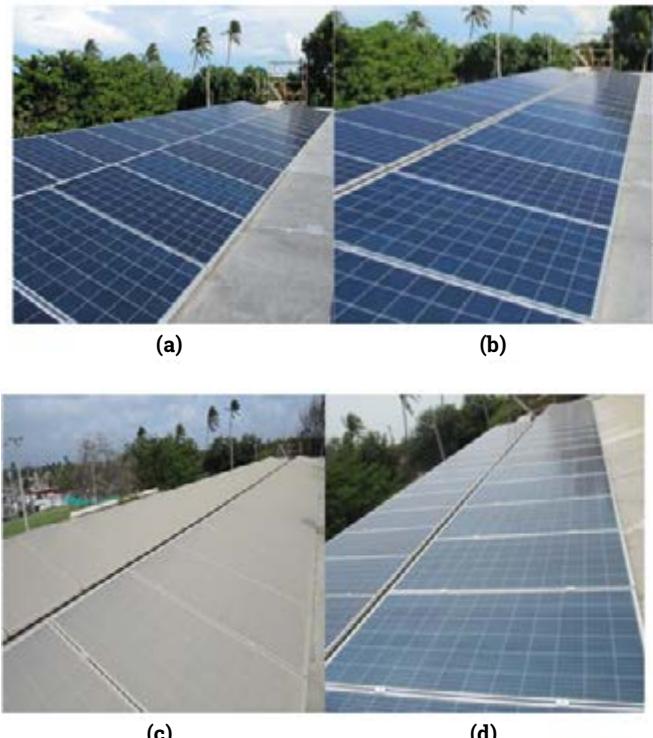
**Figure 2** shows panoramic images of the same row of PV modules in the four inspection periods. Dust concentration is a direct function of dry (December – March) and rainy periods (April to November), an image corresponding to the end of dry periods (march before clean-up) shows high dust concentration. After the cleaning process there is a slight deterioration in the modules' color as compared to the first inspection. According to **Table 1**, the identified failure mode is discoloration.

**Figure 2.** Panoramic images of the same row of PV modules in the four inspection periods: a. October 2018, b. January 2019, c. March 2019 (before clean up), d. March 2019 (after clean up)

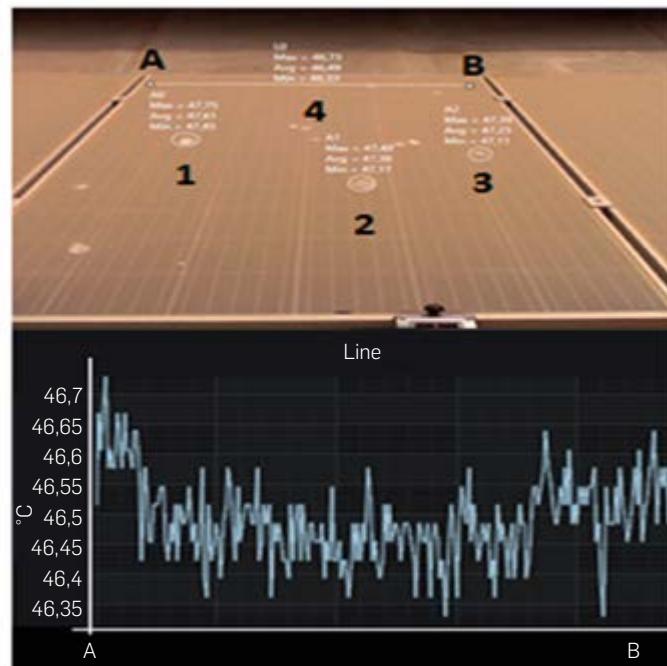
During the third inspection, a high level of dust content and a significant quantity of bird droppings were observed in the modules. A thermal analysis was performed to assess the module temperature performance; this analysis showed that the dust level maintains a homogeneous temperature on the surface, whose maximum value was 46.7 °C and minimum value was 46.35 °C, see **Figure 3**. Apparently, as the level of dirt increases, the modules temperature decreases; this phenomenon could be caused by the change in the amount of energy passing through the dirt layer.

Point	1	2	3	4
Max Temp. °C	47.75	47.48	47.39	47.73
Avg Temp. °C	47.61	47.36	47.25	46.49
Min Temp. °C	47.45	47.17	47.11	46.33

**Figure 3.** Thermal Analysis to assess module temperature performance

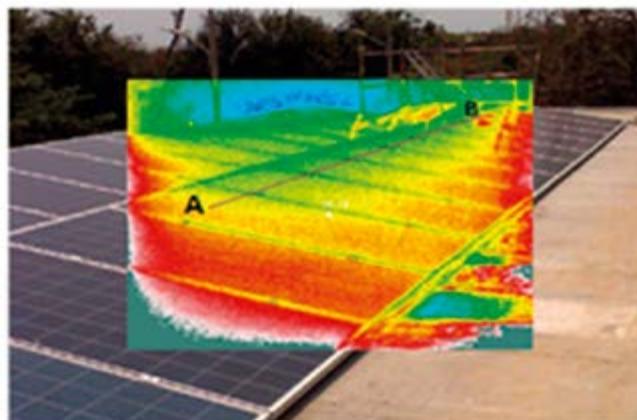
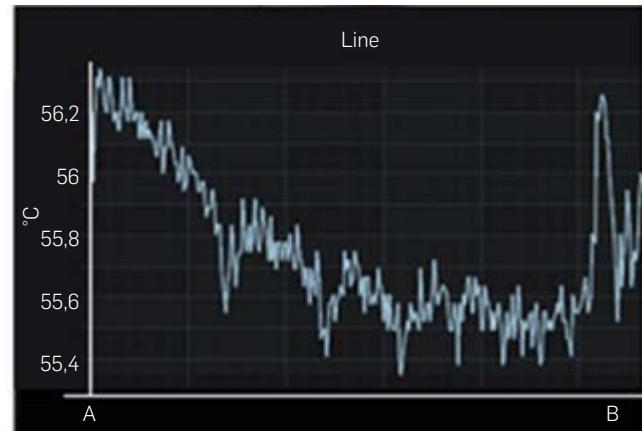
A thermal analysis was carried out after the cleaning process; such analysis showed that the modules temperature in the analyzed row varies by less than 1 °C. It was also noticed that discoloration has not generated changes in module temperature so far, see **Figure 4**.

**Figure 4.** Thermal Analysis after clean up to assess module temperature performance

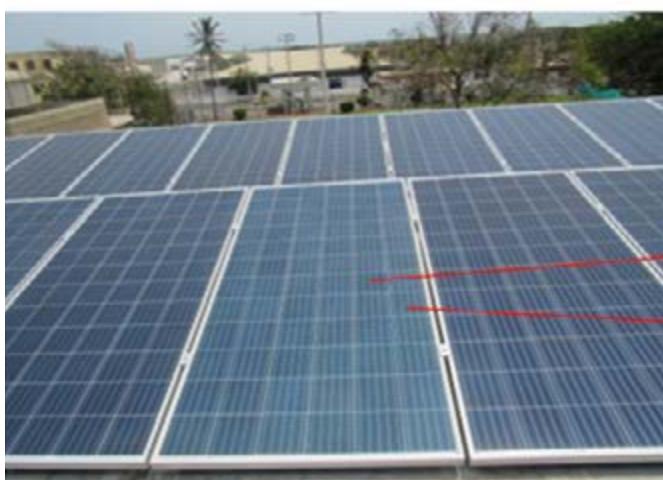
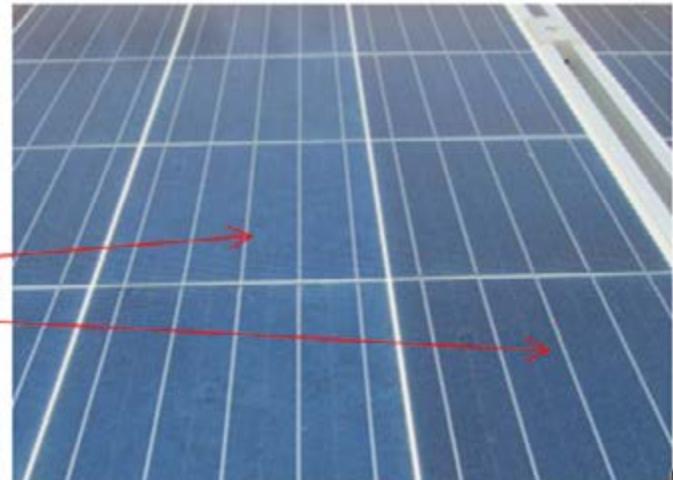
**Figure 5** shows a discoloration between cells in the same PV module. A thermal analysis was carried out to assess the effect on module temperature; however, thermography indicated that the variation between these points did exceed 1 °C, see **Figure 6**.

**Figure 5.** Discoloration between cells in the same PV module

The early degradation analysis suggests discoloration as the most common failure mode. However, according to Figures 5 and 6, at this time, there is not a substantial contribution of this failure mode on module temperature. This phenomenon could cause a problem if there would be a loss of adhesion between the encapsulating polymeric and the cells of the module, causing penetration of water within it. There are no failure modes such as delamination, corrosion

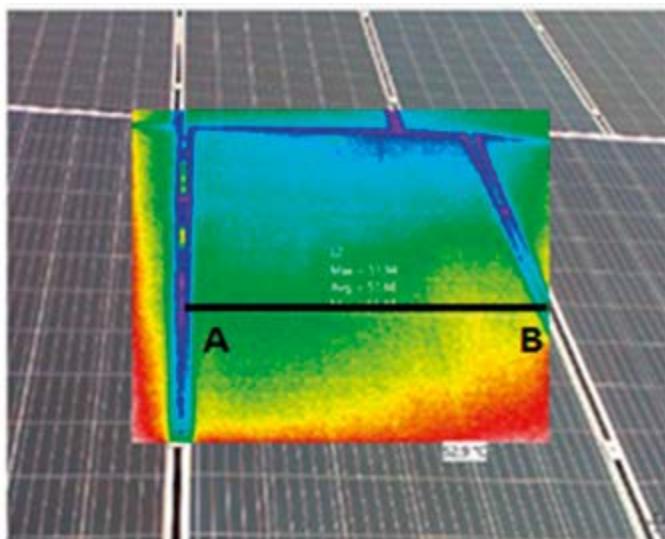
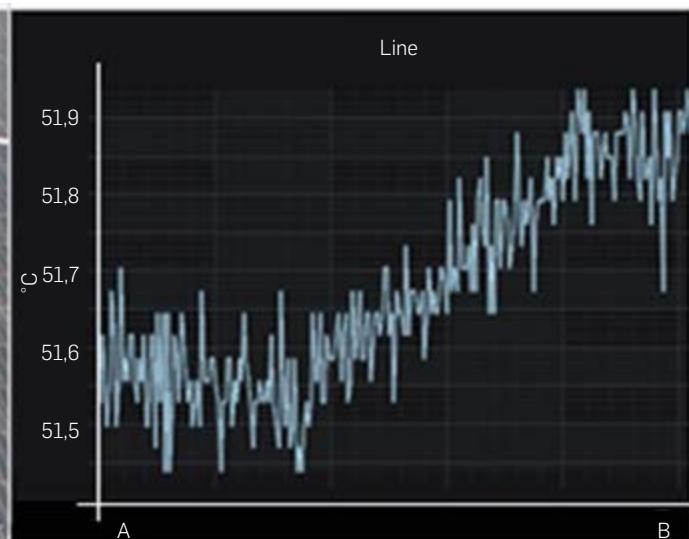
**Figure 6.** Thermographic analysis in cells which present discoloration

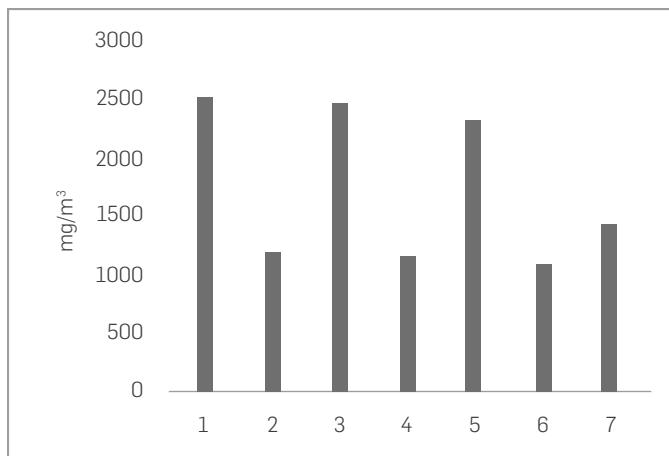
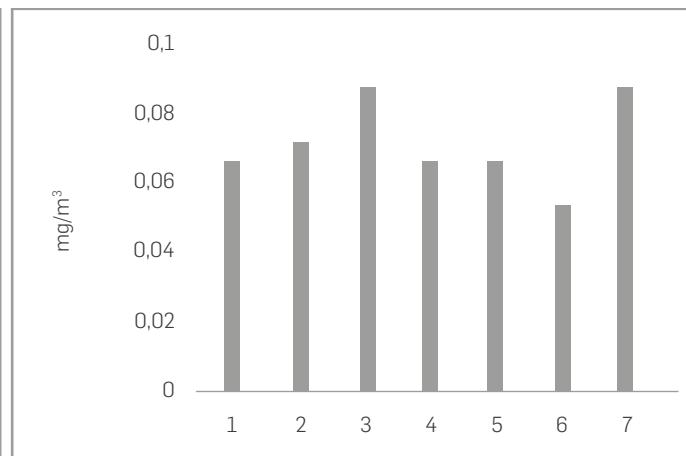
According to ISO 9223 [26], it is possible to categorize outdoor atmospheric corrosivity into 5 levels: very low (C1), low (C2), medium (C3), high (C4) and very high (C5) according to the content of  $\text{SO}_2$  and chloride type contamination [27, 28]. Given the results of the dust samples obtained, the sulfide concentration exceeded  $30 \mu\text{m}/\text{m}^3$  and levels up to  $2500 \text{ mg}/\text{m}^3$ , placing it in a high corrosivity category (C4). With this information, it is then estimated that the degradation of the aluminum structures of the photovoltaic panels is generated by the loss of mass between  $2\text{--}5 \text{ mg}/\text{m}^2 \text{ year}$  assuming uniform corrosion, which must be frequently evaluated to identify localized corrosion faults.

**Figure 11.** (a) Chlorides concentration ( $\text{mg}/\text{m}^3$ ); (b) Sulphides concentration ( $\text{mg}/\text{m}^3$ ) material taken from the surface of photovoltaic panels
