# Identification and analysis of pathological defect appearance in superstructures of reinforced-concrete bridges in Chapare region, Bolivia

Joaquin Humberto Aquino Rocha <sup>a</sup> & Rolando Ibarra-Villanueva <sup>b</sup>

Received: June 12<sup>th</sup>, 2020. Received in revised form: November 19<sup>th</sup>, 2020. Accepted: November 27<sup>th</sup>, 2020.

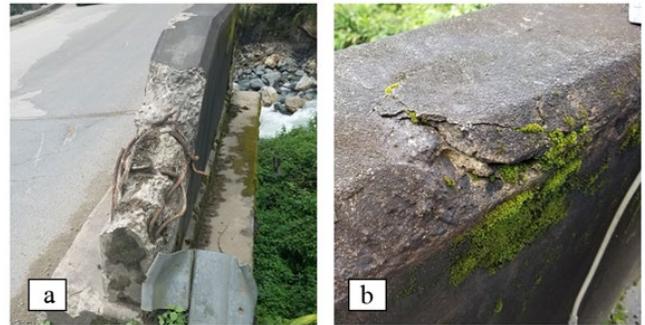
During visual inspection, fissures and concrete disintegration exposing armatures were found in every case. Latter issue is due to steel corrosion process, which gradually evidenced reinforcement exposure with oxidation and loss of cross section (Fig. 4). In addition, it was also evidenced that in some cases it was produced by a motor vehicle accident on the bridge (Fig. 5).

Figure 4. Disaggregation of concrete and armatures exposed: a) San Jacinto and b) Ronco bridges. Source: The authors.

Concrete in bridges is acceptable in terms of compression resistance, but corrosive processes that produce disaggregation and armature exposition compromise it. For this issue, different techniques for structural recovery could be implemented, but corrosion process is advanced, and risk of collapse is present. Intervention or structures replacement should be implemented once they serve their useful life [30].

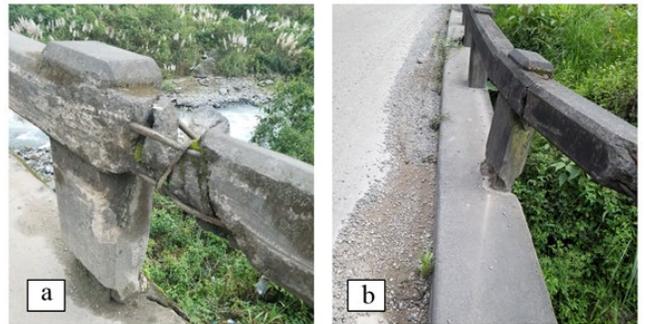
Figure 5. Structures impacted by accidents: a) Roquemayu and b) Ronquito bridges. Source: The authors.

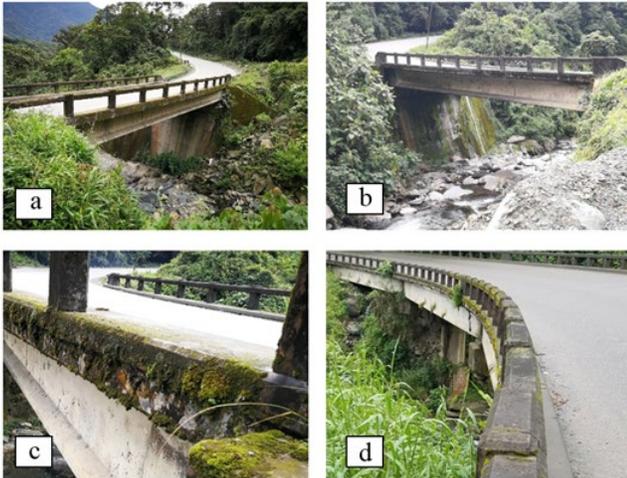
Figure 6. Vegetation, fungus and moss: a) Ronco, b) Ronquito, c) Roquemayu, and d) San Jacinto bridges.  
Source: The authors.

Another pathological defect found was excessive vegetation, fungus and moss due to high relative humidity in the air and constant rainfall in the region. These issues are shown in Fig. 6.

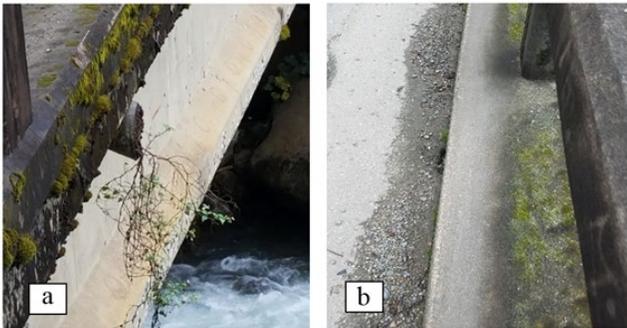
Figure 7. Obstructed drainage: a) Ronquito and b) Ronco bridges.  
Source: The authors.

Additionally, during inspection it could be verified that some bridges present their drainage systems obstructed by garbage or vegetation, thus evidencing lack of cleaning service (Fig. 7).

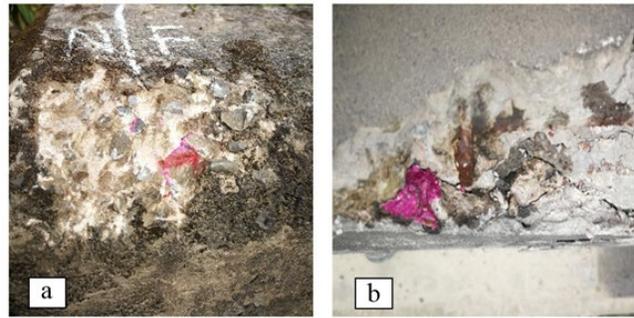
When concrete was broken in some points, iron corrosion was observed. This was verified by carbonation depth testing, since concrete coating showed no coloring compared to concrete found in inner layers (Fig. 8). It is important to mention that every bridge showed advanced carbonation,

Figure 8. Carbonation Depth: a) Roquemayu Bridge and b) Málaga Bridge.  
Source: The authors.

which reveals decrease in concrete alkalinity, hydrogen potential (pH) values below eight, which generates iron depassivation [30], that produces corrosion in bars evaluated, although points where carbonation depth was zero, showed corrosion is not present in the whole bridge, but only in some areas.

This corrosion process is due to carbon dioxide (CO<sub>2</sub>) present in the environment and high relative humidity in this region, as dry pores show no CO<sub>2</sub> in progress in concrete due to lack of water. Otherwise, whenever the pores are full of water, carbonation process has ideal conditions to progress until reaching the iron [12]. Additionally, temperature is high in the area, which favors progressive corrosion [31].

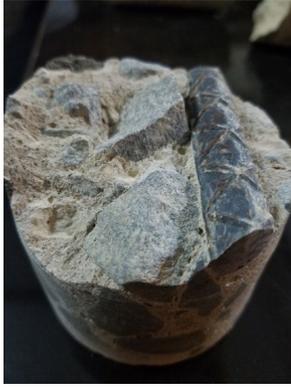
Fig. 10 shows both core extraction and compression testing. In the case of N2-E8 for Roquemayu Bridge, compression test was performed according to C42/C42M-04 recommendations [15]. This core presented iron and oxidation products (Fig. 11).

Figure 11. Roquemayu Bridge core presenting oxidation products.  
Source: The authors.
