A case study on causation of the landslide on 26 October 2016 in the northern Colombian Andes

Hernán Eduardo Martínez-Carvajal ^a, Edier Aristizábal ^b & Edwin Fabián García-Aristizábal ^c

^a Universidad Nacional de Colombia, Sede Medellín, Facultad de Minas, Departamento de Ingeniería Civil, Medellín - Colombia. hmartinezca@unal.edu.co

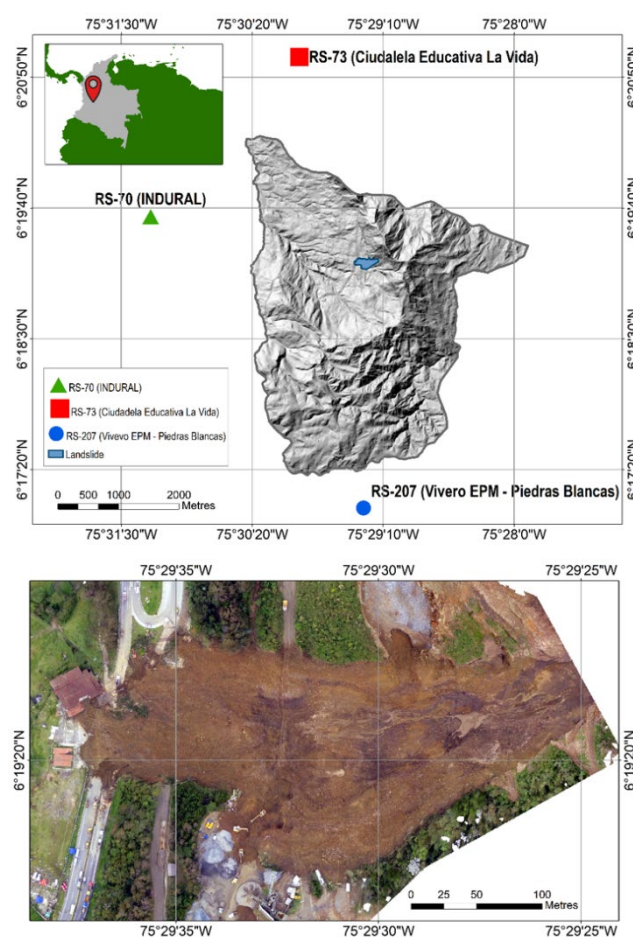
landslide began in the upper part of the slope, between the southern and northern banks of the quarry. Fig. 1 presents the location of the event and a photograph of the magnitude of the movement. The crown of the landslide presented a spoon shape with its middle portion adopting a slightly conical shape and the toe (accumulation area) was clearly wider, suggesting a high degree of water content in the sliding mass. The mass, initially solid, was transformed into a flow that buried the industrial facilities of Las Nieves quarry, both lanes of the Medellín-Bogotá highway, and part of a restaurant located next to the highway.

Figure 1. Location of the landslide in Las Nieves quarry, municipality of Copacabana, Colombia.

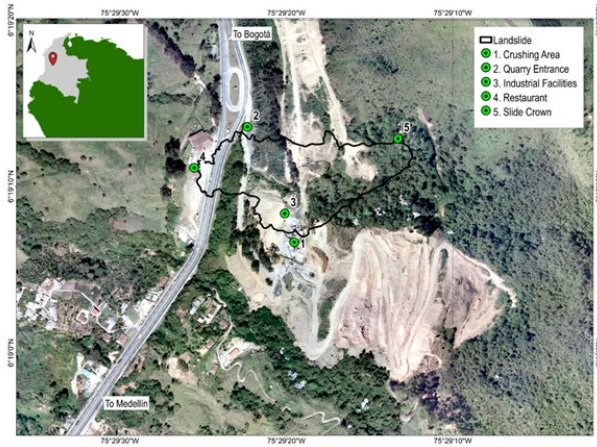
Figure 2. Location of reference sites in the area of the landslide in Las Nieves quarry, municipality of Copacabana, Colombia.
Source: The authors.

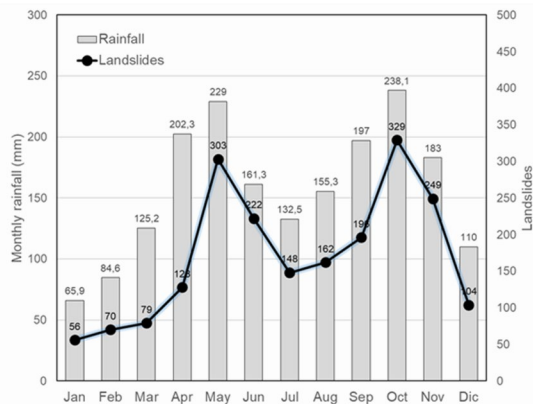
The data are consistent with previous studies conducted in the region [7], which indicate a high correlation between the occurrence of landslides and the rainy season. Fig. 3 shows that the highest number of landslides occurred in the months of May and October, with values of 303 and 329, respectively. In contrast, January and February showed the lowest number of landslides, with a total of 56 and 70, respectively.

Additionally, from Fig. 3, it is important to observe that most of the landslides occurred at the end of the rainy season when there is higher water content in the soils, which may reflect the effect of antecedent rainfalls on the generation of a greater number of landslides in the months of May and October.

Figure 3. Monthly number of landslides versus mean monthly rainfall.
Source: The authors.

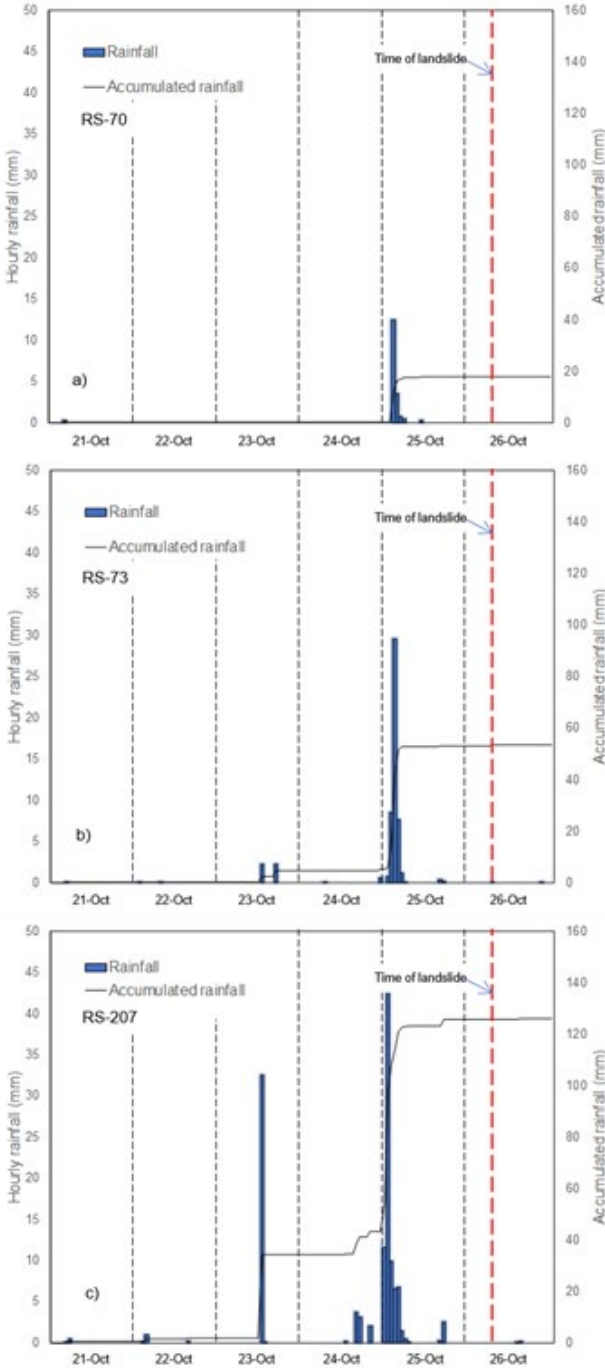
Fig. 4 shows the analysis of hourly rainfall intensity for the selected stations, from 21–26 October 2016. From this figure, it is seen that RS-207 presented a total accumulated rainfall of 125.9 mm for the five days prior to the slide, with a rainfall duration concentrated in the early morning of October 25, one day before the landslide, with a maximum hourly rainfall of 43.3 mm. This condition reflects the reduced presence of rain during the five days prior to the landslide and the dispersed distribution of significant rainfall during the 24 hours prior to the landslide. At RS-70 and RS-73, the total accumulated rainfall was 17.5 and 50.9 mm, respectively, which occurred during the five days prior to the event, with a maximum hourly rainfall of 12.4 and 28.8 mm, respectively. At these stations, the duration of the events was concentrated, as at RS-207, in the early hours of October 25. None of the stations analysed in this study indicated that rainfall occurred at the time of the landslide. This information was corroborated by personal interviews with people that were at the quarry at the time of the slide.

Figure 4. Rain intensity analysis. Hourly rainfall and accumulated rainfall between 22 and 26 October, 2016. a) RS-70 station (Indural), b) RS-73 station (Ciudadela Educativa La Vida), and c) R-S207 station (Vivero EPM - Piedras Blancas). Source: The authors.

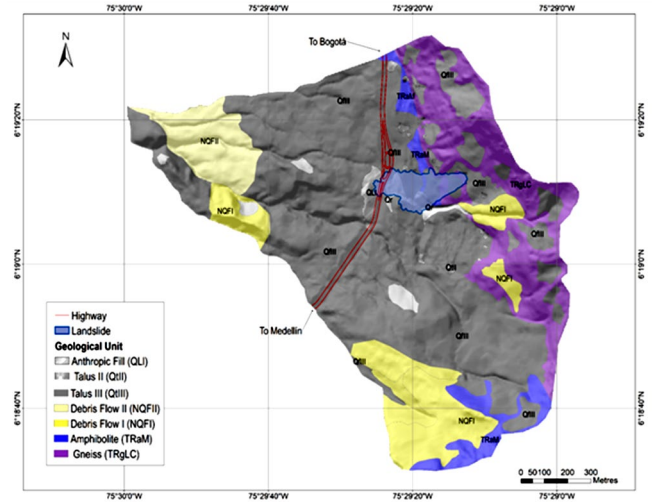
Figure 5. Geological map of the study area. Source: The authors.

Much of the area is covered by slope deposits with complex spatial and temporal relationships contextualised in the geological map. The slope deposits located in the failure zone correspond to a talus type deposit and that corresponds to deposits formed mainly by the action of gravity. These deposits produced accumulation of angular rock fragments with scarce or absent matrix in areas of steep slopes (Fig. 5). The average thickness of the talus is on the order of 2 metres. There are also rocky materials in the area that can be mapped at a working scale, but whose origin is due to anthropogenic intervention and excavation of quarry material.

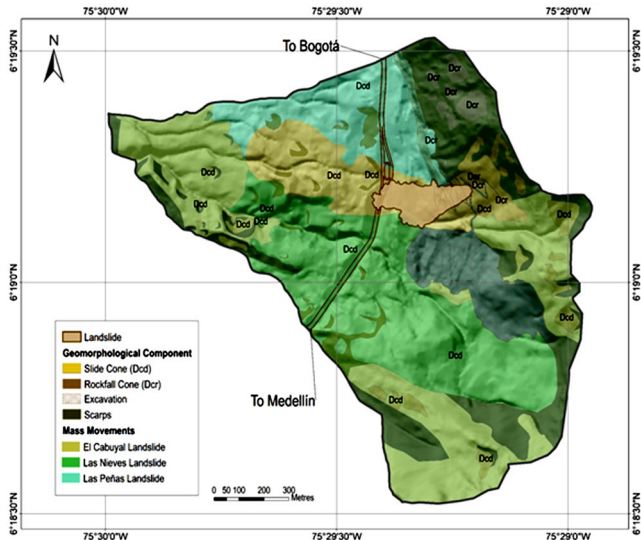
From the geomorphological point of view, it was found that more than 70% of the study area is composed of slope deposits, the multitemporal and spatial analysis of the area of interest allowed us to identify and map three series of past landslides that were grouped to be presented. These show a direct relationship with the intense denudation processes occurring in the Aburrá Valley. The first and most relevant is a huge relict landslide complex named, El Cabuyal, located in the central part of the area, which includes Las Nieves quarry. The second denudation process corresponds to a relict landslide complex namely, Las Peñas, located in the north near the southern portal of the tunnel. The third landslide complex is called Las Nieves. These landslides complexes show at least three phases of activity. The most recent phases correspond to active and/or latent landslides (Fig. 6).

Figure 6. Geomorphological map of the study area. Source: The authors.

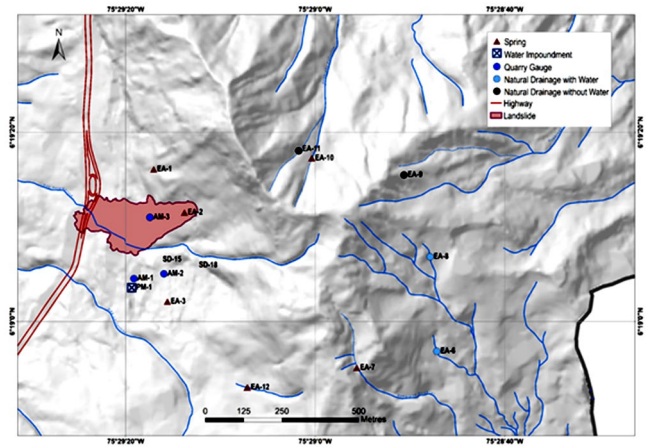
Fig. 7 presents the location and inventory of surface water sources. Due to the importance of understanding the processes that originated the Las Nieves quarry landslide, emphasis should be placed on the quarry gauging points (AM-1, AM-2, and AM-3), which roughly represent the position of the ground water table in the zone of immediate influence on the landslide. These points, together with the springs at EA-1, EA-2, and EA-3, represent the vertical oscillation band of the ground water table in the area of Las Nieves quarry. Specifically, point EA-2, located in the escarpment of the landslide, was gauged in the days following the landslide and yielded a flow of 3 L/s which gradually decreased over the following weeks until it stabilised at approximately 1 L/s between January and February 2017.

Figure 7. Location of water sources. Source: The authors.

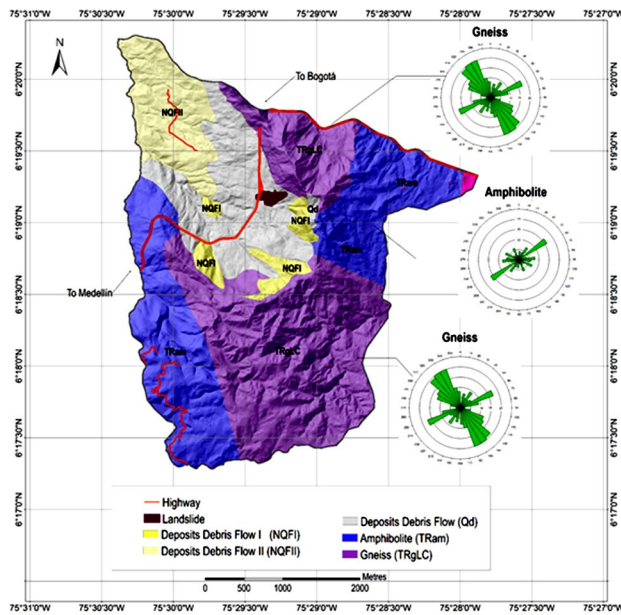
In the study area, the nearly vertical dip of the gneiss favours deep water flow in this rocky mass. By combining the sets of discontinuities, it is possible to establish a network of planes with north-west orientations which favours the hydraulic connection between the plateau and the failure zone (Fig. 8).

Figure 8. Directions of discontinuities for the two different lithological environments found in the landslide zone. Source: The authors.

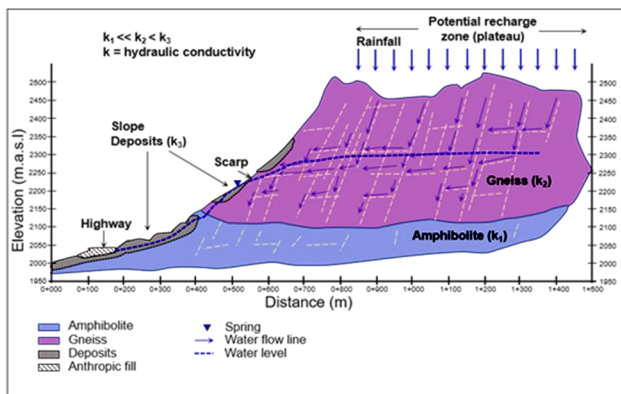
Based on the information described above, the hypothesis for the triggering factor of the landslide, is that the water from antecedent precipitation recharged the plateau zone, predominantly at sites of low slope and in the presence of residual soil, thus favouring processes of water infiltration and retention. Consequently, the infiltrated water was conducted through the discontinuities existing in the gneiss, to the slopes where the landslide occurred. The water that infiltrated through the discontinuities in the gneiss accumulated over the amphibolite, causing an increase in the water level at the failure zone. A diagram of the hydrogeology is presented schematically in Fig. 9.

Figure 9. Conceptual model of flow behaviour in the zone of Las Nieves landslide. Source: The authors.

Taking into account the information collected in the study area, we proceeded to establish the boundary conditions and the possible failure model. Colluvial deposits were found in the fault zone, and the amphibolite and gneiss units identified in the geological survey were located at depth. The topographic and geological profile along the central axis of the slide is presented in Fig. 11. From the hydrogeological information collected, it was specifically shown that at point EA-2 (Fig. 7), located on the scarp of the landslide, there was a discharge of water in the days following the landslide, with a flow of 3 L/s, which gradually decreased in the following weeks until it stabilised at approximately 1 L/s between January and February 2017. This allowed us to propose a scenario in which the landslide was caused by a rise in the ground water table as a result of the infiltration of subsurface water from the plateau, favoured by the degree of fracture and the greater secondary permeability of the gneiss with respect to the amphibolite, as shown in the diagram in Fig. 9.

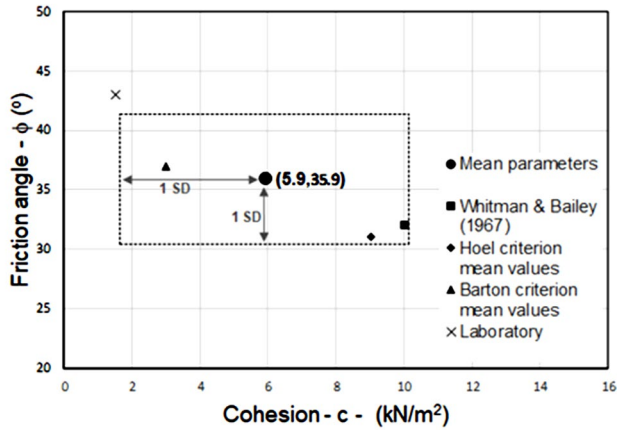
With the strength parameters obtained, assumed, and estimated, the average values for cohesion and friction angle were calculated (Fig. 10). In addition, the standard deviation (SD) of the parameters and their coefficients of variation were calculated. Finally, a region determined by the mean values of cohesion and friction (\pm SD) of the strength parameters was obtained, from which the stability analyses were performed.

Figure 10. Region of variability considered for the cohesion and friction angle values used in the stability analysis.
Source: The authors.

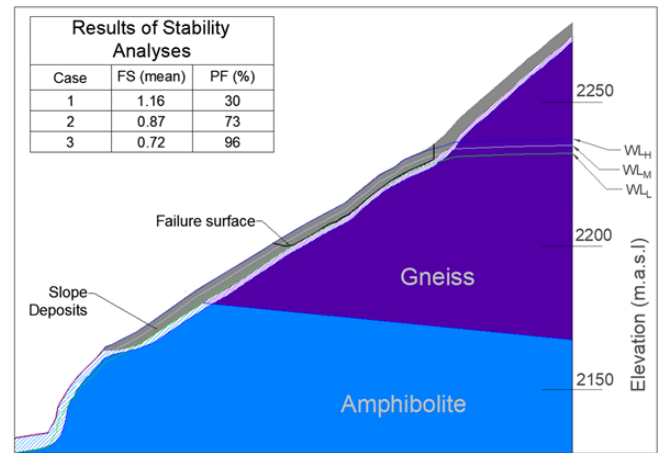
According to the information presented above, and from the values of the mechanical strength parameters and their variation (Fig. 10), a limit equilibrium statistical analysis was performed to determine the effect of the ground water table on the overall stability of the analysed slope. For the analysis, the SLIDE program [20] was used. For the analysis, normal distribution functions for cohesion and friction were assumed according to the mean values (\pm SD) established in Table 2. Three cases of groundwater-level positions were analysed, as shown in Fig. 11, and the results are described below:

- Case 1: ground water level position (WLL). The position of the ground water table at the boundary between the colluvial deposit and the rock base is assumed. For this case, a mean safety factor of 1.16 was obtained with a probability of failure of 30%.
- Case 2: Middle ground water level position (WLM). It is assumed that the ground water table is located at a height equal to half the thickness of the colluvial deposit. In this case, a mean safety factor of 0.87 was obtained with a probability of failure of 73%.
- Case 3: High ground water level position (WLH). A phreatic level is assumed which mostly saturates the colluvial deposit. In this case, an average safety factor of 0.72 and a probability of failure of 96% were obtained. For all cases, the failure surface was naturally located along the contact between the rock base and the colluvial deposit as shown in Fig. 11.

Figure 11. Profile along the central axis of the slide and position of the water levels.
Source: The authors.

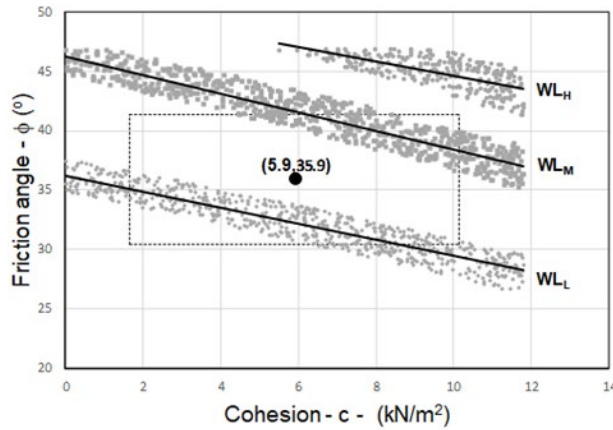
Fig. 12 shows a shaded rectangle within the estimated parameters used for the analysis are located as explained above. The comparison of the assumed parameters for the soil and the results of the safety factors equal to 1 for the three cases studied allowed us to conclude the following:

- Case 1: WLL. In this case, there is a large area above the trend line that would indicate the possibility of combinations of friction angle and cohesion that generate safety factors greater than 1. However, some combinations of these strength parameters could generate safety factors below 1 (area of the rectangle below the line).

Figure 12. Results of the sensitivity analysis of the ground water table position on slope stability.

- Case 2: WLM. In this case, the vast majority of parameter combinations results in safety factor values less than 1, indicating a high probability of failure.
- Case 3: WLH. In this case, all possible combinations of strength parameters produced safety factors less than 1, which indicate the impossibility of mass stability under these conditions.

The overall result presented in Fig. 12 indicates low initial stability conditions in the area studied (Case 1), with a considerable reduction in stability for cases in which the ground water table rises in the soil (Cases 2 and 3).
