Analysis and characterization of PV module defects by thermographic inspection

S. Gallardo, L. Hernández and O. Duque, "Analysis and characterization of PV module defects by thermographic inspection", *Revista Facultad de Ingeniería Universidad de Antioquia*, no. 93, pp. 92-104, Oct-Dec 2019. [Online]. Available: https://www.doi.org/ 10.17533/udea.redin. 20190517

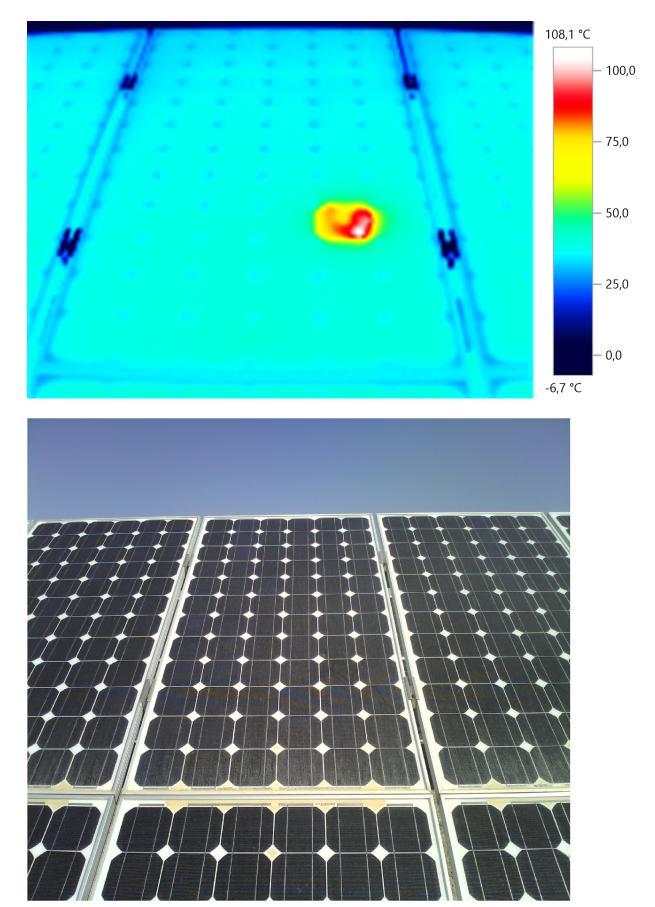
Reviewing all cells hotspot defects, it has been concluded that the pattern of this fault is an overheated cell, of approximate 15 x 15 cm² depending on the module manufacturer, located in any cell along the module. The analysis performed does not reveal any preference of appearance of the overheated cell in any of the three strings circuits. The following figure, Figure 7, presents the Δ T of each of the 859 cell hotspots detected in the inspection in descencing Δ T order, obtaining an average temperature of 12.4°C with a standard deviation on 12.8°C. Other relevant statistical values are the median, 7.4°C, and the first and third quartile, 3.8°C and 17.8°C, respectively. As it can be seen in Figure 7, the highest Δ T detected in the tests is 77.4°C, which supposes a cell hotspot

Figure 4 Hotspot located in the third string of a module, with a ΔT of 71C

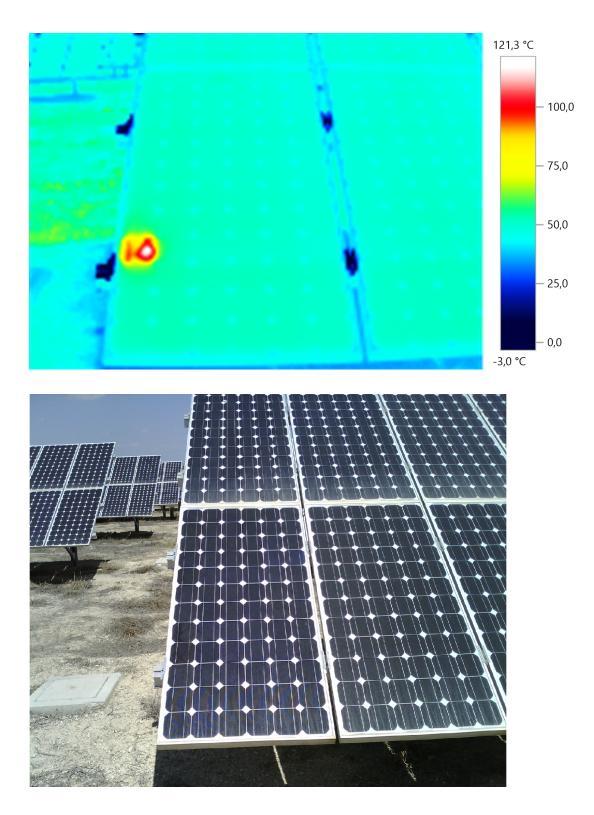
Figure 6 Overheated cell in the first bypass circuit next to the module frame, with a ΔT of 71.2°C

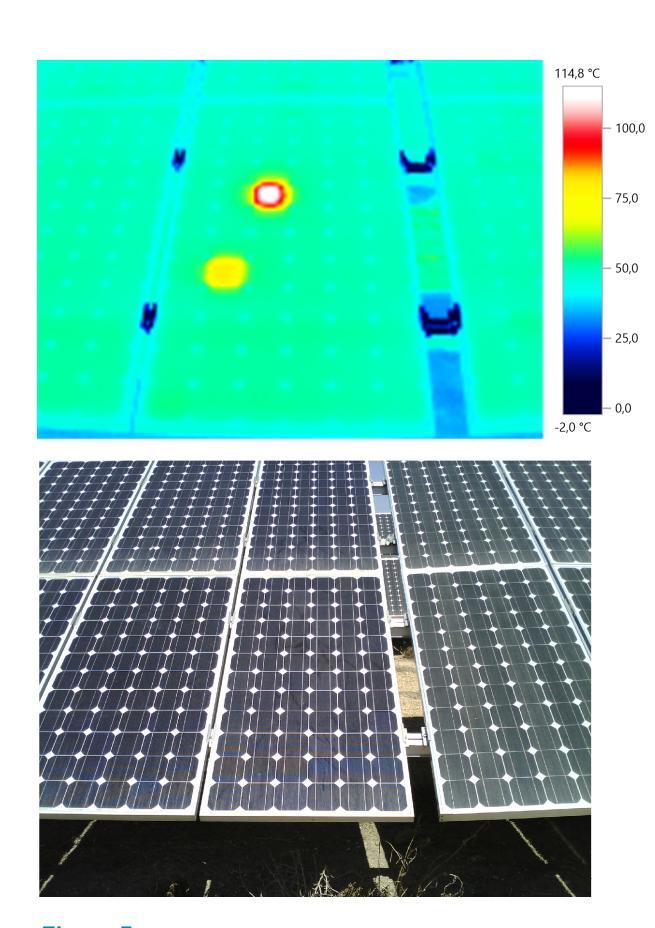
Figure 5 Two overheated cells within a module, one in the first bypass circuit and the most overheated in the second circuit, with a Δ T of 63.5°C

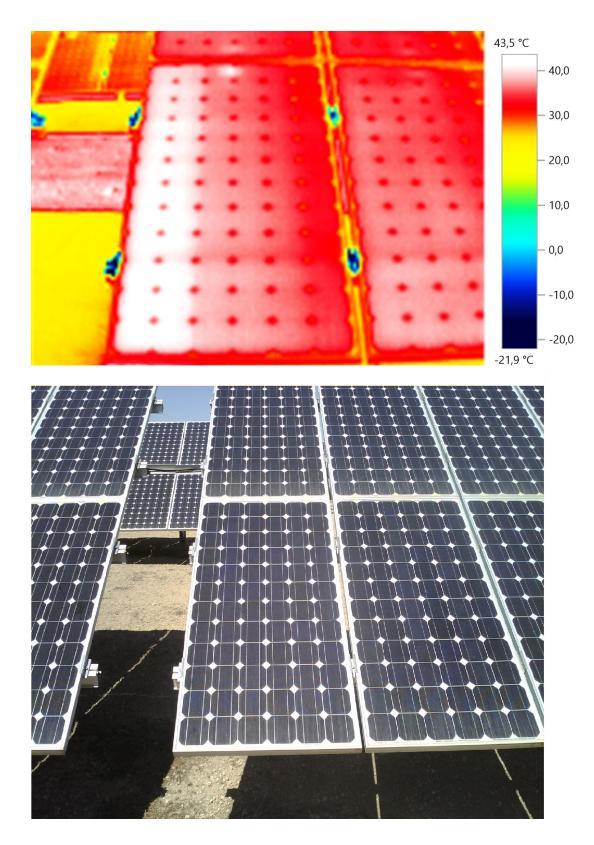
The thermographic and visual image of one bypass circuit overheated with a temperature difference of 5.7°C between the healthy area and the overheated bypass is presented in Figure 8.

Figure 8 Bypass circuit overheated with a Δ T of 5.7°C

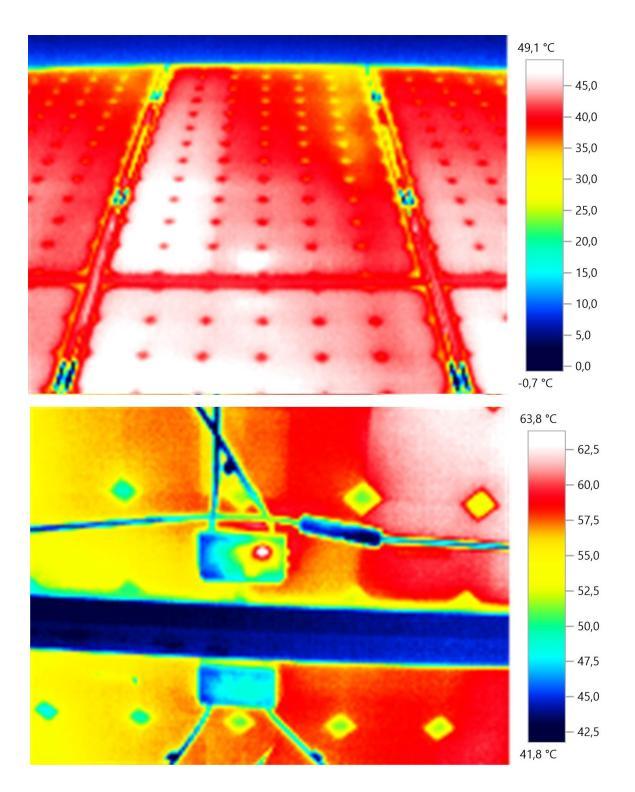
Figure 11 Front site of a module with a bypass diode overheated and of the junction box at the back of the module. ΔT is 6.7°C and 22.6°C respectively

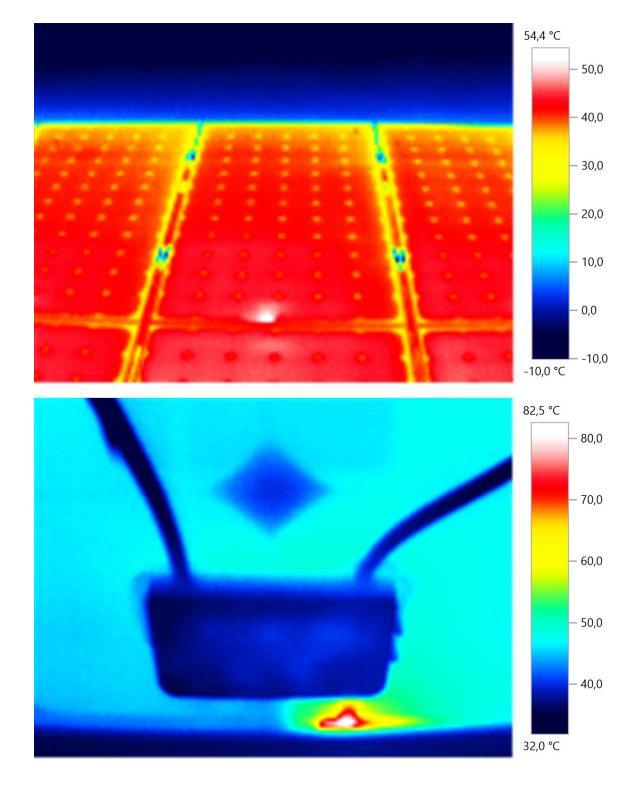
An example of an overheated connection found during the analysis is introduced in Figure 14. As it can be seen, the overheated area is not in the junction box, but in the connection between bus ribbon or bus wires and the box.

Reviewing all connection defects, it has been concluded that the pattern of this fault is an overheated point, generally smaller than a cell, located next to the frame in the same side in which the junction box is placed. The following figure, Figure 15, presents the ΔT of each of the 78 overheated connections detected in the inspection in descencing ΔT order, obtaining an average temperature of 10.9°C with a standard deviation on 8.1°C. The maximum ΔT detected in this case has been 45.1°C. Other relevant statistical values are the median, 9.0°C, and the first and third quartile, 5.2°C and 13.8°C, respectively.

Figure 14 Overheated connection between the bus ribbon or bus wires and the junction box with a Δ T of 11.7°C and 35.8°C, at the front and back side respectively

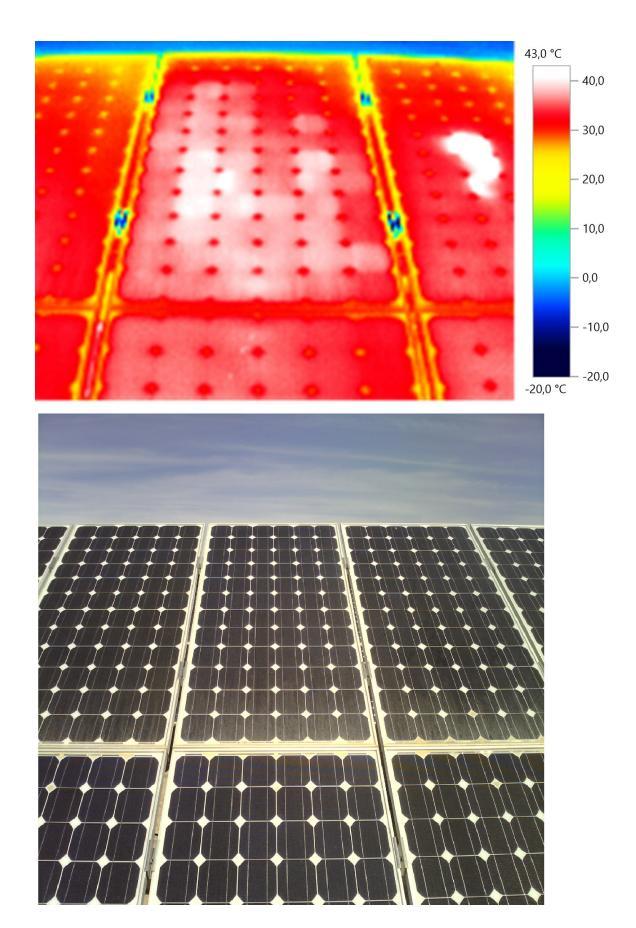
If one module or several modules connected in series have a higher temperature than the rest, the modules may not be connected to the system and the wiring should be checked. Figure 16 shows the only defect in the whole

It has been noticed that differences in temperature between a module and the rest of modules of the same row or string could be due to an erroneous connection between them, mismatching or to internal defects of the module affecting all the bypass circuits. This kind of defect can be automatically detected as a difference of the mean temperature of one module with respect to the rest of the modules of the same PV structure.

Figure 16 Overheated module with a ΔT of 10.5°C between the mean temperature of the adjacent modules and the mean temperature of the overheated module surrounded in the figure
