## Complex Failure Simulation of Underinclined Shale Slope Based on Discrete Element Method

Depart point of this study was a landslide that occurred in the cut slope at the Chongqing west railway station, in central China. This slope belongs to an under-dip shale slope, which means that its bedding dip angle is larger than the slope angle, and it is comprised of soft rock. Some on-site investigations were made to explore the deformation characteristics of this slope; the outcome suggested that sliding, buckling, and toppling deformation existed at its different parts. The discrete element method was employed in simulations to elucidate the complex failure mechanism exhibited by the under-dip slope under the long-term influence of gravity and material deterioration. The simulated failure patterns have proven to be in strong agreement with the actual slope failure. This study suggests that sliding, buckling, and toppling occur at different parts of the studied slope in sequence.

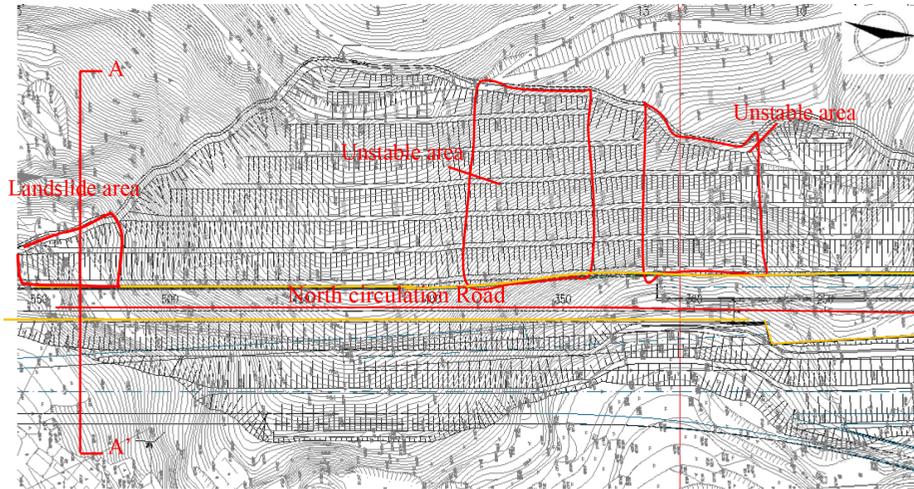
Figure 2. Engineering geologic plan of the slope.

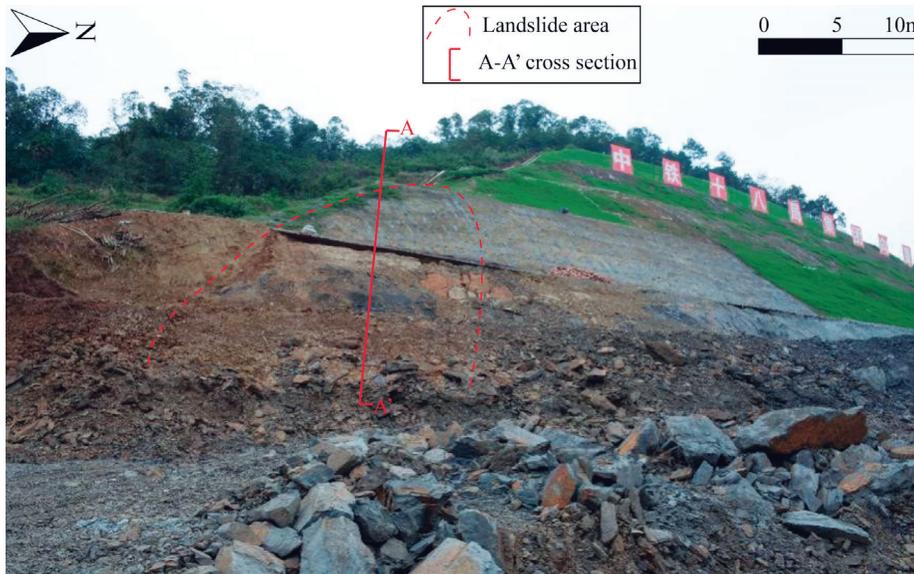
Figure 3. General view of the slope failure.

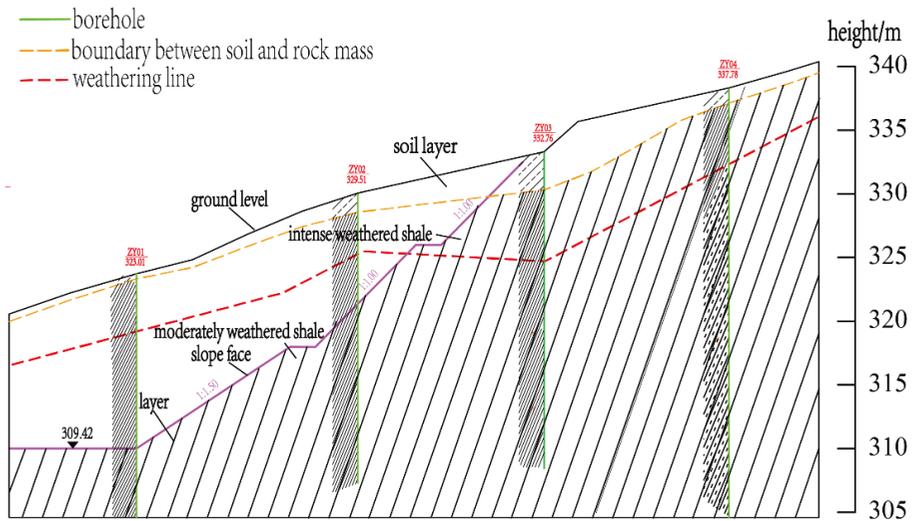
Figure 4. The engineering geological section of the slope at cross section A-A'.

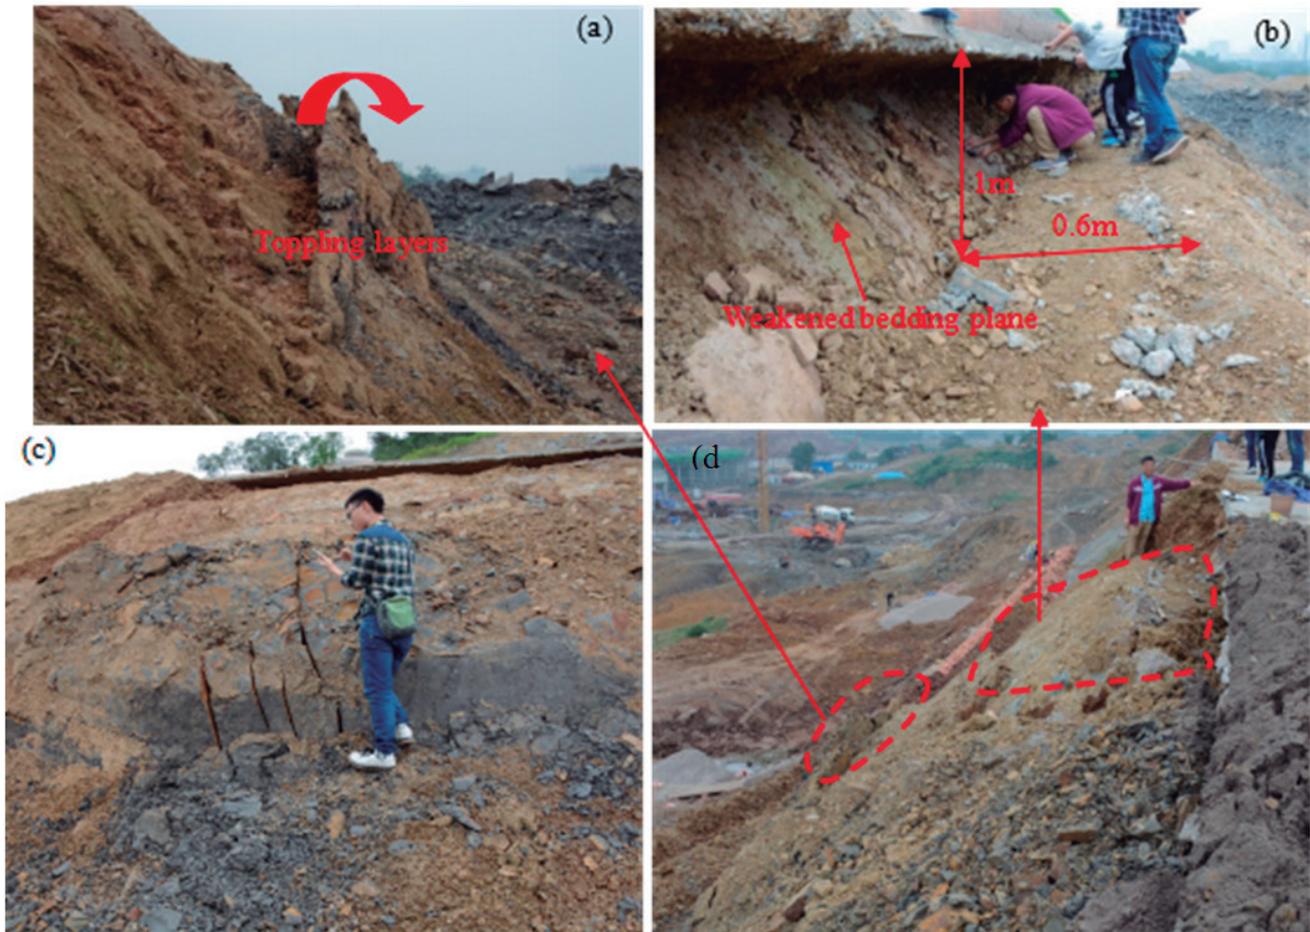
Figure 5 presents the failure characteristics of the slope at cross-section A-A'. The length of sliding mass along slope is over 30m, the height is over 8m, the rock mass is intense and intermediary weathered shale, the mechanical properties of the smooth and wet bedding plane is rather poor, It is present with an orientation of  $90^\circ/46^\circ$ , the maximum depth of the sliding mass is 60cm, the sliding distance of rock mass in the upper sections of the slope along the bedding plane is about 1m (Fig. 5b), rock mass in the lower sections of the slope is broken off and the stratified rock mass become erect (Fig. 5a), which has a height of about 2m and a thickness of about 20cm. There are some weathering cracks distributed in the superficial rock mass (Fig. 5c). Figure 6 shows the conceptual model of the studied slope based on the geological analysis.

**Figure 5.** The complex slope failure taking place in situ. (a) toppling of the rock mass in the lower part; (b) sliding along the bedding plane in the upper part; (c) cracking of the slope face due to the push of sliding rock columns in the upper part. (d) Panoramic view of the landslide.

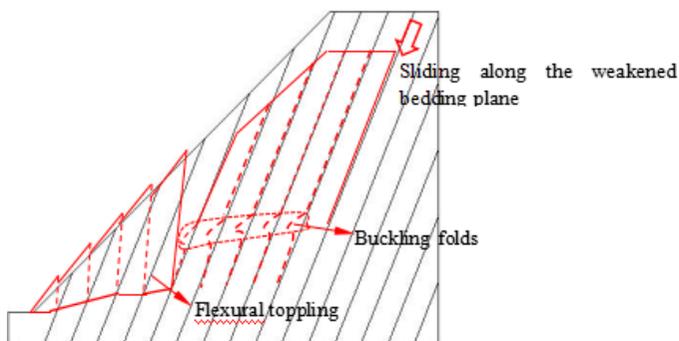
**Figure 6.** Conceptual model of the studied slope.

Based on the structural characteristics of the damaged slope, it can be inferred that the failure process of the slope involves several stages as follows:

(1) Slide-buckling deformation of the upper rock layers

The stress release perpendicular to the bedding planes make the rock mass produce spring-back towards the empty direction, consequently, the bedding planes become loose and the strength of rock mass decreases, which facilitates the sliding deformation of rock mass at the upper part along the bedding plane. For the lack of space at the lower sections of the slope for shearing out, buckling at the lower part occurs to coordinate with the compression from the sliding layers (Fig.7).

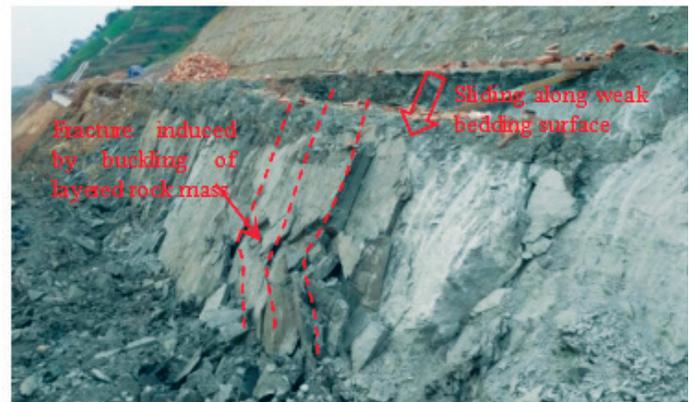
Figure 7 shows another slope failure at the study area mentioned above, the slumping block extends about 40m along the trend of the slope, with a height of 5-6m, the exposed rock mass is moderately weathered shale, the designed slope angle is  $45^\circ$ , while the excavated slope presents an angle of  $68^\circ$  which equals the dip angle of the bedding plane induced by over-excavation, under the influence of unloading, gravity and weathering, the bedded rock mass slides along the weak bedding plane, then the lower and weakened part of the layered rock mass was squeezed outward by the upper part of the slope, forming buckling folds at the toe of the slope. Consequently, the layered rock mass is fractured at the slope toe and the entire slope deforms and slides.

**Figure 7.** Buckled rock layers at the studied area.

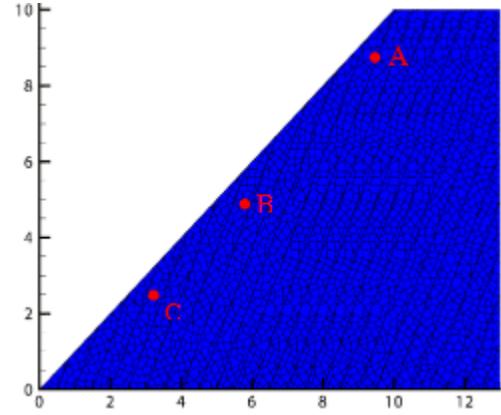
Fig.8 shows the UDEC models used in this study. The height of the slope model is 10m with a slope angle of 45°. The joints dip into the model at an angle of 68° with a joint spacing of 0.3m. To better analyze the failure mechanism of the studied slope, the simulation in the UDEC is conducted with rigid blocks and Coulomb-slip joint material model. The block densities are based on the laboratory test results shown in Table 1.

**Figure 8.** UDEC model used in this study.

For the mechanics analysis, the surface of the slope is assigned as a free boundary, while no horizontal displacement is allowed on both the left and the right vertical boundary, the bottom boundary is completely fixed in the vertical direction but free in the tangential direction. All the boundary conditions of displacement constraint for the numerical model are rigid. In order to better describe the evolution of the slope deformation in the failure process, three displacement monitoring points named point A, point B and point C were set at the upper part, middle part, lower part of the slope model, respectively.

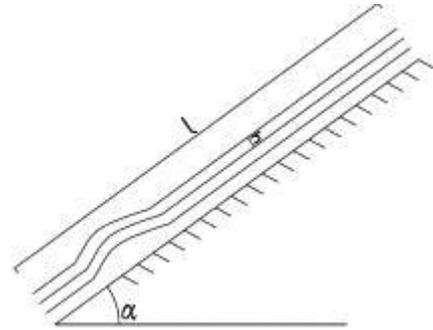
In order to ensure the veracity of DEM modeling, it is necessary to conduct back analysis of mechanical parameters of the joints according to the geological conditions from field measurement and investigation on local rock slope losing stability. Figure 9 displays the mechanical model of buckling failure.

**Figure 9.** Mechanical model of the buckling failure.

The following analysis focuses on obtaining instability criterion of this mechanical model. According to the Euler Theory, the critical slope length  $l_{cr}$  for buckling failure is given by

$$l_{cr} = 3 \sqrt{\frac{\pi^2 E h^2}{6\gamma \cos \alpha (\tan \alpha - \tan \phi)}} \quad (1)$$

For the local slope suffering buckling failure, the bedding plane dips  $68^\circ$ , the actual slope length is 10.8m, the elasticity modulus  $E$  is 1500MPa, the thickness of the layered rock mass is 0.1m, when  $K=1.0$ , the equivalent friction angle of the bedding plane  $\phi$  equals  $14.5^\circ$ . The stability of the slope is estimated based on the limit equilibrium method, the factor of safety is 0.8 when the equivalent friction angle of the bedding plane  $\phi$  equals  $14.5^\circ$ . While the calculated factor of safety of the slope approximately equals 1.0 when cohesion  $c$  is 12kPa and friction angle  $\phi$  is  $10^\circ$ , so the ultimate mechanical parameters of joint sets from back analysis is  $c=12\text{kPa}$ ,  $\phi=10^\circ$ . Table 3 describes the parameters for relevant materials included in the UDEC model for the rigid blocks and contacts.

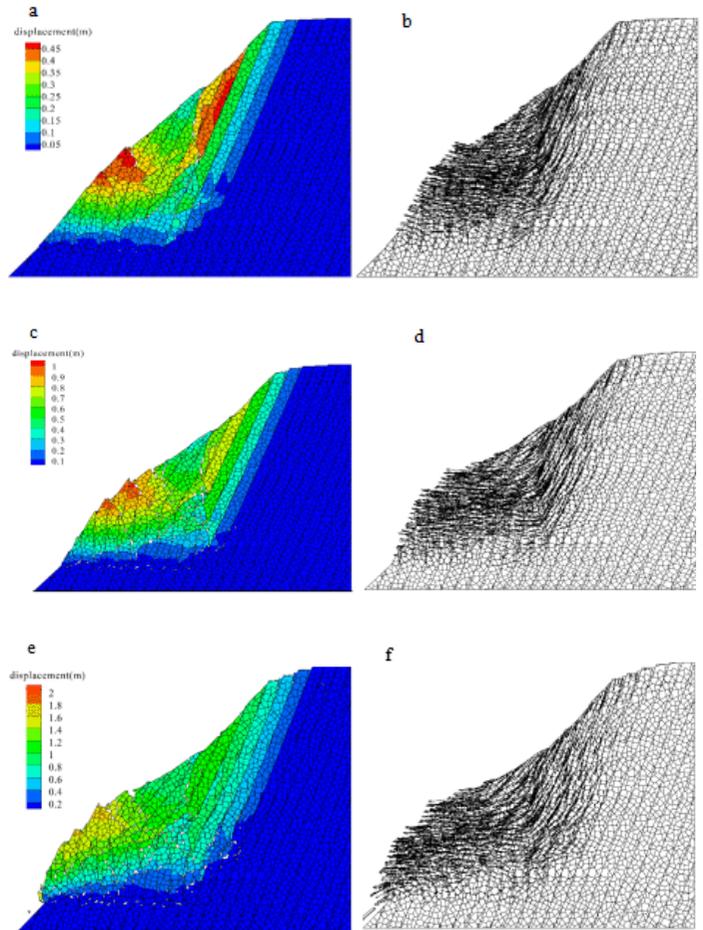
According to the simulation results, the evolution process of the deformation at different stages are shown in Figure 10. The deformation process can be divided into three stages. At the initial stage, as Figure 10a shows, obvious shearing at the trailing edge occurs, sliding of rock mass along the weak surfaces under the force of gravity can contribute to this process. Meanwhile, some shearing surfaces occur in the lower part and the toe, which can be attributed to the passive compression caused by the sliding layers from the upper part. At the medium stage, as shown in Figure 10c, buckling deformation of layers in the lower part occurs, it can be attributed to the intensifying of compression, which forces rock layers to buckle upward from the inside outwards. In addition, layers at the toe rotates under the force from the buckling layers in the rear and the layers become erect. At the final stage, more shearing surfaces occur in the buckled rock layers with the development of deformation and rock layers at the toe topple outwards (Fig. 10e), the force transformed from the buckling and shearing rock mass in the rear may contribute to this toppling deformation.

**Figure 10.** Plot of numerical simulation results:(a) the 2000 time step displacement contour (b) the 2000 time step velocity vector (c) the 5000 time step displacement contour(d) the 5000 timestep velocity vector (e) the 10000 time step displacement contour(f) the 10000 time step velocity vector.

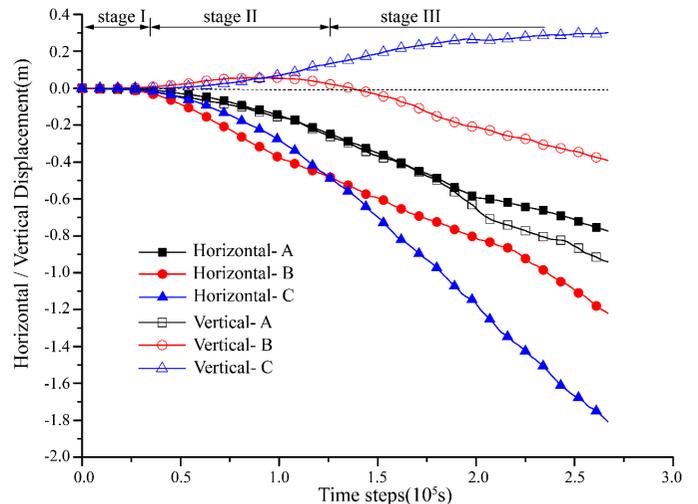
To further describe the deformation process of the slope, the horizontal and vertical displacements of the monitored history points in the deformation process were analyzed, which are displayed in Figure 11. Three stages called stage I, stage II and stage III are proposed to better describe the monitoring results, which refer to the stage of elastic deformation, development of the slide-buckling deformation and the stage of toppling deformation, respectively. Clearly, the horizontal displacement of the rock mass near point A is lower than that near point B and point C in the whole deformation process, and the horizontal displacement at point A during stage I is negligible. Moreover, the horizontal displacement at point C increases more rapidly than that at point B at stage III due to the intensifying toppling at the toe where point C locates. We can see that the rock mass at the upper part where monitored point A locates moves downward in the whole process and the displacement increases more rapidly at stage III, it may be due to the intensifying toppling at the toe which provides more space for the downward sliding of the rock mass at the upper part. Moreover, increasing vertical upward displacement occurs to the rock mass at the toe where point C locates at stage I and II, and then the vertical displacement gradually becomes stable at stage III with the intensifying of toppling deformation at the toe, but the value of the vertical displacement is much lower than that at point A in the whole deformation process. It also shows that the rock mass at the lower part near the monitoring point B moves upward at stage II and then turns to moving downward at stage III, the upward displacement may be caused by the shearing force from the sliding rock mass in the upper part at stage II and the subsidence may be caused by the intensifying toppling deformation at the toe at the later stage. Comparison between the horizontal and vertical displacements at the monitored points in the deformation process indicates again that vertical displacement is dominant for the rock mass in the upper part while horizontal displacement is dominant at the toe.

**Figure 11.** Displacements of the monitored history points versus numerical time steps: Stage I, Stage II and Stage III refer to the stage of elastic deformation, development of slide-buckling deformation and the stage of toppling deformation, respectively. Horizontal-A, Horizontal-B and Horizontal-C refer to the horizontal displacements at point A, point B and point C; Vertical-A, Vertical-B and Vertical-C refer to the vertical displacements at point A, point B and point C.
