## Computer vision and machine learning for the detection and classification of pavement cracks

### Técnicas de visión artificial y aprendizaje de máquinas para la detección y clasificación de grietas

Lizette Tello-Cifuentes<sup>1</sup>

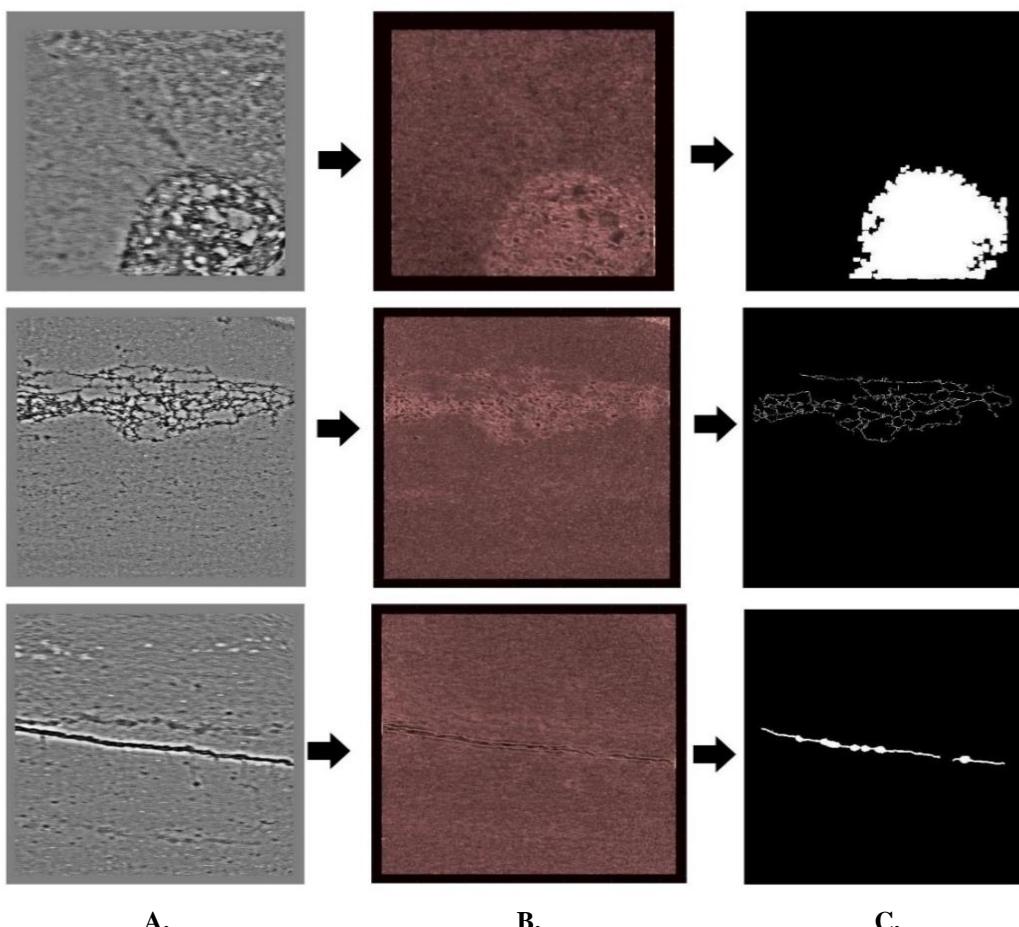
**Figure 1.** Images were obtained in the processing stage, for each of the deterioration pothole, alligator crack, and longitudinal crack. A. Images with contrast enhancement, B. Images obtained from the Scattering transform, and C. Images obtained after noise removal.

As the considered images had different sizes, the processing time varied with the image dimensions. The maximum processing time of 3 minutes and 10 seconds was determined by the wavelet scattering transform, the most time-consuming process. This transform highlighted the deteriorations by producing data representations that minimize differences within a texture type and discriminate textures, thereby improving edge detection. Figure 1 shows the images obtained at different processing stages for each type of deterioration.

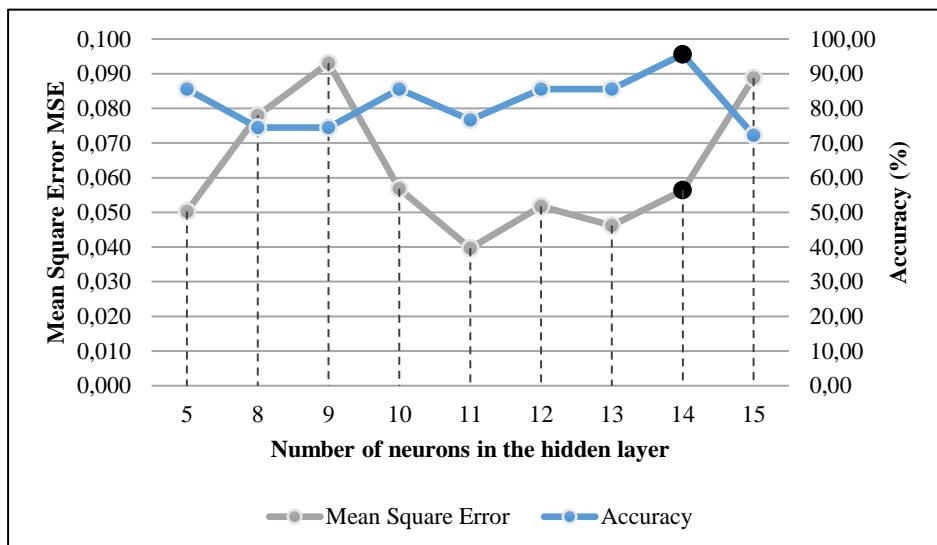
Figure 2. MSE and accuracy obtained for the selected neural networks.

network architecture that would yield the highest classification performance. This approach allowed for a comprehensive evaluation of the neural networks and their ability to accurately classify pavement deterioration. This provided valuable insights into the impact of the hidden layer configuration on the performance of the classifiers. By comparing the accuracy and precision metrics of each network, it was possible to identify the neural network with the highest overall performance. The input layer was composed of a 12-dimensional feature vector based on the Hu moment invariants for three images obtained in the processing stage. The output layer was composed of three neurons coded according to deterioration type. The 10 neural networks with the lowest mean square error was used for validation. Figure 2 shows the classifier results.

The selected neural network had 12 neurons in the input layer, 14 neurons in the hidden layer and 3 neurons in the output layer. This network had a mean square error of 0.056, which was not the lowest value among the 20 networks, but it had the highest overall accuracy of 95.56% and a precision of 94.44%. Sensitivity and specificity performance metrics were also calculated for each type of deterioration. The sensitivities were 100% for both alligator and
