### Extreme Testing of Guard Cables with Fiber Optics: A Case Study

**Context:** Optical fiber ground wires (OPGWs) sometimes melt and rupture when exposed to extreme conditions, such as atmospheric discharges, short circuits, and corrosive agents, that affect their electrical and mechanical properties. These conditions depend on the geographical area where the cable is installed, with the most critical being industrial and coastal zones as well as marine and mountainous environments. This research analyzes a cable rupture due to lightning strikes from a coastal zone.

A sample of failed OPGWs was acquired from a transmission line located in the coastal area of Valladolid, Yucatán, Mexico (DZT-A360-RXXY-LT 400  $kV$  line). The samples were divided into sections, A and B, whose properties and conditions after cable failure were analyzed. The failure zone was also studied. The tests carried out were visual and dimensional inspection and mechanical stress and chemical tests. Some lightning strike points were preliminarily marked as the main causes of OPGW breakage.

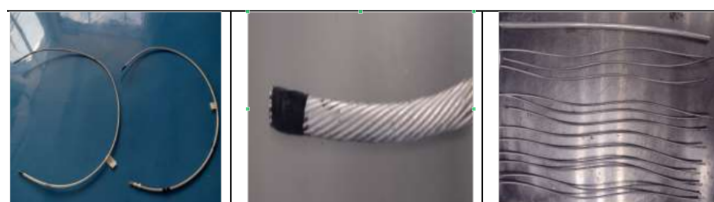
Fig. 8 shows two cable sections (class 0, 0.30 m in length, as stipulated by the E1000\_21 specification for stress testing). The elastic modulus (E) of the analyzed cable is around 116 Gpa. Table II analyzes the

**Figure 8.** 0.30 m long OPGW cable for tension tests, aluminum tube containing the optical fibers and their 12 test wires

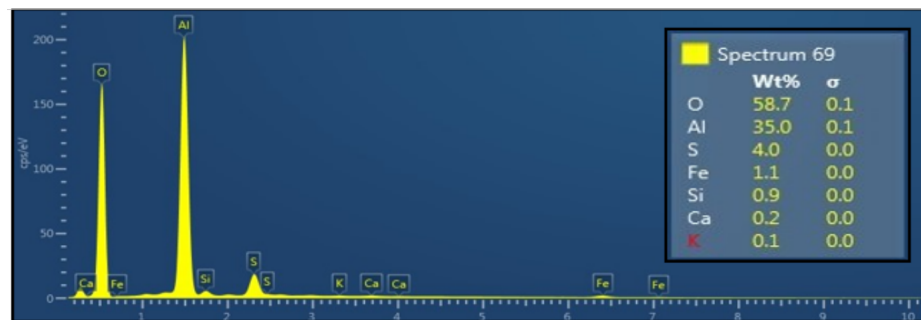
The chemical analysis of the pitting area defined as *Spectrum 69* can be observed in Fig. 15. The results indicate a high concentration of oxide due to the amount of oxygen recorded (58.7 %), which suggests an accelerated process regarding the natural oxidation of the base material (Fe), observed in the form of a reddish-brown coloration. In this case, natural oxidation was mostly generated by humidity

and environmental conditions. The deposits attached to the wire's aluminum contained highly corrosive elements concentrated in the pitting area, such as sulfur (S), *i.e.*, up to 4 %, which is a large amount of corrosive agent. The percentage of coating on the wire, which should remain above 90 % (Al), was 35 %, indicating losses. Therefore, the health of the element's coating was affected by the operating conditions. The guard wire with optical fibers exhibited reduced electrical properties and mechanics in this area.

Figure 15. Elemental chemical analysis of pitting in the OPGWs

The deposits adhered to the wires were also identified. The aluminum coating contained corrosive elements such as S and Na in the zone of base material loss, and we observed the loss of the covering layer and a significant percentage of oxygen due to the oxidation process caused by environmental and industrial impacts. The agents usually come from industrial areas and combine with oxygen and moisture in the environment, leading to the formation of acids and hydroxides that act as corrosive agents and accelerate the degradation of the material. These corrosive agents act mainly on the galvanized steel wires that make up the core of the cable, aggressively deteriorating their Zn layer, penetrating into the base material. With the above, a material loss process takes place, decreasing the wire's diameter and inducing a stress concentration on the driver element. The area decrease generates a temperature increase in the wires, as current is conducted through a smaller cross-section. Under these conditions, wires subjected to combined electromechanical and thermal stress can gradually yield, resulting in rupture.

The observed corrosion was caused by deposits of the corrosive agents described in the chemical analysis. These agents originate from natural sources or pollutants generated in industrial areas. When combined with oxygen and moisture from the environment, they produce acids and hydroxides that corrode and accelerate the degradation of the material.
