CT&F - Ciencia, Tecnología y Futuro Vol 11, Num 1 June 2021. pages 11 - 20

# EVALUATION OF PERFORMANCE AND EARLY DEGRADATION OF A 180.8 KWP ROOFTOP ON A GRID-CONNECTED PHOTOVOLTAIC SYSTEM IN A COLOMBIAN TROPICAL REGION ENVIRONMENT

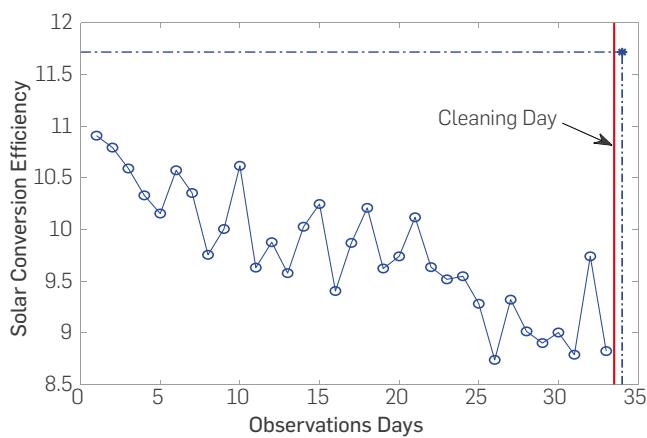
Figure 7. Solar Conversion Efficiency performance.

Figure 7 shows the solar conversion efficiency changes after 33 days of dust accumulation on the surface of the photovoltaic modules. Hence, there is a substantial reduction in system efficiency. Although the design efficiency value is 15.32 %, the highest value, measured on the first day of analysis, was 10.91 %, and the lowest value was registered on day 26, as 8.65 %.

On day 34, a cleaning process was performed on the photovoltaic system to analyze efficiency behavior; this value was registered with a superior performance of (11.72 %) and a global irradiance of  $570 \text{ W/m}^2$ , which means an increase of 2.98 %. This value is marked with an asterisk in Figure 7.

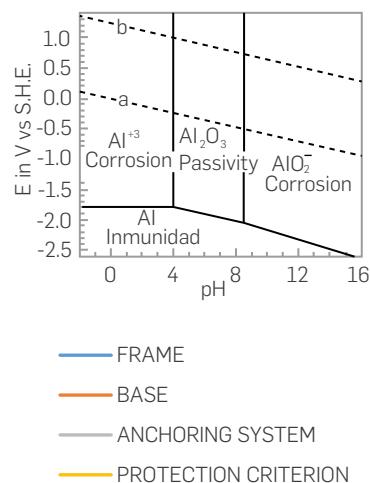
**Figure 10.** Photovoltaic panels corrosion potential (Based on [24])

The galvanic series is the location of different types of materials with respect to their electrochemical potential. In the specific case of aluminum, potential measurements are obtained against a Cu/CuSO<sub>4</sub> electrode, allowing the identification of the tendency of corrosion, immunity or passivation of the material relative to the pH of the surrounding environment [22]. According to the cathodic protection criteria of the NACE RP 0169 standard, the aluminum metal structure is protected with more negative potentials of -0.9 volts [23]. **Figure 10** presents the potential measurements for the selected panels showing active corrosion processes, which is favored with the pH range between 4-8. This shows the formation of a protective layer of Al<sub>2</sub>O<sub>3</sub>. For the particular case of residues gathered in the selected points, the average pH measured was 7.06; therefore, the formation of passivating film is stable.
