# Identification and analysis of pathological defect appearance in superstructures of reinforced-concrete bridges in Chapare region, Bolivia

Joaquin Humberto Aquino Rocha <sup>a</sup> & Rolando Ibarra-Villanueva <sup>b</sup>

Received: June 12<sup>th</sup>, 2020. Received in revised form: November 19<sup>th</sup>, 2020. Accepted: November 27<sup>th</sup>, 2020.

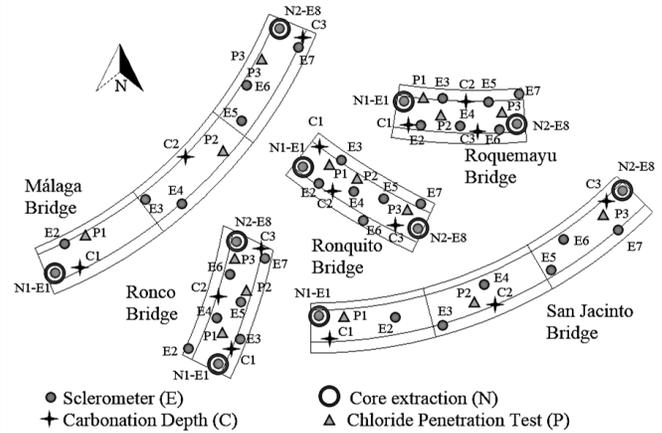
Figure 3. Location of tests performed. Source: The authors.

Fig. 3 shows in detail the tests performed in all five bridges studied.

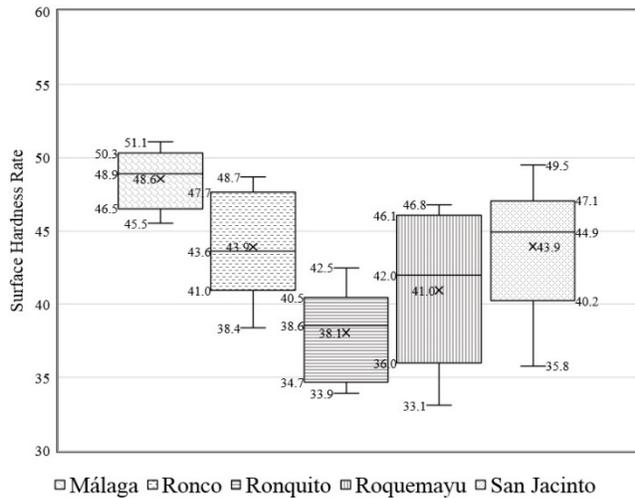
Figure 9. Box-and-whisker plot of results for surface hardness rate per bridge.  
Source: The authors.

Fig. 9 shows a box-and-whisker plot of results for surface hardness per bridge. It is evident that every bridge, except for Ronco Bridge, present a negative asymmetry, the average is below the median, which shows data concentrate on the upper part of distribution. In the case of Ronco Bridge, data concentrate in the lower part.

It is important to consider that sclerometer test results are influenced by concrete age and carbonation [35,36]. As previously mentioned, studied bridges are old and present carbonation in some areas, thus generating variability in results. However, rate values for surface hardness are used to compare dispersion among these bridges. It was noticed that concrete in Málaga Bridge is better qualified than concrete found in Ronquito Bridge and that concrete in Roquemayu Bridge is the most heterogeneous.

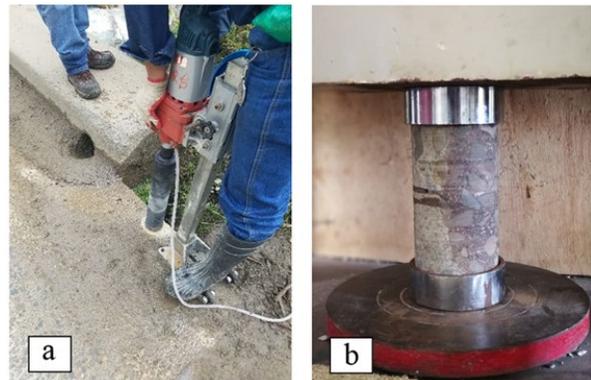
Figure 10. a) Core extraction, and b) Compression Test – Ronquito Bridge  
Source: The authors.

Fig. 10 shows both core extraction and compression testing. In the case of N2-E8 for Roquemayu Bridge, compression test was performed according to C42/C42M-04 recommendations [15]. This core presented iron and oxidation products (Fig. 11).

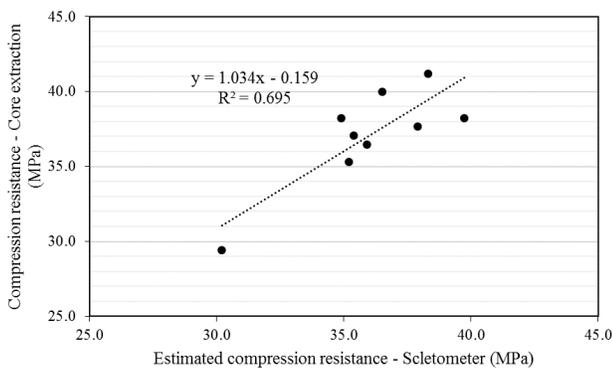
Figure 12. Correlation between compression resistance in cores and sclerometer testing.

A correlation between compression resistance in cores and sclerometer testing was made as shown in Fig. 12. A high positive linear relation could be observed ( $R^2=0.695$ ). Nevertheless, significance of correlation coefficient must be determined.

Value  $t_{\alpha, N-2}=2.36$  is obtained in *t-student* distribution tables for  $\alpha=0.05$ . Then:  $t > t_{\alpha, N-2}$ , therefore null hypothesis ( $H_0$ ) with an error probability of 0.05 is rejected. Obtained correlation does not come from a population characterized for having zero correlation. There is a relation between compression resistance both in core and sclerometer testing.

Even though a relation between compression resistance in cores and sclerometer testing is present due to results obtained, determination coefficient ( $R^2$ ) is lower when compared against results found in literature [23]. This is
