Analysis and characterization of PV module defects by thermographic inspection

S. Gallardo, L. Hernández and O. Duque, "Analysis and characterization of PV module defects by thermographic inspection", *Revista Facultad de Ingeniería Universidad de Antioquia*, no. 93, pp. 92-104, Oct-Dec 2019. [Online]. Available: https://www.doi.org/ 10.17533/udea.redin. 20190517

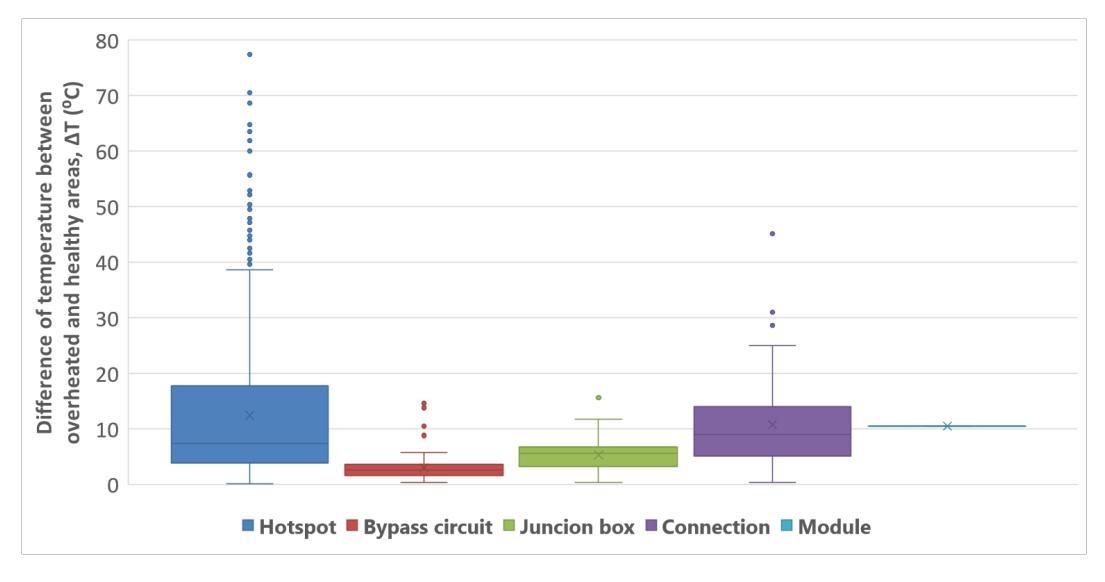
Figure 3 Box chart showing the difference of temperature between overheated and healthy areas, Δ T, grouped by defect type for each of the 1,140 defective modules detected

the severity of the anomalies for manual thermal inspection proposed in [17]. Differences higher than 30°C are considered as severe failures, from 10°C to 30°C are considered as medium severity failures, and lower than 10°C as minor failures. According to [23], temperature gradients lower than 10°C are normally considered as unproblematic and do not have to be listed separately. Temperature gradients from 10°C to 20°C are unproblematic in the current stage, although they have to be reported and observed in subsequent regular thermal inspections as they can increase during the operation of the PV power plant [23]. Differences of temperature above 20°C are expected to cause degradations of panel output and eventually, the material compound may even degrade, resulting in a safety issue. Table 3 summarizes the severity of all defects detected, grouped by defect type or affected component.

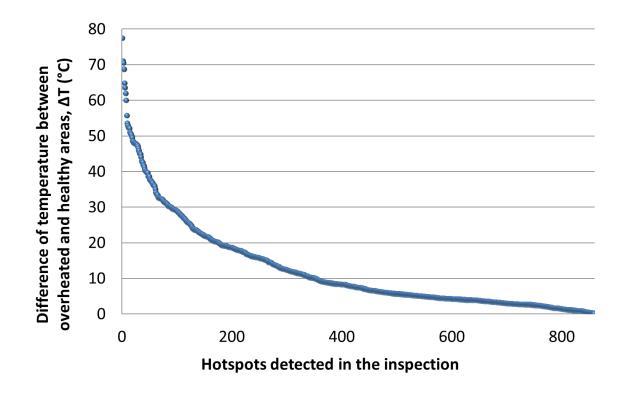
Figure 7 Δ T of each hotspot detected during the inspection in order from the highest to the lowest

Reviewing all cells hotspot defects, it has been concluded that the pattern of this fault is an overheated cell, of approximate 15 x 15 cm² depending on the module manufacturer, located in any cell along the module. The analysis performed does not reveal any preference of appearance of the overheated cell in any of the three strings circuits. The following figure, Figure 7, presents the Δ T of each of the 859 cell hotspots detected in the inspection in descencing Δ T order, obtaining an average temperature of 12.4°C with a standard deviation on 12.8°C. Other relevant statistical values are the median, 7.4°C, and the first and third quartile, 3.8°C and 17.8°C, respectively. As it can be seen in Figure 7, the highest Δ T detected in the tests is 77.4°C, which supposes a cell hotspot

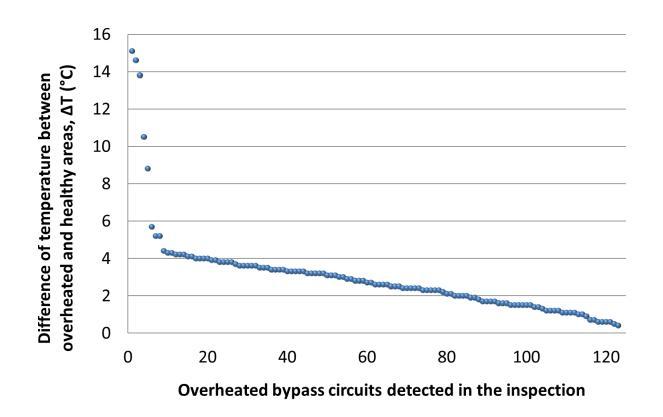
Figure 9 Δ T of each bypass circuit overheated detected during the inspection in order from the highest to the lowest

circuits detected in the inspection in descencing Δ T order, obtaining an average temperature of 3.0°C with a standard deviation on 2.3°C. As it can be seen in the figure, most of these defects present a Δ T under 4°C. Only 8 modules (which supposes a 6.5%) present a Δ T over 4°C and only 4 modules (3.25%) have a Δ T over 10°C. The maximum Δ T detected has been 15.1°C. Other relevant statistical values are the median, 2.6°C, and the first and third quartile, 1.7°C and 3.6°C, respectively.

in the modules, as the power dissipated in the fault decreases with respect to the temperature reached in a longer series of cells. However, authors in [39] conclude that the reliability of the bypass diode function remain uncertain and it is recommended to use application of specific PV modules with custom design of bypass diodes for specific applications in which high temperatures can suppose a risk hazard, as hydrocarbon industries.

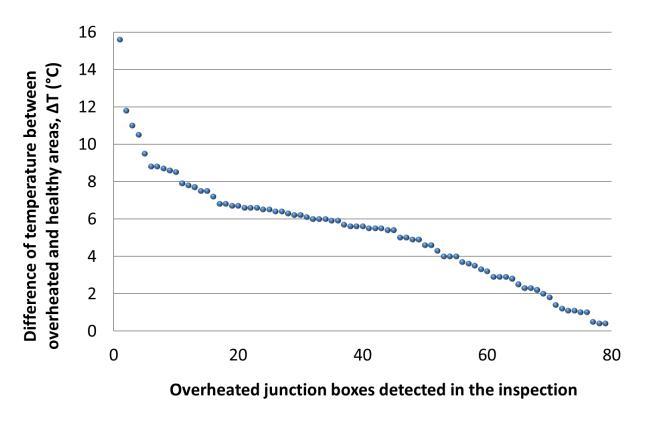
Figure 13 ΔT of each junction box detected during the inspection in order from the highest to the lowest

In relation with the pattern this kind of defects present, it has been shown that they are revealed as an overheated point in the middle part of the shorter side in which the box is located. This overheated point habitually appears in the middle of two different cells. In the PV plant in which the research has been performed, the modules of the upper row have the junction box underneath while the modules of the second row have the box in the upper part, as it can be seen in Figure 11 and Figure 12. The location of junction boxes along rows must be considered if a software must classify automatically the defects. The following figure, Figure 13, presents the ΔT of each of the 79 overheated junction boxes detected in the inspection in descencing ΔT order, obtaining an average temperature of 5.3°C with a standard deviation on 2.8°C. The maximum ΔT detected has been 15.6°C. Other relevant statistical values are the median, 5.6°C, and the first and third quartile, 3.3°C and

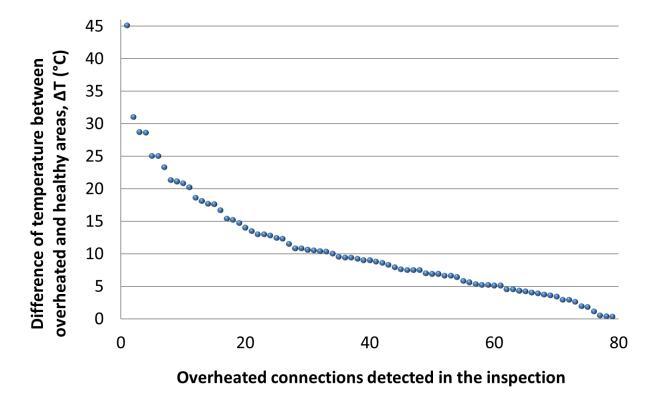
Figure 15 Δ T of each overheated connections detected during the inspection in order from the highest to the lowest

Reviewing all connection defects, it has been concluded that the pattern of this fault is an overheated point, generally smaller than a cell, located next to the frame in the same side in which the junction box is placed. The following figure, Figure 15, presents the ΔT of each of the 78 overheated connections detected in the inspection in descencing ΔT order, obtaining an average temperature of 10.9°C with a standard deviation on 8.1°C. The maximum ΔT detected in this case has been 45.1°C. Other relevant statistical values are the median, 9.0°C, and the first and third quartile, 5.2°C and 13.8°C, respectively.
