# STUDY OF MECHANICAL BEHAVIOR OF TEXTILE REINFORCED COMPOSITE MATERIALS

## ESTUDIO DEL COMPORTAMIENTO MECANICO DE MATERIALES COMPUESTOS REFORZADOS CON TEXTILES

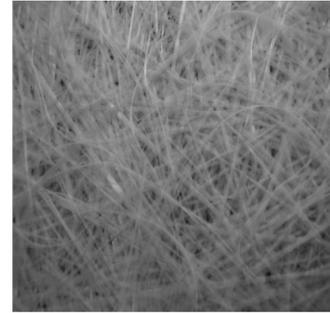
**Mat textile:** Glass fiber geometry is completely random with fibers dimensions of about 15-30 cm long in average. Figure 1 presents an actual size image of the mat textile.

Figure 1. Mat textile.

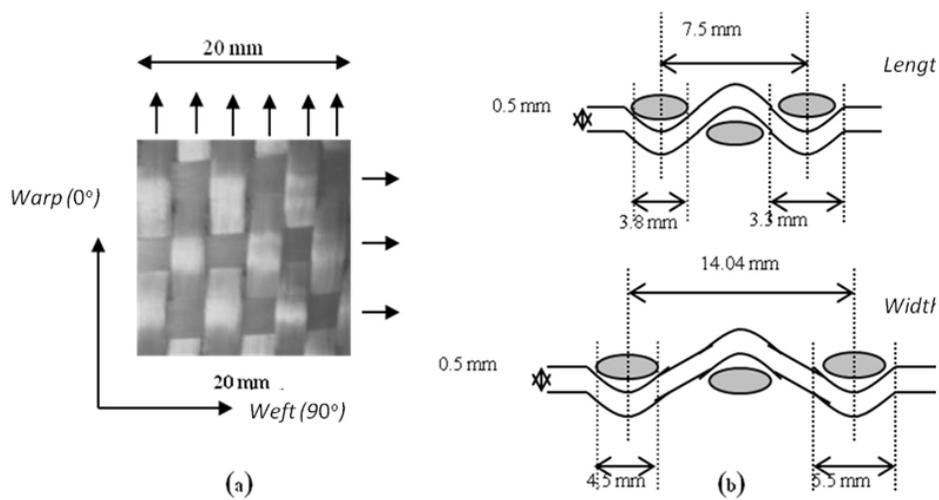
**Woven textile:** Constituted of glass fiber type E of 0.4 N/tex, which is identified by its two main directions (length and width) as it is woven it is typified as a biaxial fabric. It is very important to notice that direction in the textile length is referred as 0° (warp), while the width is referred a 90° (weft). Figure 2a shows an image of the original textile where it is possible to identify the two main directions. It is also important to mention that, in 20 mm<sup>2</sup> of the fabric, 6 yarns running on warp direction (0°) and only 3 yarns in weft direction (90°) are found. However, yarns running in weft direction (90°) are slightly thicker (a higher number of filaments) than those oriented at warp (0°). Both textiles were acquired from Norteen Fiberglass Inc.

Figure 2. Woven architecture: (a) original, (b) crimp dimensions.

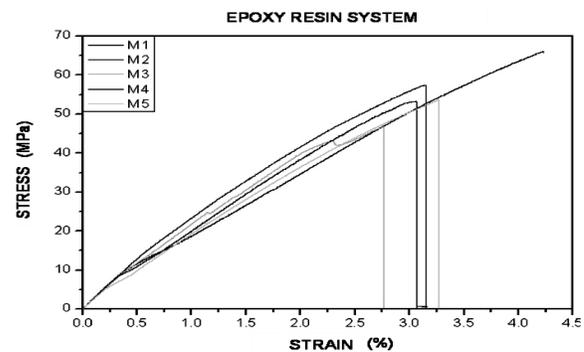
**Figure 3.** Strain-stress curves for epoxy resin in tension mode. M1...M5 symbols in the chart refers to the five composite samples tested respectively.

For this reason a mechanical test in tension mode was carried out on samples manufactured in only one direction by taking into account the isotropic characteristics of this fabric. Typical stress vs. strain curves can be observed in Figure 3 and Figure 4 for the epoxy system and the composite material respectively. A mat textile reinforced composite provides a slight increment in the resistance (elastic modulus) with respect to the epoxy resin properties increasing from 2,754 MPa to 3,804 MPa. However the elongation decreases approximately 50% due to the effect caused by the amount of fibers which augments the stiffness in the thermosetting matrix. There is also a reduction in the ultimate strength between the epoxy matrix and the composite from 66.9 MPa to 38.9 MPa respectively. This is clearly observed in Table 1, in which, for comparative reasons, mechanical parameters obtained from the epoxy system without reinforcement, the mat reinforced composite and the woven reinforced composite in its

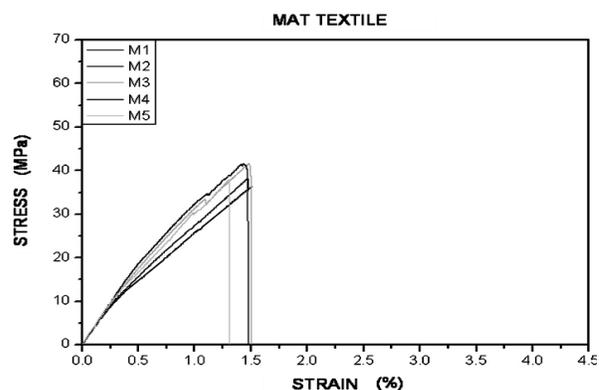
**Figure 4.** Strain-stress curves for mat reinforced composite in tension mode.

material samples suffered catastrophic fracture with the first major signal of failure. In the stress-strain curve there is no discontinuity that could be related to previous damage indicating the initiation of failure. Figure 5 illustrates the fracture zone of the composite samples tested in tension. Random orientation of the fibres can be observed due to the transparency of the resin. Composite material fiber volume fraction ( $V_f$ ) was calculated to be 13% on average.

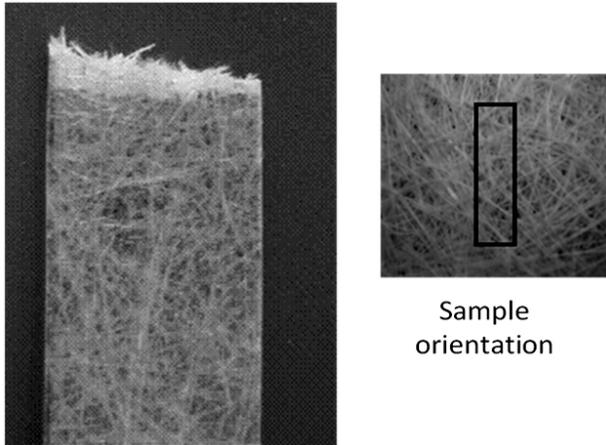
**Figure 5.** Fractured sample, mat composite.

From this failure mode three aspects can be observed:

- 1) No dominion of the textile geometry (long fibres randomly oriented) over the mechanisms of fracture was identified since all fibres suffered initial interface delamination.
- 2) Subsequent transversal crack development and coalescence of the initial crack induce the final fracture.
- 3) Samples did not display any cracking pattern along the sample previous to total failure since they fractured with the first main crack.

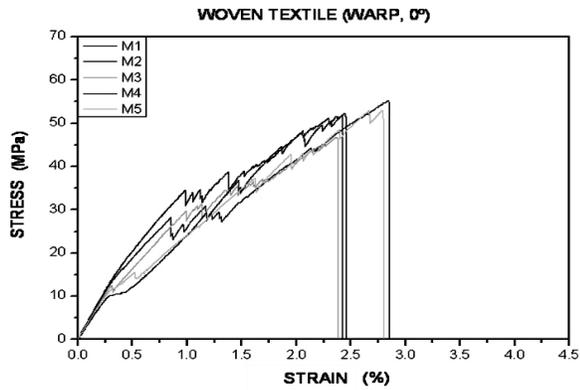
Typical stress vs. strain curves for these samples oriented in the warp direction exhibited several discontinuities (Figure 6) indicating the successive appearance of mayor cracks (visible and audible) along the material. These cracks ran transversally from side to side of the sample, perpendicular to the loading direction.

**Figure 6.** Strain-stress curves for woven reinforced composite in tension mode at 0° orientation.

Table 1 presents the numerical values of the mechanical parameters where it is possible to observe the effect induced by the reinforcement with a defined geometry, such as woven. In this case the elastic modulus augmented 13%, the maximum stress increased 33% and the elongation reached 85% in relation to the corresponding values obtained for mat reinforced composite. This difference is due to the higher amount of unidirectional fibres oriented to the loading direction (parallel to the applied stress).

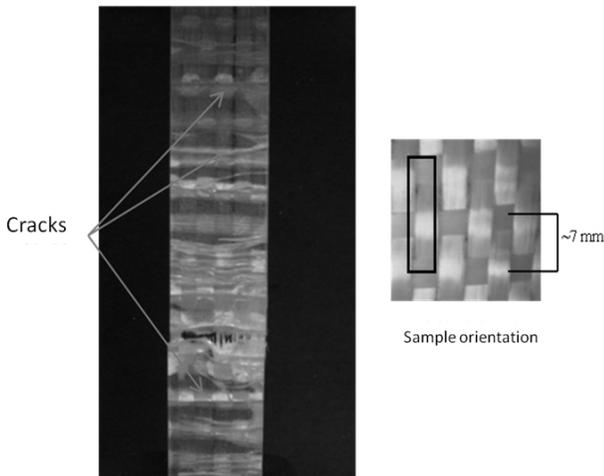
It is possible to observe in the fractured sample (Figure 7) the damage pattern and the spaces between the fissures running transversally as delaminations in the fiber/matrix interface zone (blue arrows). These cracks, perpendicular to the applied load, presented interspaces of about 7 mm, which is possibly related to the separation distance between the transversal yarns of the woven fabric.

**Figure 7.** Fractured sample, woven 0°.

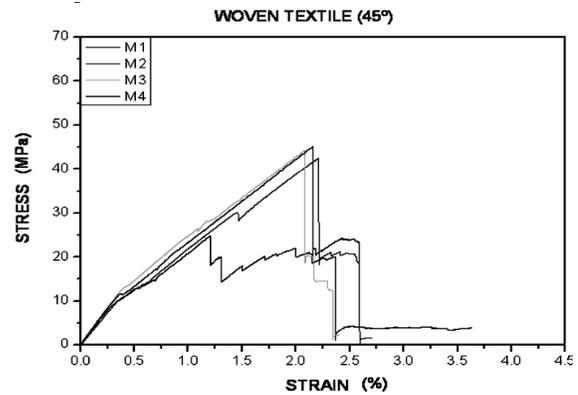
The stress-strain curves for this material are displayed in figure 8. These samples oriented at 45° exhibited a minimum of discontinuities before maximum stress, less than the damage sequence observed when oriented at 0° and 90°. The arrangement of threads at 45° lacks parallel

filaments (unidirectional) to the loading direction. Therefore cracks are easily formed and total fracture appears with the first sign of damage. Transference of load from matrix to fibers is not good enough to bear the tension load. Consequently, cracks coalesce between the points where tows cross each other perpendicularly at 45°. In this particular case, samples did not present a successive damage development since some of them fractured when the first visible crack appeared; therefore damage was only noticed around the fractured area. No damage pattern was observed. Table 1 presents the numerical values of the mechanical parameters. For these samples, the mechanical properties tend to decrease in comparison with samples oriented at 0°.

**Figure 8.** Strain-stress curves for woven reinforced composite in tension mode at 45° orientation.

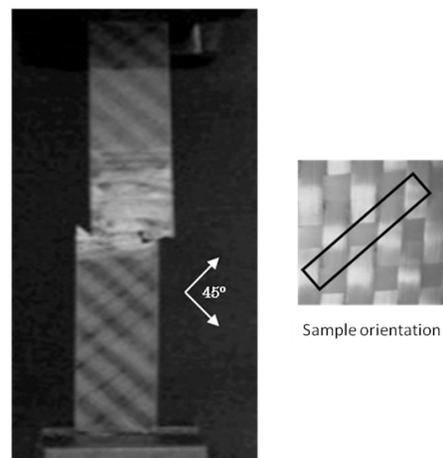
As shown in figure 9, failure develops and propagates in the rich resin zones around the yarns intersection (crimps oriented at 45°) diminishing the strength of the material.

**Figure 9.** Fractured sample, woven 45°.

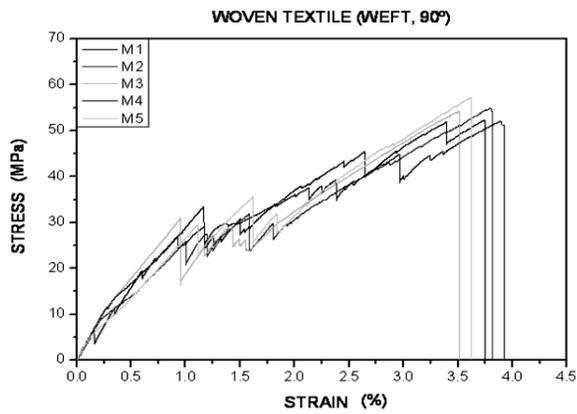
Similarly to the stress vs. strain curves found for warp (0°) direction samples, at 90° they presented several discontinuities (Figure 10) related to damage progression of transversal cracks along the samples. They also exhibited higher crack density (number of cracks/area). The values for the mechanical parameters are displayed in Table 1. These results are very similar to those found for warp direction (0°) samples. Such similarity is due to the almost identical amount of fibers in both directions (0° and 90°) despite the dissimilar amount of yarns. As it was mentioned before, less yarns are oriented at 90° than those at 0° however they are wider containing a higher amount of fibers per thread.

**Figure 10.** Strain-stress curves for woven reinforced composite in tension mode at 90° orientation.

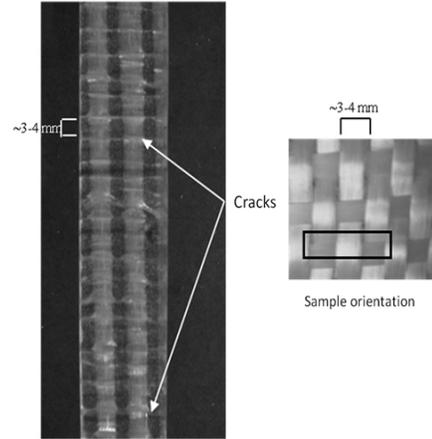
**Figure 11.** Fractured sample, woven 90°.

Fractured samples exhibited several transversal cracks along the tested material similarly to the damage pattern identified at 0° orientation samples but in higher numbers (Figure 11). This cracking pattern is intimately related to the woven textile architecture which generates a successive cracking sequence with a distance space between cracks of about 3 to 4 mm. Fiber volume fraction ( $V_f$ ) of the composite material reinforced with woven textile was calculated to be 16% on average.

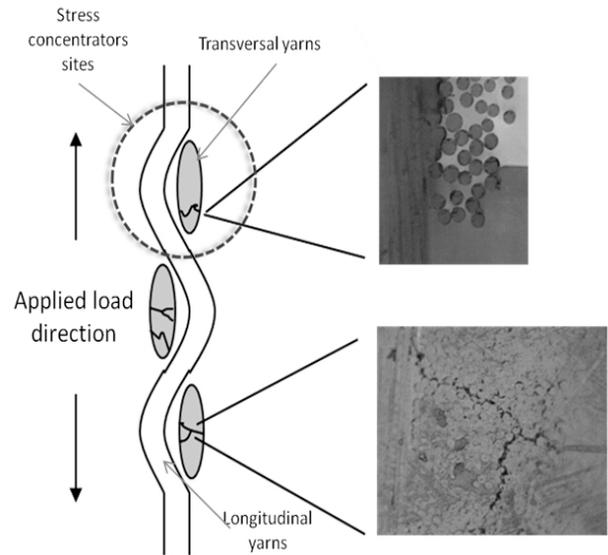
**Figure 12.** Crack development, woven 0°.

Several damaged samples oriented at 0° and 90° prior to total fracture, were chosen to be polished in order to be inspected under the scanning electronic microscope (SEM) to identify the possible initiation sites. This

fractographic analysis demonstrated that transversal cracks are apparently developed perpendicularly to the loading direction through fibre/matrix delaminations from side to side of the samples.

Most transversal cracks were observed to appear at the samples edges through small delaminations in the interbundle interface area between orthogonal threads. Microscopic analysis identified the extreme points and the middle zone of the transversal bundles (crimp regions) as the probable origin of the crack initiation as illustrated in figure 12. These cross-over sites are considered as stress concentrators where it is possible to find crack initiation points.

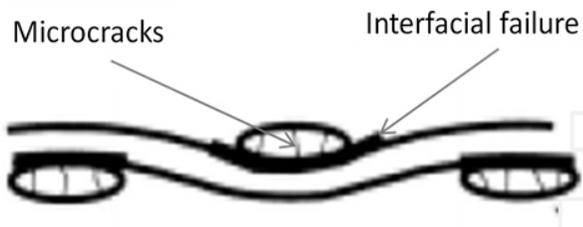
- 4.) Interfacial failures coalesce inflicting damage to the polymeric matrix causing main visible and audible cracks. Once the sample is saturated due to stress distribution, cracks lead to total fracture of the material (Figure 13).

Figure 13. Stress concentration points.

- 3.) Microscopic evaluation indicated that cracks are initiated in the crimp zones within the bundle, into the fibers that form the thread (oval shape). Cross-over points act as stress concentrators contributing to damage initiation.
