Thermal damage evaluation of full scale concrete columns exposed to high temperatures using scanning electron microscopy and X-ray diffraction

Bruno Fernandes ^a, Augusto Masiero Gil ^b, Fabrício Longhi Bolina ^b & Bernardo Fonseca Tutikian ^b

Keywords: concrete; high temperature; microstructure; scanning electron microscopy (SEM); x-ray diffraction (XRD).

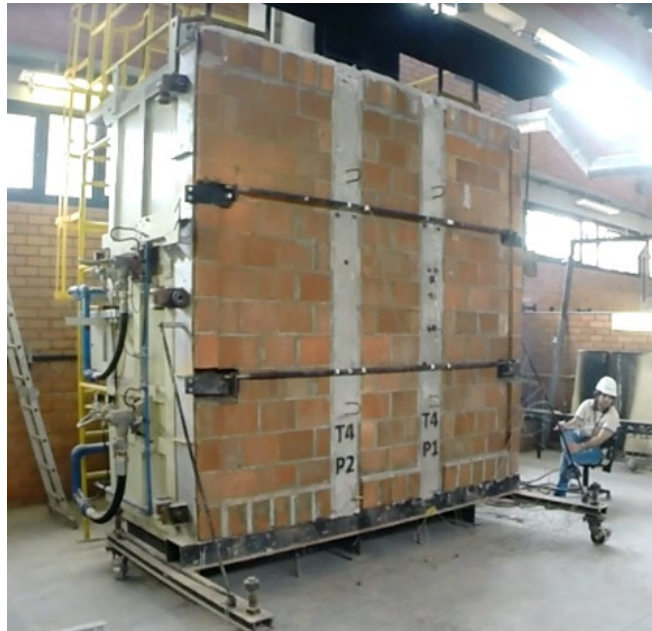
Figure 2. Experimental setup: columns embedded in masonry wall
Source: Authors

For the heating process, a vertical furnace was used. The inside of the furnace is 2.5 m tall, 2.5 m wide and 1.0 m long. The experimental model consisted of columns embedded in a masonry wall built within a frame, so that 45% of the cross section would be exposed to high temperatures, in three faces. Fig. 1 shows how the columns were tested, and Fig. 2 depicts the experimental setup.

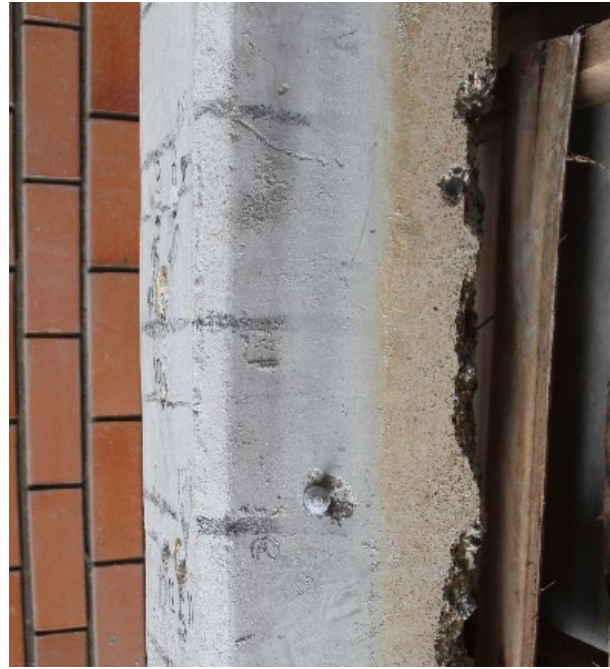
Figure 6. Surface of reinforced concrete column
Source: Authors

The surface of one of the reinforced concrete columns, after the fire resistance test, is shown in Fig. 6. A yellowish color is visible, indicating that the concrete surface surpassed the temperature of 900 °C [2,16,17]. It was also noted that the color of concrete changes as depth increases, with a grey tone appearing, indicating that the concrete reached a range of 600-900 °C [2,16]. This is also observed in Fig. 7, which shows a piece of concrete cover. Small black dots can be seen in this picture, which can be related to use of crushed basalt sand, since the mineralogical nature of the aggregate induces color changes to the concrete. As expected, the material from the concrete cover was fragile and had an intense incidence of pores (observed visually). Yet, only column P1 underwent spalling.

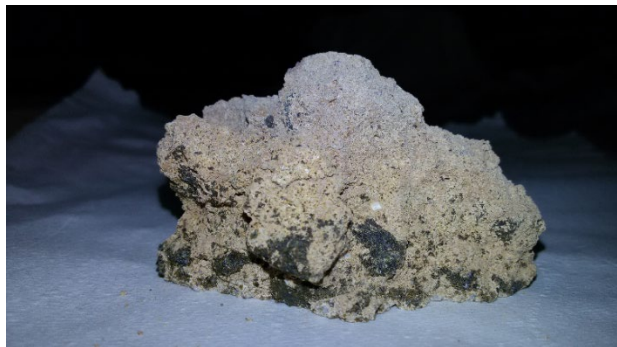
Figure 7. Piece of concrete cover
Source: Authors

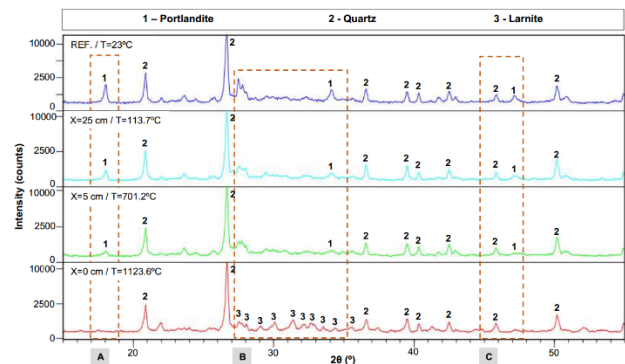
Figure 11. XRD diagrams 25 cm, 5 cm and 0 cm depth (P2 column)
Source: The authors

XRD diffractograms of the reference concrete and 25 cm, 5 cm and 0 cm depth samples of both columns are presented in Figs. 10 and 11. The transformations observed are highlighted.

P2 samples displayed portlandite and quartz as well, but larnite was identified in the XRD diffractograms. Contrary to P1 samples, portlandite could be seen at the 5 cm depth, but not at 0 cm, where the temperature was 1123.6 °C. A similar behavior was observed by Kim, Yun and Park [14]. Furthermore, larnite (β -C₂S) was found at 0 cm depth, most likely as a result of the C-S-H disassociation, in accordance to what is pointed out by the literature [5,6,20].
