Mechanical Deterioration by Weathering of the Adobe from the Tausa Chapel (Colombia)

J. Camacho-Tauta, C. Uribe-Kaffure, A. Ramos-Cañón,
“Mechanical Deterioration by Weathering of the Adobe from
the Tausa Chapel (Colombia),” *TecnoLógicas*, vol. 26, nro. 58,
e2733, 2023. <https://doi.org/10.22430/22565337.2733>

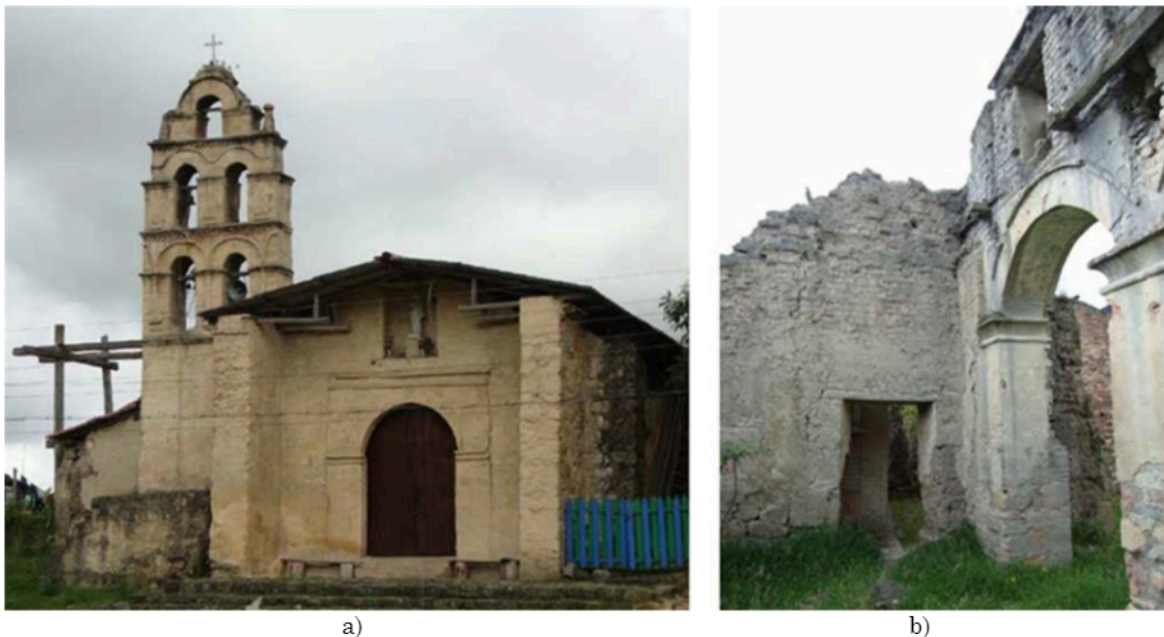
Figure 1. Doctrinal chapel in Tausa: a) frontal sector; b) rear sector. Source: Created by the authors.

atrium is built in stone, forming four staircases that lead to the street. According to the current structural preservation state, the building can be divided into two parts. The frontal sector presented in Figure 1a) is currently in use and is composed of the nave built in masonry, adobe, rammed earth, and collar roof. The rear sector in abandoned conditions as can be seen in Figure 1b) corresponds to the ruined walls of the presbytery and two lateral areas, of which it is unknown its use. A description of the architectonic distribution, constructive technique and physical, mechanical, and chemical characteristics of the materials can be found in [31].

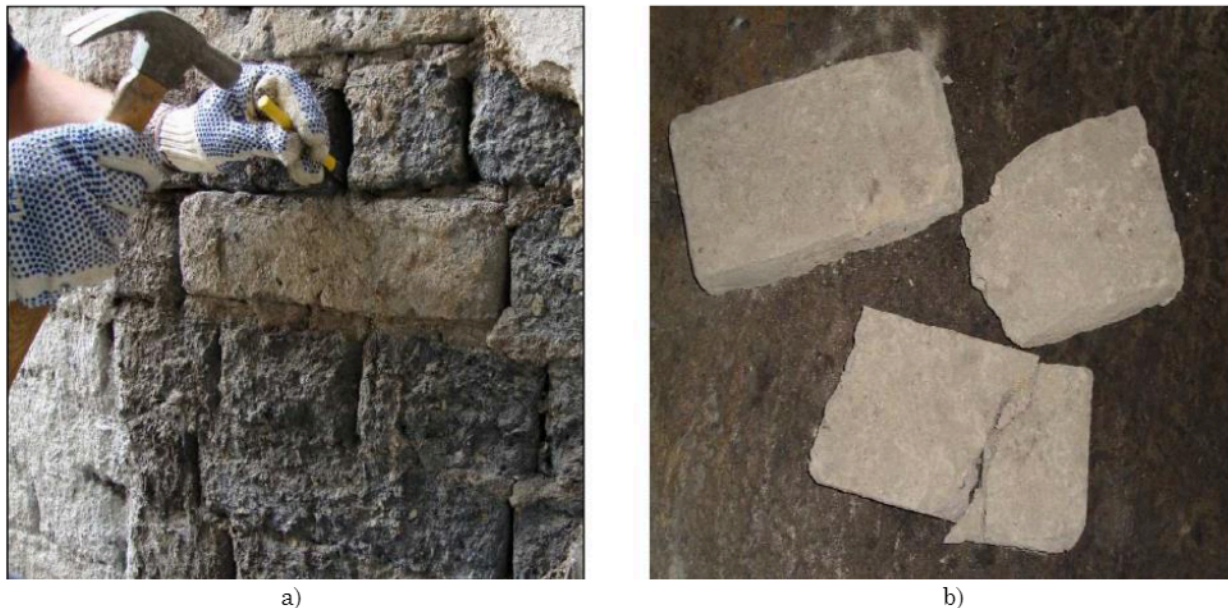
Figure 2. Samples of old adobe: a) recuperation of an adobe unit; b) recovered samples.
Source: Created by the authors

The experimental program was carried out on two groups of materials. The first one corresponds to adobe samples recovered from the rear sector of the chapel (old adobe). 15 complete adobe units and 24 fragments (Figure 2) composed old adobe samples. The second group was obtained from a soil deposit located in the area close to the chapel (new adobe). Three soil deposits in the locality were preliminarily studied by performing soil classification tests and the most similar soil to the old adobe was the chosen one. Only results from the selected soil deposit are presented in this paper. With the new adobe, 60 samples were prepared by compaction in cylindrical molds under controlled water content. Then, they were extruded from the mold and left to air-drying with no action of direct sunlight for 45 days (Figure 3). Compaction of samples was carried out to simulate the methods employed by ancient construction workers in the production of adobe walls. For this reason, modern procedures such as Proctor compaction were avoided to preserve the authenticity of the compaction process. The moisture conditions for compaction were those necessary for better workability, mirroring the practices of traditional construction [32]. This procedure aimed to obtain samples with similar characteristics of adobe units made with this conventional technique. A comparison of the physical characteristics of old adobe and new adobe samples are presented in Table 1. Results from old adobe are like results previously obtained on samples of the same chapel by [32]. However, plasticity limits are slightly lower than the results found in the present work.

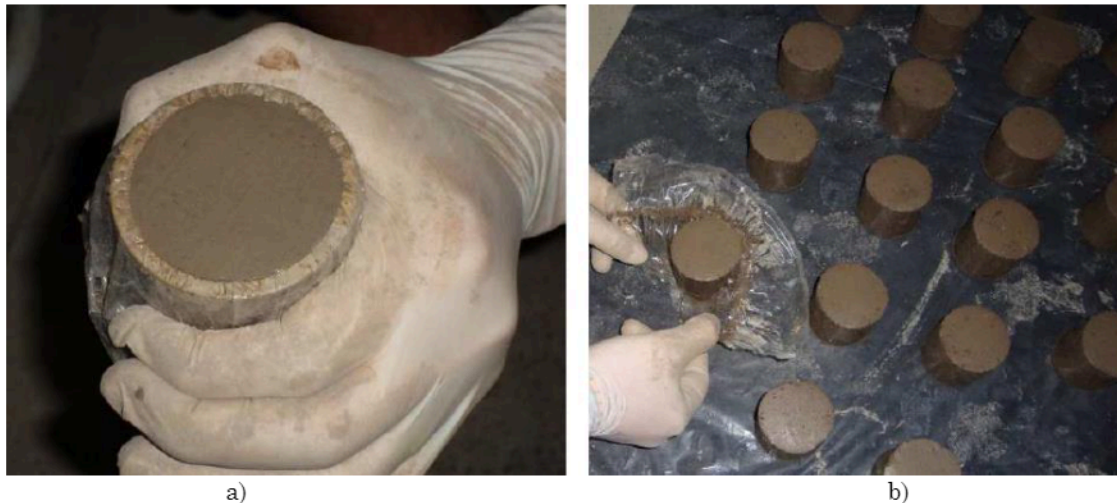
Figure 3. Samples of new adobe: a) preparation of the sample; b) air drying process.
Source: Created by the authors

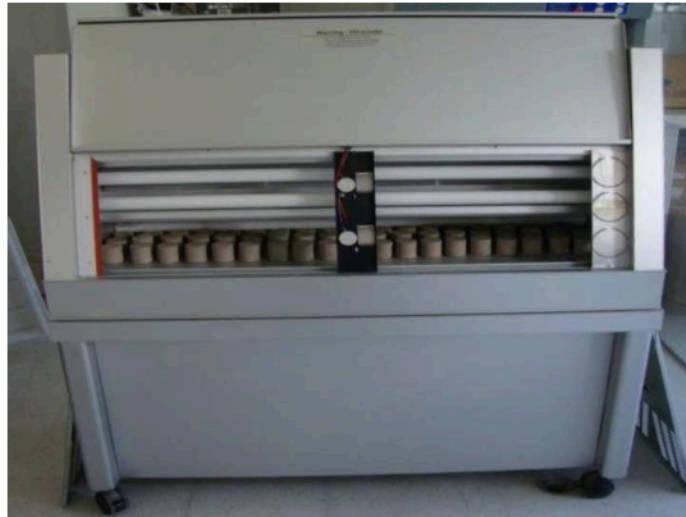
Figure 4. Accelerated weathering tester QUV-SE. Source: Created by the authors.

Cylindrical samples from old adobe were obtained from adobe samples by using a core extractor. An accelerated weathering tester QUV-SE [33] simulates the effect of ambient exposition. Figure 4 illustrates the equipment with a group of samples ready to be exposed to weathering. The equipment is capable of controlling irradiance by a closed-loop control and uses eight UVA-340 lamps simulating the sunlight from 365nm down to the solar cut-off of 295 nm. In addition, the apparatus has a condensation mechanism to simulate outdoor moisture attack by heating a water reservoir to produce a vapor that maintains a 100 % relative humidity. Radiation and condensation alternate cyclically in programmable periods. Exposition of materials to this artificial regime produces degradation in a similar way that natural ambient conditions. Proportionally time factor between natural and artificial exposition is not constant since it depends on several variables that are not fully controlled (e.g., tested material, variation in natural conditions, variables capable of controlling in the equipment). The standard ASTM G154-16 [34] covers the principles and operating procedures for apparatuses designed for UV exposition of non-metallic materials.

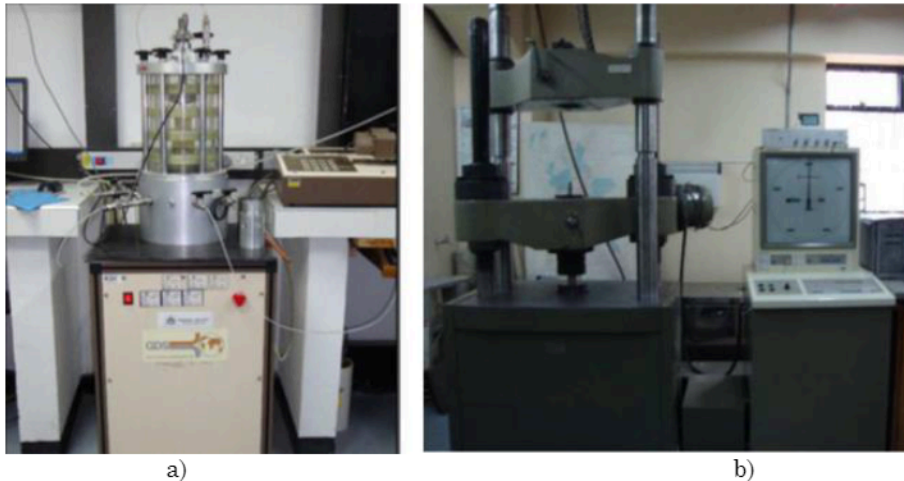
Figure 5. Mechanic devices: a) triaxial testing apparatus; b) compression tester machine. Source: Created by the authors

Mechanical tests on the samples were done by using the GDS triaxial testing apparatus shown in Figure 5a [35]. The system allows controlling confinement pressure and vertical stress. A universal compression tester machine was used for unconfined compression tests on cylindrical samples (Figure 5b). Additional equipment and accessories include scale, oven, sieves, soil classification instruments and compaction molds.

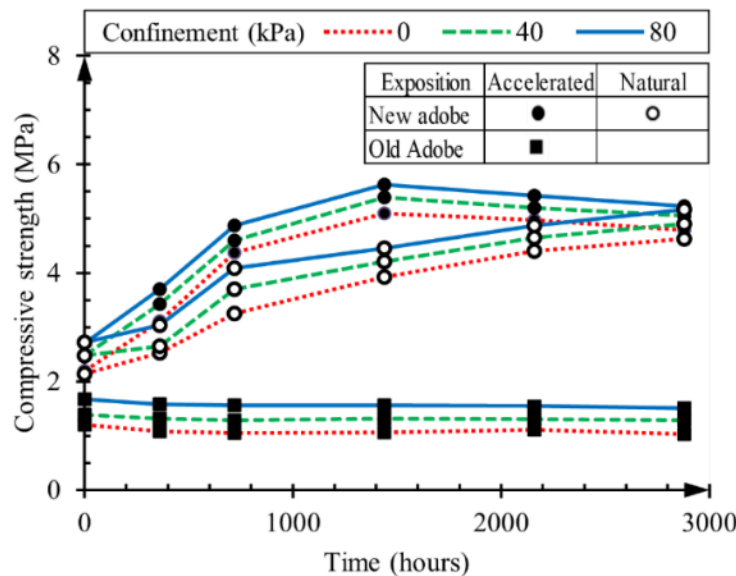
Figure 6. Unconfined and confined compressive strength of adobe samples. Source: Created by the authors

Results of compressive strength from unconfined and confined compression tests appear synthesized in Figure 6. The first characteristic is the difference between the compressive strength at null exposition time: for all the test points, new adobe samples exhibit higher strength than old adobe samples. For instance, the unconfined compressive strength of new adobe was almost twice than the same property for old adobe. The substantial difference between old and new adobe could be a result of long years of direct weathering and absence of maintenance that finally resulted in the ruined conditions in which the rear sector of the chapel was found. The second evident characteristic in Figure 6 is the almost constant behavior of the strength of old adobe along the exposition time. In other words, no further deterioration is observed by additional hours of accelerated ageing for a material that was already exposed to a prolonged time under neglecting conditions. Results of unconfined compressive strength of new adobe found in literature varies depending on the soil type, curing period, water content, among others. For instance, [40] report an unconfined compressive strength around 1.5 MPa for a sample after 28 days of natural curing and 3.5 %

water content. In the present work, for similar conditions of natural curing and water content new adobe reaches 3.2 MPa, which is similar to the value reported by [32]. Reported data for unreinforced adobe units varies from 0.55 to 3.4 MPa [41]. Changes in water content have strong influence in the shear strength of adobe materials because the soil suction increases when the soil moisture reduces [27], [42].

The natural-exposed new adobe gradually increases its strength, since during the period studied, the unconfined compressive strength raised from 2.2MPa up to 4.4 MPa with a rate of strengthening decreasing with time. On the other hand, artificially exposed new adobe showed an initial rapid increase in the strength, followed by a slight reduction of this property. By comparing natural and accelerated exposition curves from new adobe, naturally exposed curves could represent the first stages of accelerated curves, that is, 2880 hours under natural exposition could be reproduced by approximately 720 hours under artificial conditions. This ageing factor of four is approximated and only should be representative of the conditions in which the samples of this new adobe were subjected to ambient conditions. The effect of the confinement is reflected in the three set of samples: the higher the confinement stress, the greater the compressive strength is. Additional compressive strength caused by the applied confinement is practically constant irrespective of the adobe, weathering regime and exposition time.

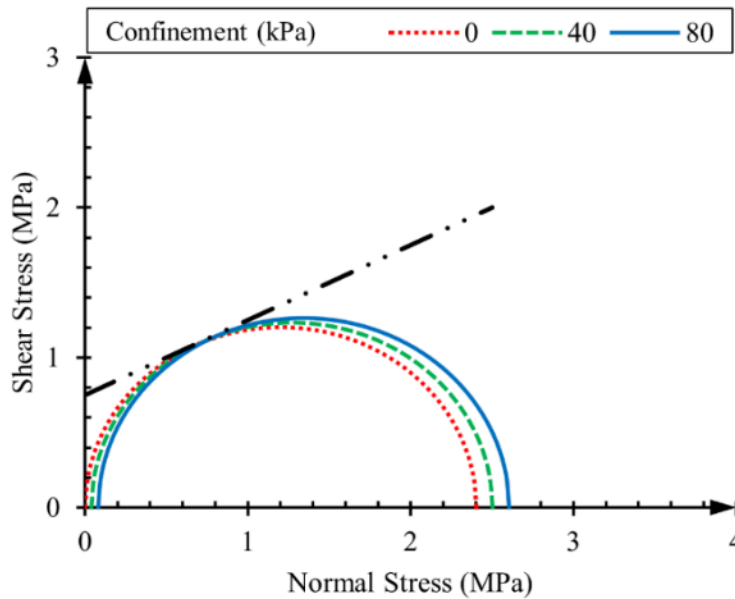
Figure 7. Mohr's circles and failure envelope of new adobe and no exposition to weathering. Source: Created by the authors.

Stress states at failure from compression tests were represented by Mohr’s circles as can be shown in Figure 7, which includes the failure envelope according to the Mohr-Coulomb failure criterion given by (1). In this criterion, τ_f is the shear stress at failure, c is cohesion, σ is the normal stress to the failure plane, and ϕ is the shear strength angle.

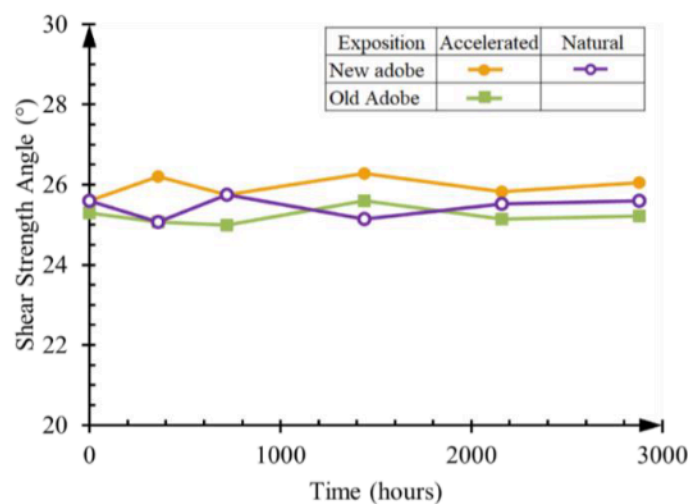
Figure 8. Shear strength angle of adobe samples. Source: Created by the authors.

Similar graphics for different adobes, exposition period and type of weathering were plotted and estimated the corresponding shear strength parameters, ϕ and c . Figure 8 presents the comparison of the different shear strength angles. It is evident that this parameter was not affected by the duration of the exposition, neither by natural nor by artificial regime. As a result of the acceleration in the weathering process, new adobe exposed to artificial conditions had a very little increment in the shear strength angle compared with the same adobe but naturally exposed. It is important to realize that old adobe retained the same shear strength angle despite the long and unfavorable conditions of natural weathering. From a practical point of view, the shear strength angle is 25° for old and new adobe, regardless the exposition conditions.

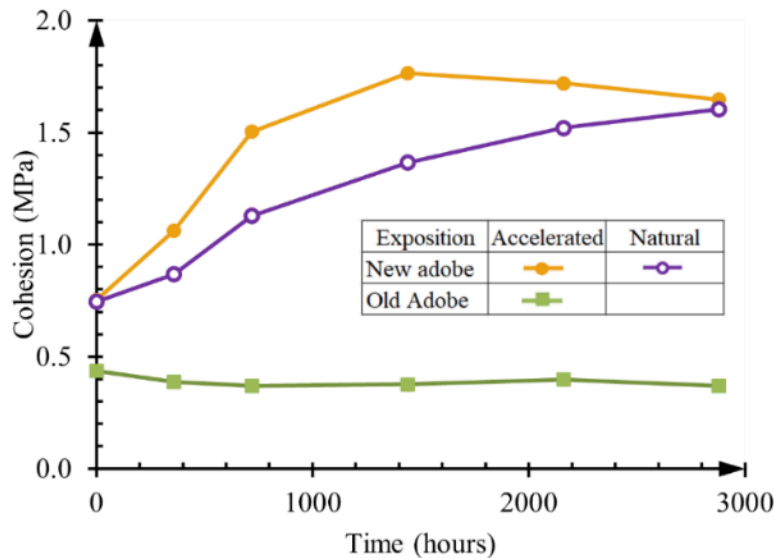
Figure 9. Cohesion of adobe samples. Source: Created by the authors.

The patterns observed in the compressive strength analyzed in the preceding section, are reflected in the cohesion parameter (Figure 9). This observation indicates that the growth in the strength is primarily governed by an increase in the cementation of the clay minerals by cause of exposition to natural or artificial ageing. Old adobe is nearly insensitive to accelerated exposition because after approximately 300 years of natural exposition to weathering, almost 3000 hours of additional accelerated exposition are insignificant. Nevertheless, prolonged exposition to ambient conditions without preventive or reconstructive interventions seriously diminished the cohesion of adobe units. Reduction in cohesion values after 1500 hours of accelerated exposition evidenced in new adobe samples could be due to the same mechanism that occasioned the gradual reduction of cohesion in old adobe after many years from its construction until the present.

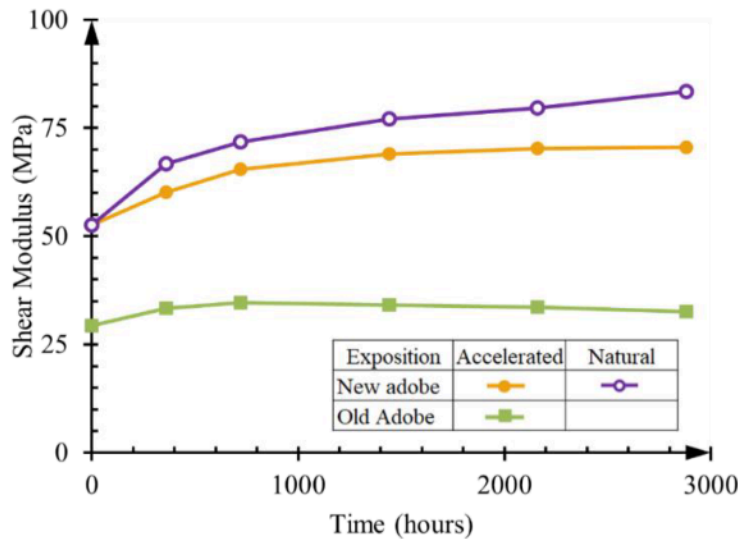
Figure 10. Shear modulus of adobe samples. Source: Created by the authors.

The initial slope of the curve shear stress against shear strain is suitable to estimate the shear modulus. Despite the deficiency in the resolution of the sensors regarding the small strain range in which the material is elastic, results presented in this section are useful for comparative purposes. Figure 10 compares the evolution of the shear moduli for the samples studied. As other results presented in previous sections, shear moduli from old adobe are not significantly affected by additional weathering.

Regarding new adobe, naturally exposed samples were stiffer than artificially exposed samples for all the periods of exposure to weathering. This fact could be due to the condensation cycles that allow more flexibility to the material as a consequence of the gain in moisture. New-adobe samples artificially exposed reached a kind of stabilization at the end of the weathering period imposed by the accelerated tester.

Comparing shear moduli of new adobe against old adobe, it is clear the significant difference along the entire period studied. Moreover, the ratio between new-adobe modulus and old-adobe modulus from samples artificially weathered is around two for all the exposition periods. The substantial reduction of the modulus observed in old-adobe samples could be caused by the careless conditions of the structure throughout the last century during which the walls were non-protected with a roof.
