EVALUATION OF FAULTS IN THE SQUIRREL CAGE THREE-PHASE INDUCTION MOTORS

Abstract

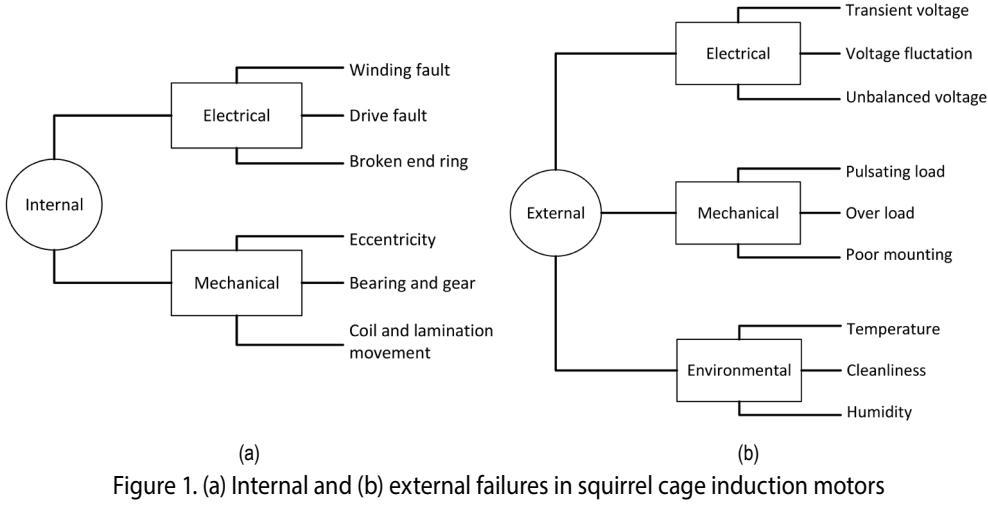
Specifically, squirrel cage motors are highlighted for being the most widely implemented in industrial applications. Various methodologies for fault detection in electric induction motors have been proposed in the literature, which can be comprised as internal or external, as shown in Figure 1 [10]–[13].

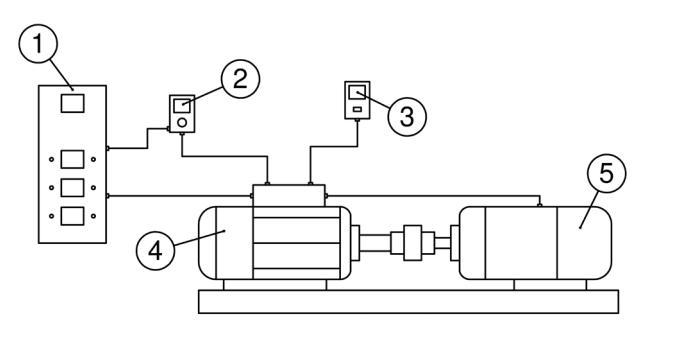
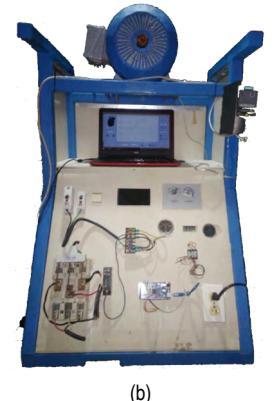
Figure 2. (a) Scheme of the experimental test bench and (b) Test bench.

The experimental test bench is made up of an autotransformer in charge that adjusts the current and voltage levels in the induction motor. A Foucault brake was used to modify the motor load conditions. An oscilloscope (Fluke 43-B) was used to measure the power developed by the motor, Total Harmonic Distortion (THD) values, and harmonic variations. An amperemeter (UNI-T UT58A) is employed for current measurements. Table 2 shows the main features of the measuring equipment.

Transformer, 2. Amperemeter, 3. Oscilloscope, 4. Induction motor, 5. Foucault brake.
(a)

For the experimental testing, a 5.5 kW, 4-pole, three-phase induction electric motor was used. The technical characteristics of the motor are shown in Table 1 and Figure 2 displays the test bench schematics.

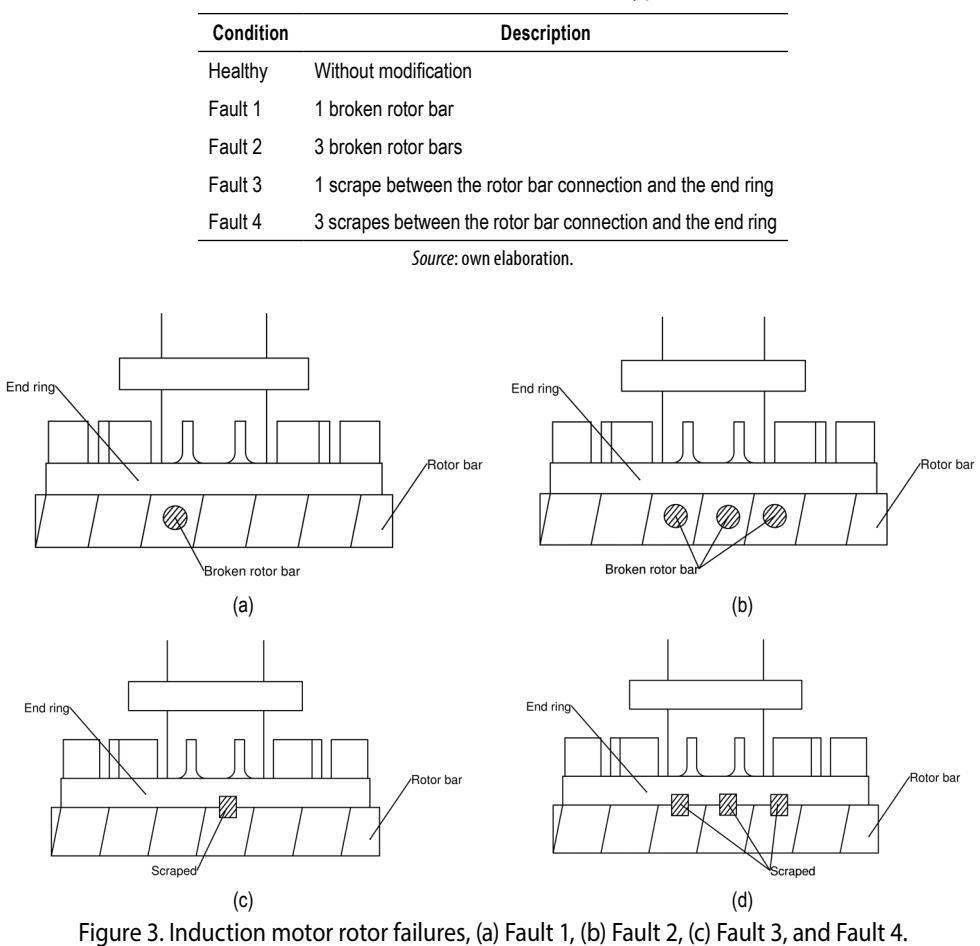
Table 3. Induction motor failure types

The study of the induction motor comprises the analysis of four failure cases based on the defects in the rotor bars and scratches at the junction between the end ring and the rotor bars, as described in Table 3. Besides, Figure 3 shows a schematic representation of the failures analyzed. It is worth mentioning that for each failure type, different operating conditions are established, namely motor without load, partial load, and blocked rotor.

the behavior of the motor under an early failure condition until its subsequent growth. To break the bars, a circular perforation was made with a diameter of 5 mm and a depth of 4 mm. The end ring scraping of the rotor covered a surface area of $4 \times 8 \text{ mm}$ and a depth of 2 mm, respectively.

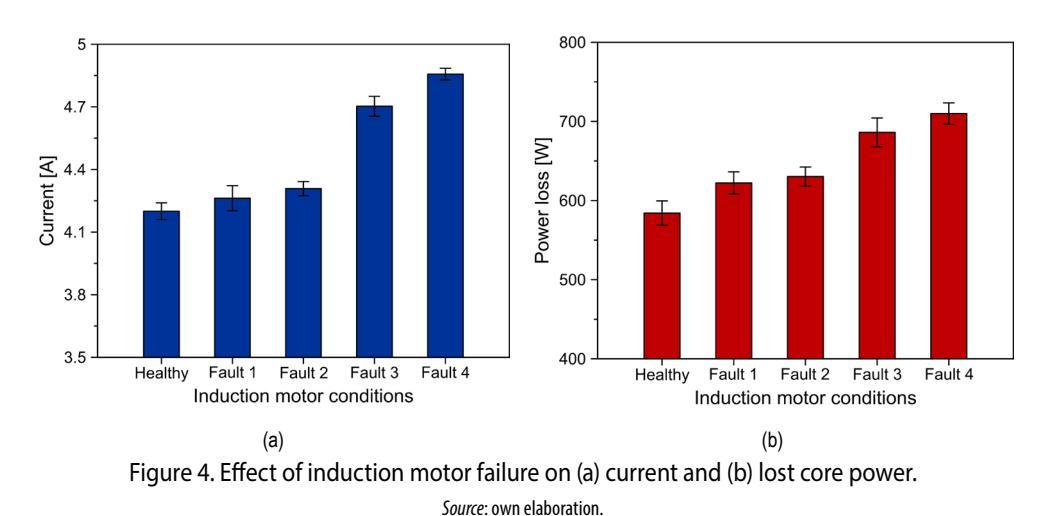
of 50 Hz. Accordingly, the induction motor currents are shown in Figure 4a, while the core power losses of each failure case are displayed in Figure 4b.

First, Figure 4a reveals that failures related to rotor bar rupture slightly increased the motor current. This behavior can be explained considering that this failure fosters an unbalanced magnetic pull that results in an additional frequency component in the stator current [28]. In contrast, the defects in the connection of the rotor bars and the end ring (fault 2 and 4) significantly increase the current in the motor. For instance, failure from 1 bar to 3 broken bars causes a 1.08 % increase in current, whereas the progression in scrapings (fault 3 and fault 4) intensifies the current by 3.27 %. The highest current obtained was 4.85 A in fault 4; as a comparison, the current in the healthy condition was 4.2 A.

Interestingly, the results obtained for the power losses in Figure 4b resemble those reported in Figure 4a, which can be explained considering that in both cases, each fault type stimulates the electromagnetic field disturbance, which directly impacts the torque modulations and vibratory effects. The latter is in agreement with other studies [22, 28, 29]. For the faults caused by scratches, the range of power loss range between 651 to 667 W. In the case of rotor bar failure, a range of power loss was recorded between 622 to 630 W. The critical case of each type of failure, namely fault 2 and fault 4, boosts the power losses by 8 % and 21 %, respectively, when compared to healthy motor conditions.

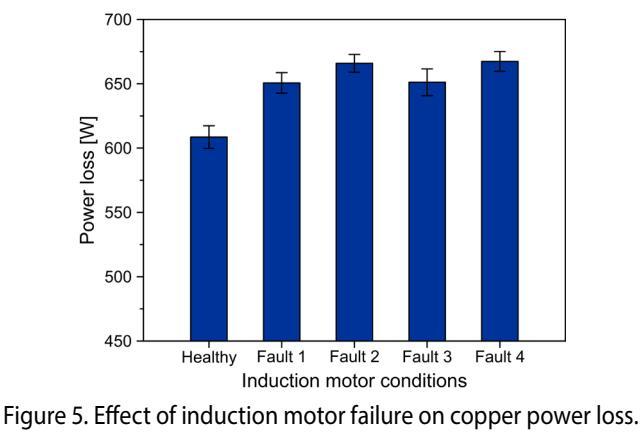
To perform the locked rotor tests, a modification was made in the power factor of the rotor and the voltage, which is fixed at a current in the induction motor (nominal current). The voltage value for a locked rotor condition was 80 V, under a 50 Hz frequency condition. Under these conditions, copper power losses are quantified. The results obtained are shown in Figure 5.

In the case of copper losses, it was observed that the bus break failures and the scratches in the end ring promote power losses of a similar magnitude. The latter can be a consequence of a balanced intensification of the thermal stresses since all the types of failures increase the stator current, which facilitates temperature rise [33]. Overall, both types of failures produced a 9.5 % increase compared to the healthy motor condition. However, scratch losses were slightly higher. The highest power loss values were 667 W and 665 W for fault 2 and fault 4, respectively.

In the healthy motor condition, an approximate efficiency of 77 % was achieved. The presence of faults causes a reduction in motor efficiency due to currency fluctuations and the thermal stress produced by the failure conditions. In the case of broken rotor bar failures (fault 1 and fault 2), the efficiency is reduced in a range of 75.5 %-76 %. For scratches in the end ring, there is a greater reduction, reaching a minimum value of 74.3 % in the efficiency of the motor. This behavior is attributed to the greater loss of core power produced by the scrapes (see Figure 5).

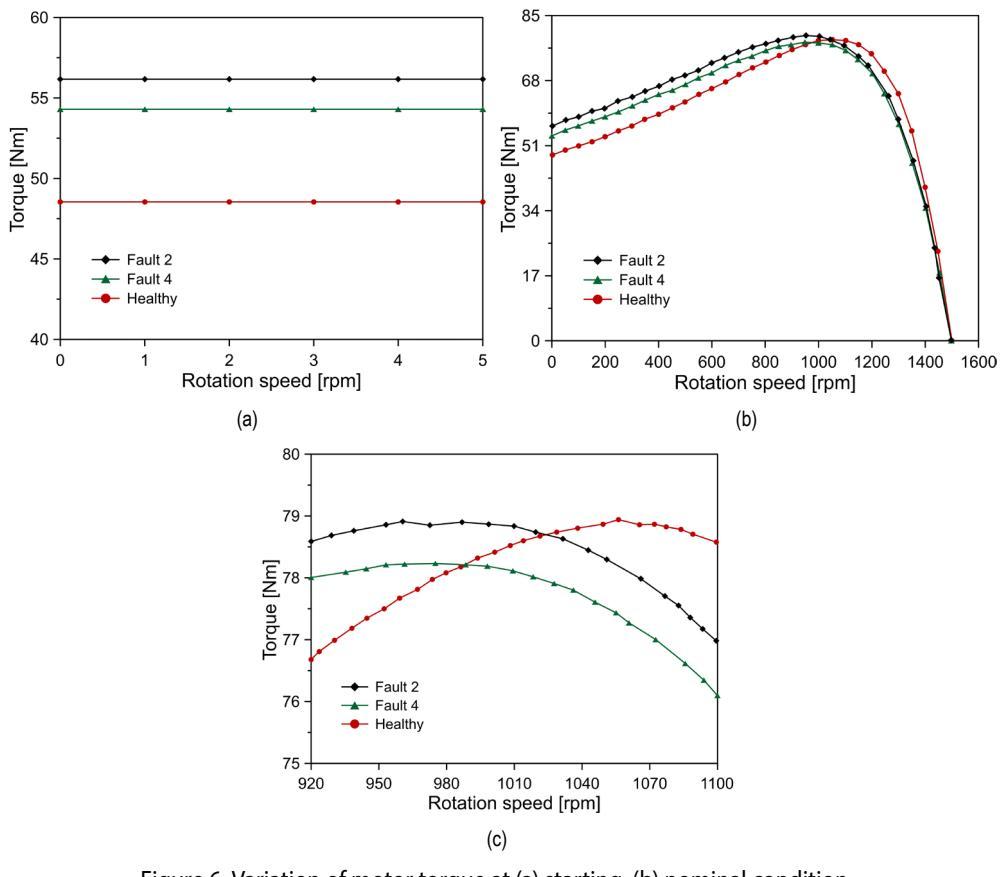
Figure 6. Variation of motor torque at (a) starting, (b) nominal condition, and (c) maximum torque for fault conditions. Source: own elaboration.

Figure 6a shows the results of the motor starting test, which consists of measuring the torque that the electric motor developed when it starts from zero speed. By installing a pony brake, the starting torque was measured. According to the starting condition shown in Figure 6a, the presence of the two types of failures increases the torque, which is aligned with the modulation in this parameter with failure progression. Specifically, for broken bar failure (fault 2) and end ring scraping (fault 4), an approximate torque of 56 Nm and 54 Nm was observed, respectively, which represents an increase of 15.6 % and 11.8 % compared to the healthy state.

Figure 6b and Figure 6c show the relationship between rotational speed and motor torque. For the construction of this curve, a direct measurement method was used, in which the pony brake is used to vary the rotational speed conditions and measure the torque that is being exerted on the motor. The test is performed at a nominal

voltage condition. Rotation speed was determined by a crank angle sensor (Beck Arnley 180-042). Specifically, it is observed that the torque developed is higher at low rotational speeds when compared to the healthy condition; however, as the rotation speed rises, the torque drops behind the values of the healthy condition. The latter results from the magnification of the magnetic field disturbance as the rotation speed increases, which induces greater vibration in the motor that further deteriorates the output torque [28]. The effect is relevant at maximum torque conditions, which elucidates the benefits of maintaining operation within the rated load conditions to prevent failures and maximize the overall performance. In general, failure related to the defect in the joint between the rotor bars and the end ring promotes the greatest reduction in the maximum torque.

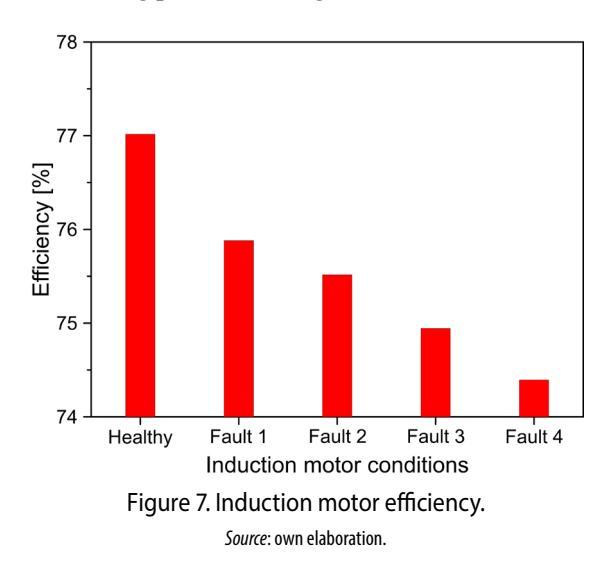
To provide a wider perspective of the influence of the failure conditions, Figure 7 displays the overall efficiency of the cases analyzed. The efficiency of the motor is determined by equation (1), which is based on the standard test procedure for polyphase induction motors and generators [34].

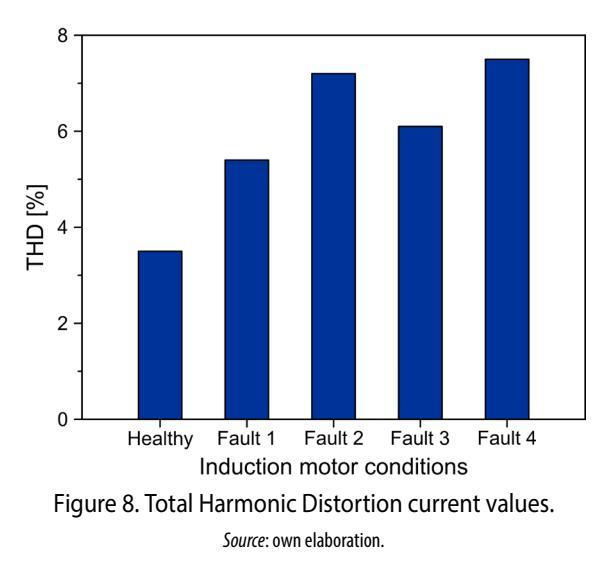
To study the Total Harmonic Distortion (THD) for the current produced by faults in the induction motor, the calculations are performed for the healthy state and fault conditions. The tests were performed under a load condition on the motor. The results are shown in Figure 8.

The results shown in Figure 8 indicate that broken rotor bar failures and scratches in the end ring boost the THD up to 106 % and 114 %, respectively, compared to the healthy state. This behavior is a direct consequence of higher currents as the severity of each failure progress [25]. The maximum harmonic distortion was 7.2 % and 7.5 %, achieved under fault 2 and fault 4. The increase in THD is made more visible by observing the odd harmonics of each condition, as shown in Figure 9.

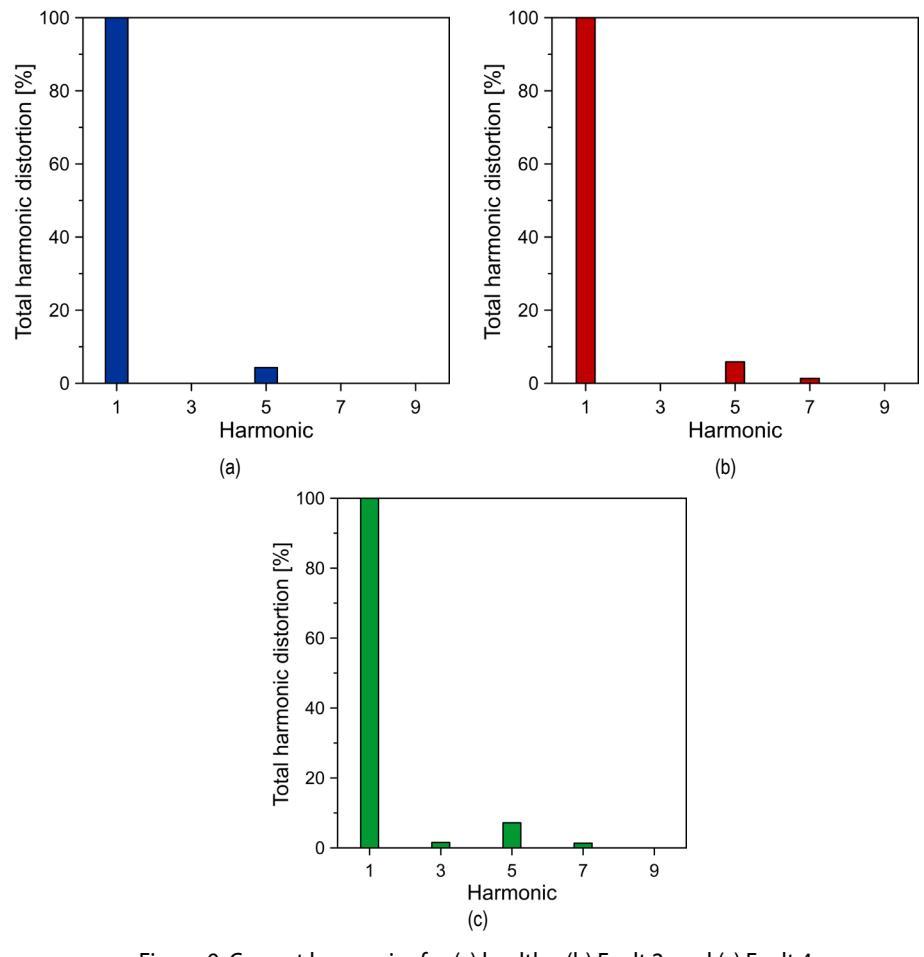
Figure 9. Current harmonics for (a) healthy, (b) Fault 2, and (c) Fault 4. Source: own elaboration.

It is observed that the harmonic 5 escalates by 36 % (fault 2) and 67 % (fault 4) with the presence of failures when compared to the healthy base case. Additionally, the appearance of harmonic 7 occurred for the failure of broken bars in the rotor and the appearance of harmonics 7 and 3 for scratches in the end ring. The latter becomes relevant since it represents a direct sign of failure progression.

Lastly, the harmonic analysis provides clear signs of the probability of failure initiation and progression as ratified through the study by the appearance of harmonics 3 and 7. Additionally, both types of failures augmented the amplitude of harmonic 5 by up to 67 %.
