**ELECTRICAL IMAGING TECHNIQUES  
FOR GROUNDWATER POLLUTION STUDIES:  
A CASE STUDY FROM TAMIL NADU STATE, SOUTH INDIA**

**ABSTRACT**

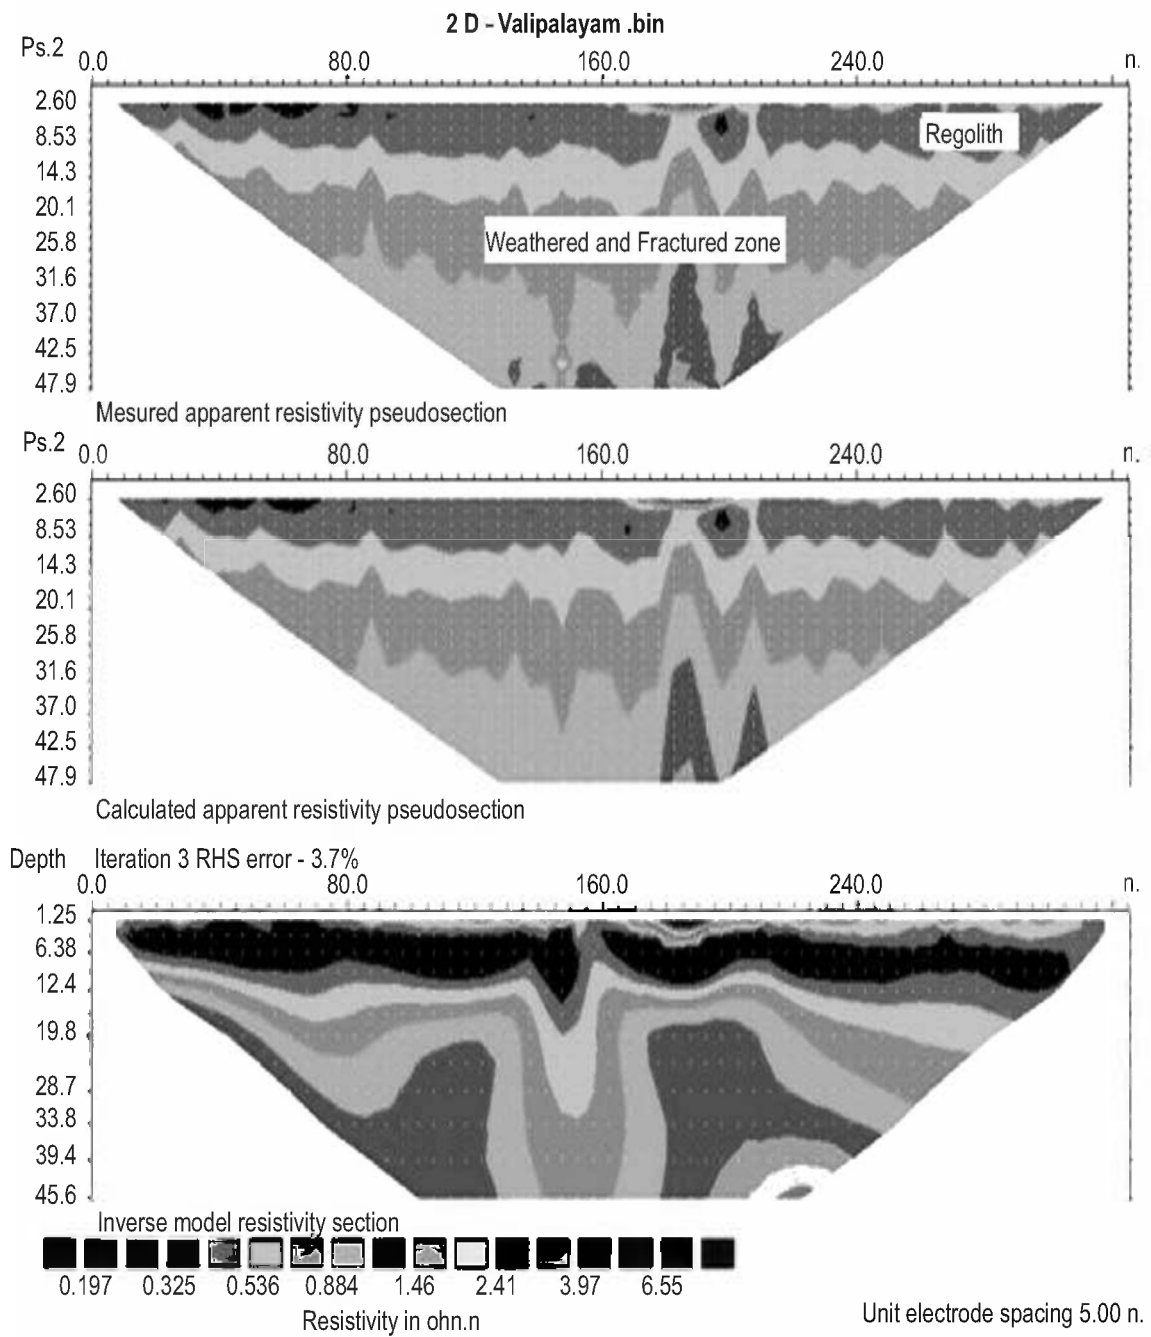
**Figure 2.** Resistivity imaging at Valipalayam.

The first survey was conducted at Valipalayam 1Km from river Noyyal (Figure 2). The profile shows a low resistivity zone ranging from 10 to 100  $\Omega$  m, indicating presence of highly weathered rock materials. The basic concept of electrical resistivity method is to demarcate higher resistivity zones within the low electrical resistivity rocks at the sub surface. This is because; the very low resistivity is an indicator of highly weathered rock material. The regolith with a resistivity range of <10  $\Omega$  m is found at a depth of 8 m indicating the contamination of top soil due to the discharge of effluents. The weathered and fractured zones were identified at a depth of 27 to 47 m with increase in resistivity from 46 to 95.5  $\Omega$  m indicating that the deeper layers are exposed to groundwater contamination in the absence of clay materials (Ron barker and others, 2001).

An attempt was made in Tirupur a highly industrialized zone to determine the extent of pollution in aquifers by using ERT techniques. A total of 4 profiles were conducted more or less 1 KM and parallel to river Noyyal. The profile at Valipalayam indicates contamination of top soil by a drop in resistivity by  $< 10 \Omega$  m at a depth of 8 m. The weathered and fractured zones identified at depth of 27 to 47 m with greater resistivity range indicate deeper layers without any groundwater contamination. The second pro-

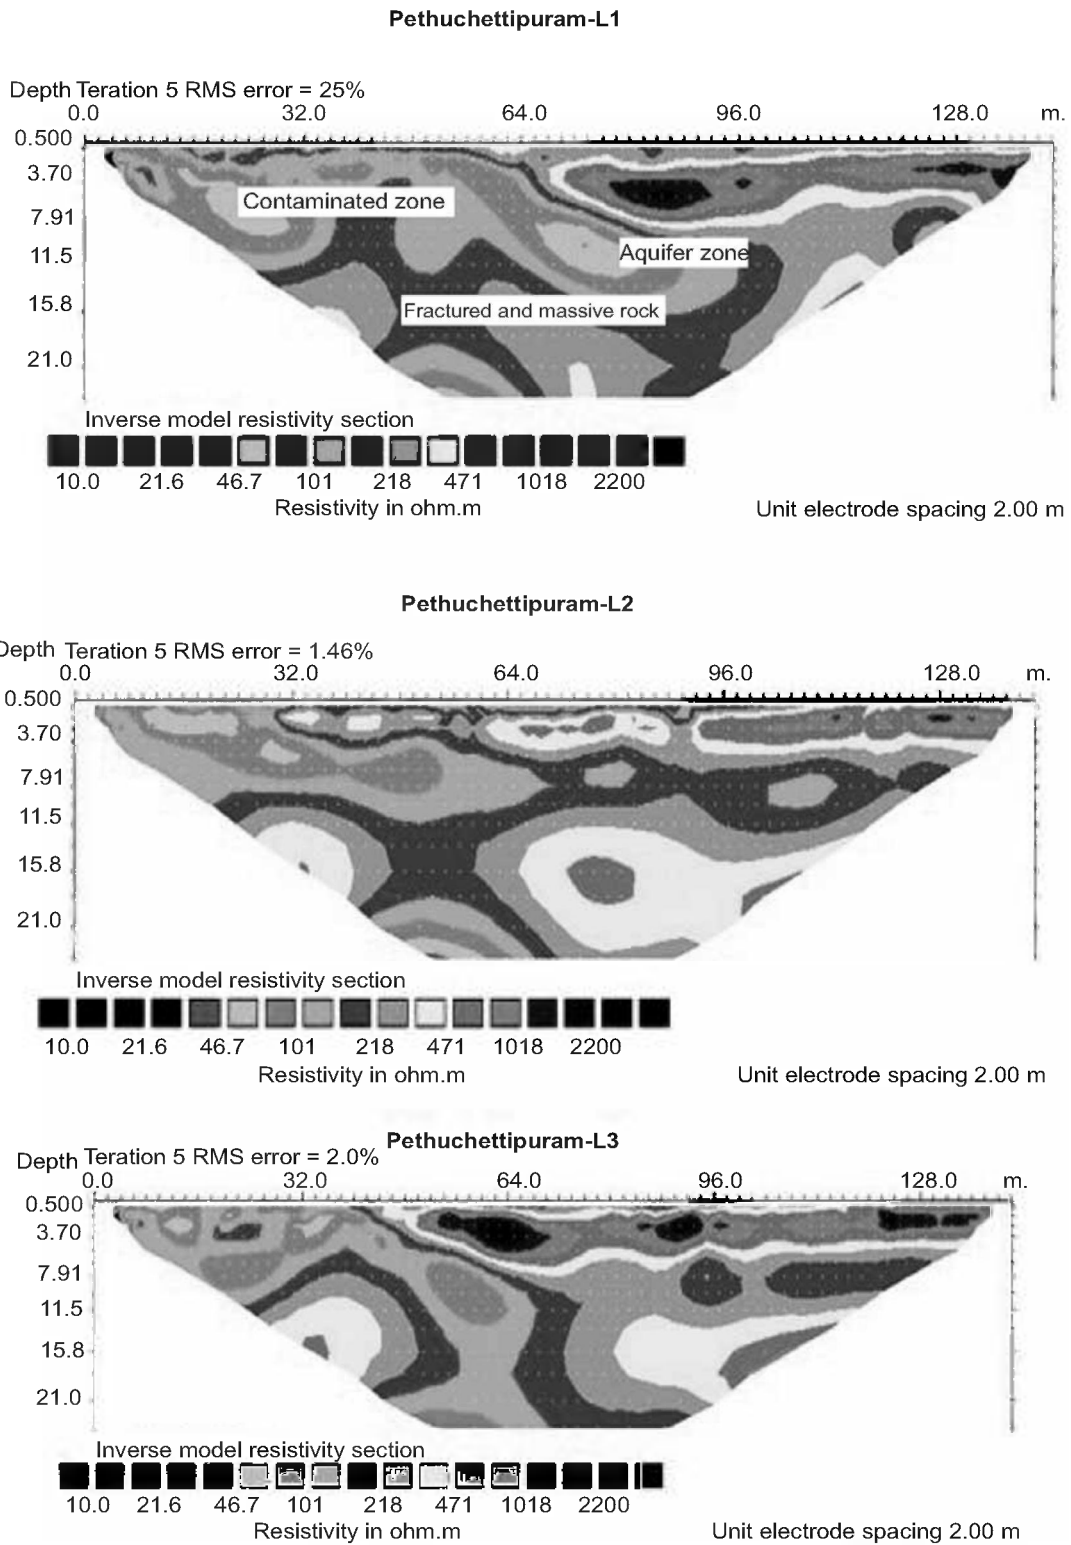
**Figure 3.** Resistivity imaging at Pethuchettipuram.

The second survey was conducted near Pethichettipuram just 1Km away from the Noyyal river. The survey indicates source of contamination at left end corner with a drop in resistivity by <46.5  $\Omega$  m at a depth of 7.91 m (Figure 3). The same trend was also noted at a depth of 11.5 m with a drop in resistivity by <21.6  $\Omega$  m indicating the contaminated zone at deeper regoliths. This is supported by a groundwater sample collected in a dug well to a depth of 15m showing higher TDS value >3,500 ppm. The fractured and massive rocks revealed higher resistivity varying from 46.7 to 2200  $\Omega$  m indicating the non polluted nature of deeper formations. A thin subsurface layer with low resistivity extends to deeper area in the middle of the profile, followed by a thick layer with high resistivity (resistivity greater than 1000  $\Omega$  m) acting as a basin at deeper depth (Apparao and Sarma, 1993). This basin is more dominant at the last quarter of the traverse where it is closer to the surface. This high resistivity layer could represent the bedrock, which is competent without

any structures. From the survey result a geological division is observed between the lower and high resistivity materials. In the central part of the profile a very low resistivity zone exist, indicating existence of an aquifer within the profile, based on its lower resistivity in relation to the background resistivity.

file conducted near Pethichettipuram indicates sources of contamination at a depth of 7.91 m with a drop in resistivity  $< 46.5 \Omega$  m. Another drop in resistivity at a depth of 11.5 m indicates the contaminated nature of the deeper regolith. The fractured and massive rocks follow the same trend like that of the first location with greater resistivity. The third survey conducted in Palayakadu indicates greater contamination of regolith at a depth of 0 to 20 m with a resistivity less than 40  $\Omega$  m. Bed rock resistivity was higher  $> 1058 \Omega$  m indicating their massiveness present at shallow depth. The fourth survey conducted at Chellapuram indicates high resistivity rock materials which are layered and boundaries of the different resistivity materials are clearly defined by the sharp change in electrical resistivity. The high resistivity observed is typical of fresh granite rocks. From a total of four profiles the first, third and fourth showed top 10 to 25 m of regolith has resistivity of less than 10  $\Omega$  m, with top 5 m having a resistivity of less than 10  $\Omega$  m indicating soil with greater contamination. The second profile has shown low resistivity at pockets at shallower depth and resistivity of above 100  $\Omega$  m is not contaminated. None of the five images measured across the contaminated sites show any strong lateral change in resistivity and it must be admitted that similar information could be obtained with resistivity sounding. A few soundings over the

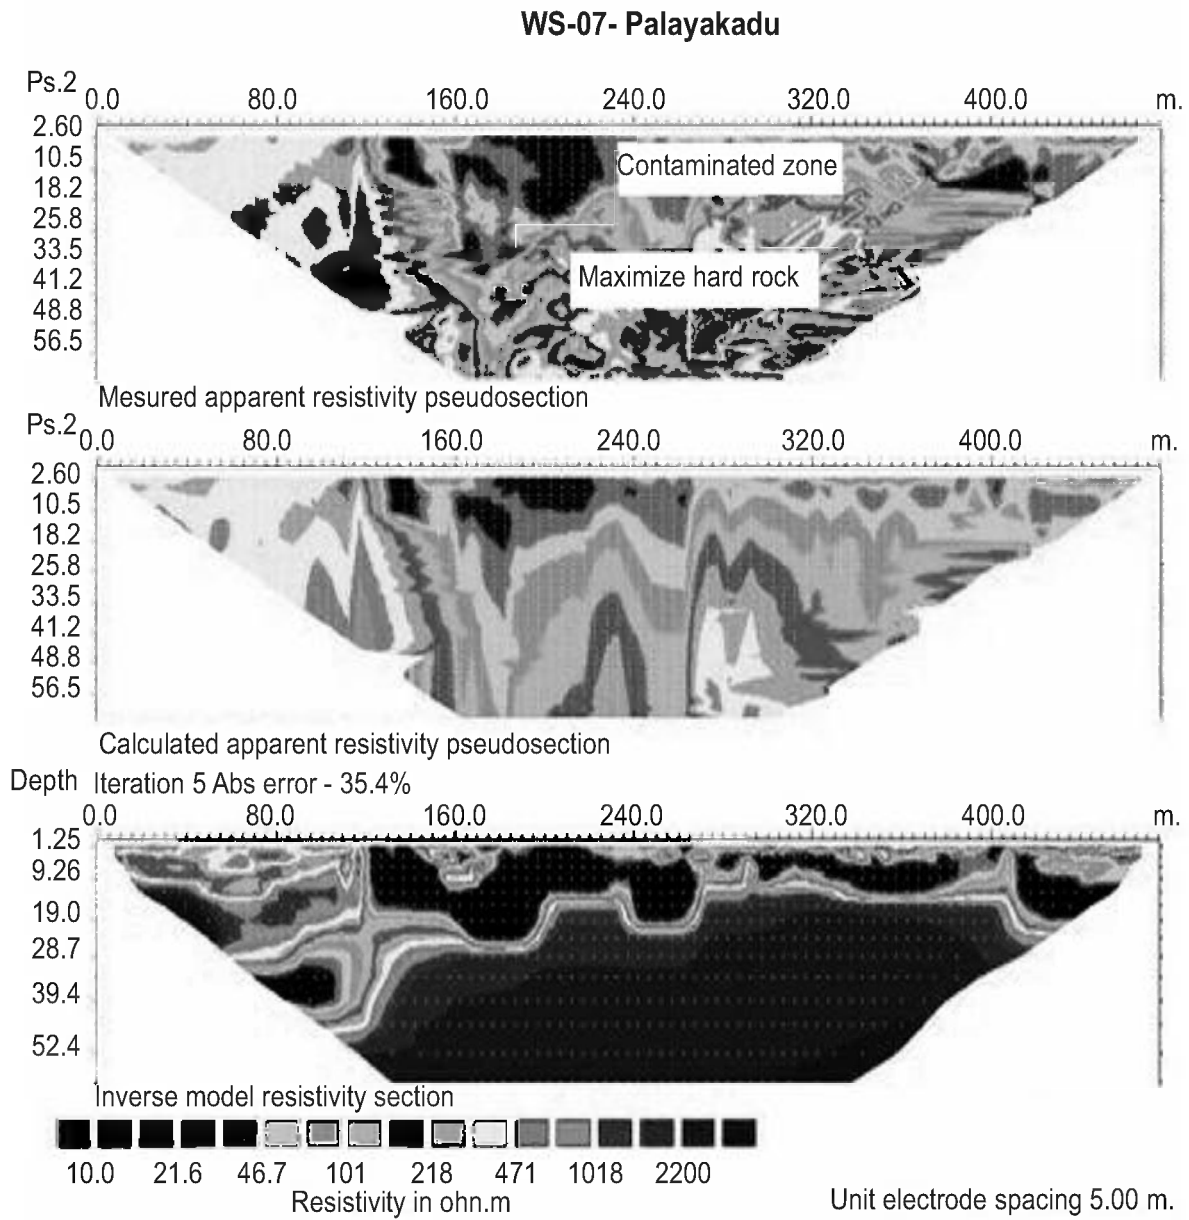
**Figure 4.** Resistivity imaging at Palayakadu.

The third survey was conducted in Palayakadu (Figure 4), indicating extensive contamination of regolith from ground surface to 20 m as the resistivity of the regolith drops less than 40  $\Omega$  m. Bed rock resistivity was higher >1058  $\Omega$  m indicating their massiveness at shallow depth. The profile produced three different resistivity of layered rock which is clearly defined by their different resistivity layers at various depths as follows; A thin subsurface layer with comparatively low resistivity values ranging from 10 to 46.7  $\Omega$  m at an depth of about 15 m. This layer of low resistivity is typical of weathered rock materials of the underlying rocks in the area. An intermediate resistivity layer ranging from 101 to 218  $\Omega$  m at the intermediate depth zone, which could be represented as weathered to moderately weathered rock material. This depth layer between the depth ranges (15-40 m) has a comparatively moderate resistivity from 150 to 1018  $\Omega$  m. A thick layer with a comparatively high resistivity (>218  $\Omega$  m) is also observed below the layers of low to intermediate resistivity rocks. This relatively high resistivity rock layer represents the presence of fresh rock material with no structural patterns like fractures and joints, as good indications for aquifers (Kelley, 1976) due to their sheared nature represented by the wavy pattern. The shallow depth layers could also be interpreted to be layers of different rock materials. The resistivity layers of the different rock materials in the range (180 to 1080  $\Omega$  m) and its contact with the fresh rock observed at a depth range of about 55 m was also accounted.

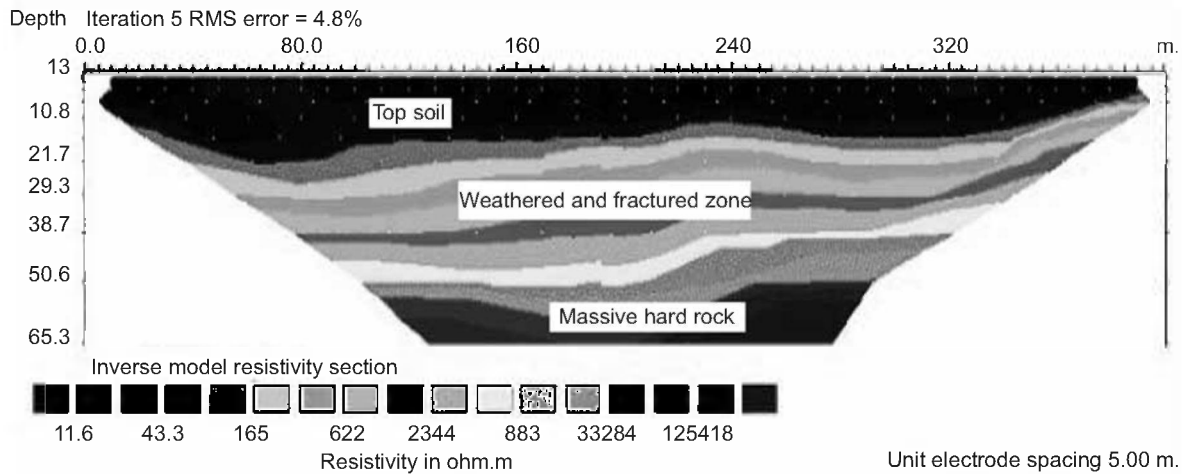
**Figure 5.** Resistivity imaging at Chellapuram.

The fourth survey conducted at Chellapuram is shown in (Figure 5). The profile indicates that the area is underlined by varying high resistivity rock materials by sharp changes in their electrical resistivity values. The high resistivities observed are typical of fresh granite rocks. The general structural trend observed is as follows; an overburden with low resistivity to a

depth of about 29.3m with a resistivity range of (11 to 45  $\Omega$  m). This layer is due to the presence of weathered materials with greater risk of contamination (Urish, 1983). An intermediate zone with resistivity range from 663 to 3328  $\Omega$  m at a depth of 21.1 to 38.7 m is noted. A very high resistivity zone (125418  $\Omega$  m) is observed at a depth of 55 m indicates fresh rock material without any structural pattern like folds and faults. Resistivity distributions observed at greater depth are high when compared with low resistivity values observed at the surface. The profile therefore could be interpreted as the different layering of weathering with low resistivity values on the surface and higher resistivity values are confined to the fresh electrical resistant rock materials.
