# Electrical performance of distribution insulators with *chlorella vulgaris* growth on its surface

### ABSTRACT

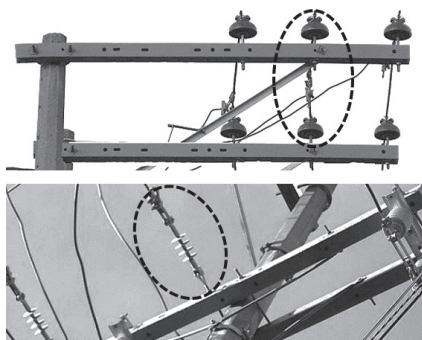
**Figure 1.** Examples of distribution insulators used in Colombia.  
Source: <http://www.maderplast.com/>

materials, glass and resin) materials. An example of ceramic and polymeric insulator applications is shown in Figure 1. Some of these ceramic insulators are approaching more than 15 years in service, while a great quantity of non-ceramic insulators have service exposures of about 3 to 10 years.

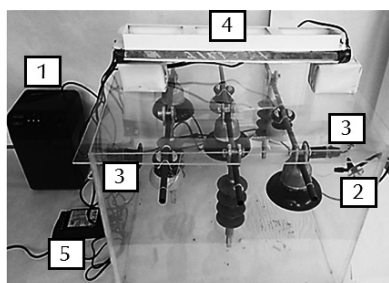
**Figure 4.** Elements of the CEC. (1) humidity system, (2) spray nozzles, (3) ceramic bulbs, (4) UV radiation lamps, (5) lighting control system.

The CEC recreates the specific conditions for algae growth, keeping the temperature range between 23-28 °C, maintaining the relative humidity between 80-100% and controlling cycles of 12 hours of light (to represent day and night). In order to achieve this, a microcontroller Arduino Leonardo was used to automate and control the CEC (León et al., 2014). The control system acquires the information

from the measurements provided by two dual (temperature-humidity) RHT-03 sensors. Later, these variables are compared with reference values previously established.

Once the variables are evaluated and compared, the mechanism of the high pressure misting, heat emitter and day-light cycle are triggered according to the reference values. Finally, to provide an adequate exposition to the environmental conditions, the insulators are placed inside the chamber in a random position.

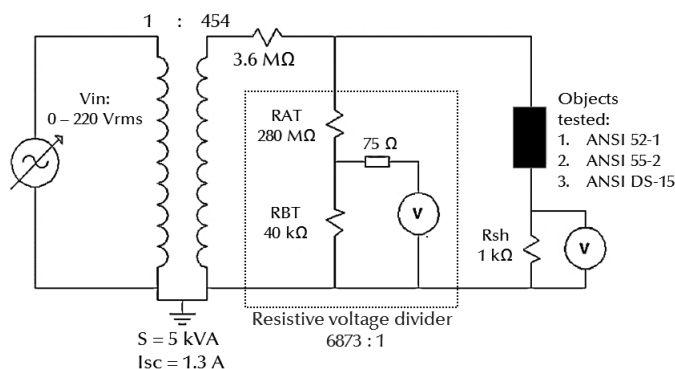
Figure 8. Circuit used for FOV, WFOV and LC in all laboratory tests.

The procedure used to develop the electrical tests is defined by the Colombian national standard NTC 1285 (Instituto Colombiano de Normas Técnicas - ICONTEC, 2002). The test circuit used in LAT-UD to measure the FOV, WFOV and LC in all insulators is shown in Figure 8.

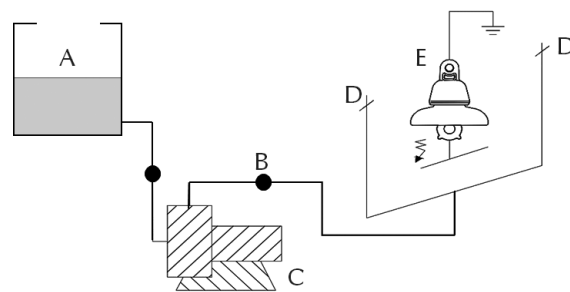
Figure 9. Scheme used for wet laboratory tests (A) water tank, (B) precipitation control, (C) pump, (D) spray nozzles, (E) insulator.

On the other hand, the testing facilities used in wet conditions are the same used in dry conditions. However, the standard NTC 1258 requires the inclusion of a uniform spray on the insulators surface in order to realize the wet tests. Figure 9 shows the scheme to produce the artificial spray at LAT-UD. In this case, a Monsoon RS400 unit was used as artificial spray system. This system is composed by a pump and a water tank with capacity of 9.5 liters. Finally, the output of the system is composed by two nozzles that have variable pressure and adjustable direction.

According to NTC 1258 the artificial spray should be directed in a downward form, so that when it hits the surface of the insulator an angle of 45° must be formed. In addition to this, the vertical precipitation rate is defined in 5mm per minute, the water temperature should be similar

to environmental temperature and the water used during tests should have a resistivity between 151 and 205 [Ω·m].

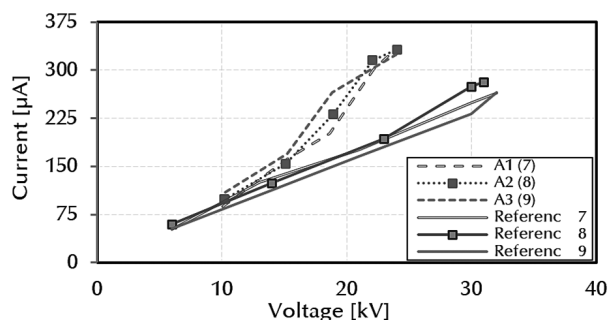
**Figure 10.** Leakage currents for ANSI 55-2 before and after *Chlorella vulgaris* contamination.

For LC measurements, a set of voltages between 5kV and the 75 % of the FOV were applied. A shunt resistor of 1k $\Omega$  was used to get the current that flows to earth using the Ohm's law and the voltage across the shunt. To analyze the behavior of leakage currents each insulator was distinguished by a different number. Figures 10, 11 and Figure 12 show the leakage current curves (before and after contamination) of suspension ceramic, pin ceramic and polymeric insulators, respectively. In all cases, the solid lines represent the reference values and dotted lines are related with biocontamination tests.

Experimental tests show that ANSI 55-2 insulators contaminated with algae have higher leakage currents (at same voltage) compared to reference tests. In the case of bio-contaminated insulators, they reached values close to 350 $\mu$ A with an applied voltage of 24kV, while for clean insulators the leakage current reached 260  $\mu$ A when 30kV was applied.

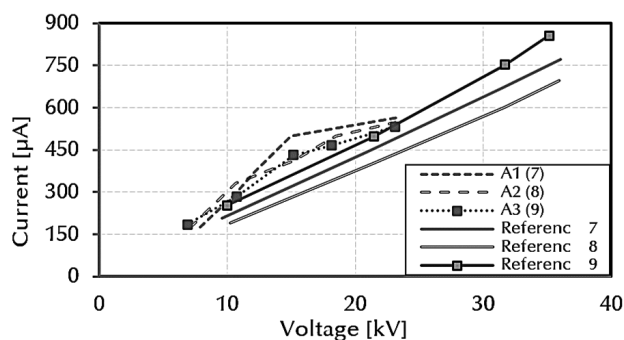
**Figure 11.** Leakage currents for ANSI 51-2 before and after *Chlorella vulgaris* contamination.

In the range between 8 and 24 kV the leakage currents in suspension ceramic insulators (ANSI 52-1) contaminated with *Chlorella vulgaris* show slight changes with respect to currents obtained with the reference group, reaching maximum values of 520  $\mu\text{A}$ . However, the applied voltages during biocontamination tests (before multiple discharges generation) are less than the voltages achieved in reference tests. This value was reduced in 30 % with respect to reference tests where clean insulators achieved voltages up to 36 kV.

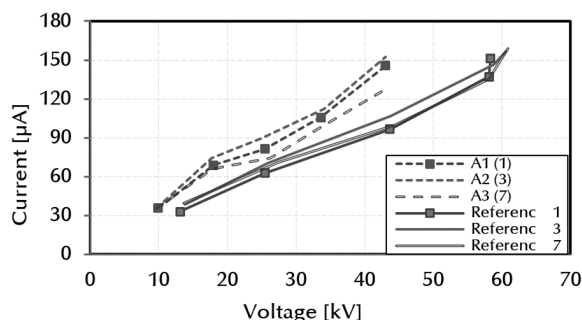
**Figure 12.** Leakage currents for ANSI DS-15 before and after *Chlorella vulgaris* contamination.

Finally, for polymeric insulators the maximum values of leakage currents are near to 150  $\mu\text{A}$ , in both, clean and contaminated insulators. However, the applied voltages during test with contaminated samples were close to 42 kV in comparison to the 60 kV achieved in reference tests.
