# Application of physico-chemical indexes and BMWP / Col. to establish the impact of urbanization on Río Frío (Bucaramanga, Colombia)

Application of physico-chemical indexes  
and BMWP / Col. to establish the  
impact of urbanization on Río Frío  
(Bucaramanga, Colombia)

*Universitas Scientiarum*, 23 (1): 109-128, 2018.

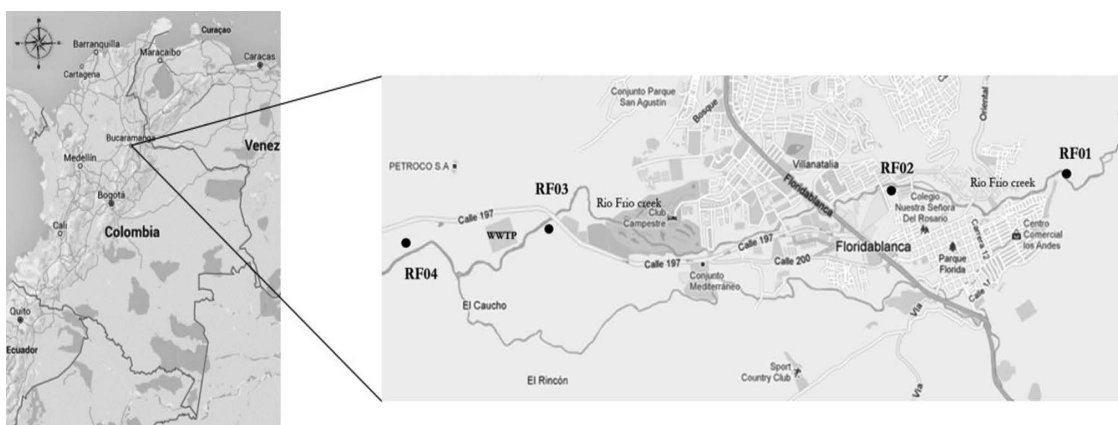
**Figure 1.** Río Frío (Bucaramanga-Santander-Colombia) sampling sites location. Source: Google Earth map (2016).

Location of Río Frío sampling sites is presented in **Fig. 1**

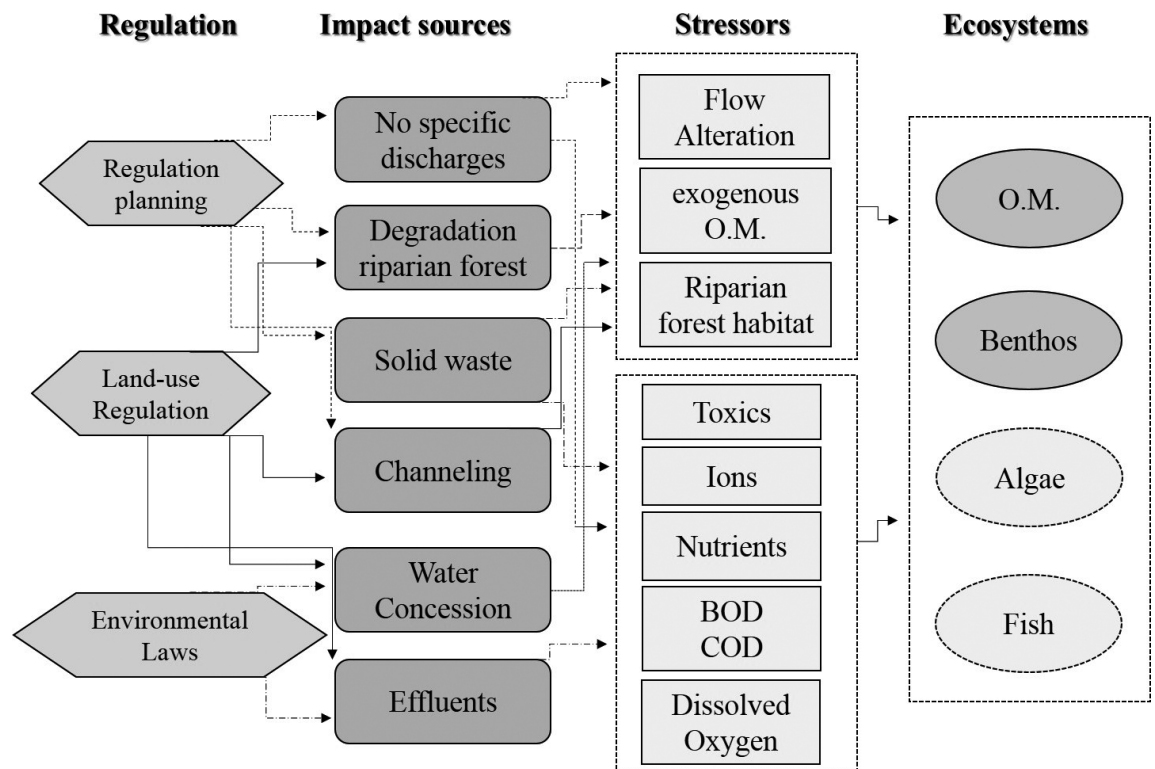
Likewise, it also serves as guidance for impact identification of urban growth on rivers at a regional level. The diagram is divided into four columns. The first column -regulation- determined regulation instruments involved in urban activity. These include land use planning, which takes into account actions exerted by curators, regional and national territorial planning (*plan de ordenamiento territorial* POT), and current Colombian environmental legislation to protect water, air, soil, and watersheds, among others.

**Figure 2.** Conceptual model of urban impacts on Río Frío. O.M.: organic matter.

Using Wenger *et al.* 2009 proposed guidelines [32], a conceptual model was structured to establish possible impacts Río Frío receives as an urban stream pilot (Fig. 2).

The second column identified sources of impact along the basins. Within this category the first three are related to human urban activity, and the last two to those directly related to legal procedures. The third column determined attributes generating stress in aquatic communities, named stressors. Two types of stressors were acknowledged: exogenous or outside the water or on river or stream banks (water flow alterations, exogenous or external organic matter, - also named contributions - and alterations of riparian forest or gallery forest, accompanying basins). The other type of stressor is endogenous, present in the water column (toxic ions, dissolved gases, nutrients, endogenous organic matter, etc.). Stressors are the result of impact sources. Some may be more influential than others, for example, alteration of riparian forest can have an effect on flow disturbance and the contribution of ions or nutrients to the river [33, 34] in contrast to normal flood fluctuation of the riparian zone.

The last column describes ecosystem components, such as endogenous and exogenous organic matter. In addition, elements of the ecosystem also involve freshwater communities: benthos, fish, and algae. In the present study only benthic macroinvertebrate fauna, organisms that live and develop in the bottom of rivers or lentic systems, was studied [14].
